**SERVICE INFORMATION BULLETIN**

**APPLICABILITY:** 2020MY-2023MY Legacy & Outback  
2022MY-2023MY WRX

**NUMBER:** 15-273-20

**SUBJECT:** Denso CP1 BASE (Dual 7" Display Screen)  
Erratic Operation

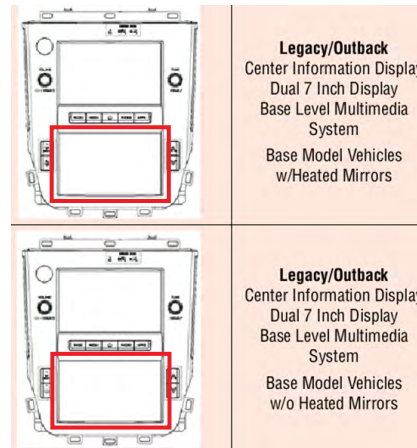
This Service Information Bulletin addresses isolated customer concerns regarding the pictured CP1 BASE Model Center Information Display (CID) LOWER 7-inch display screen flashing, not responding to touch inputs and / or shutting off intermittently.

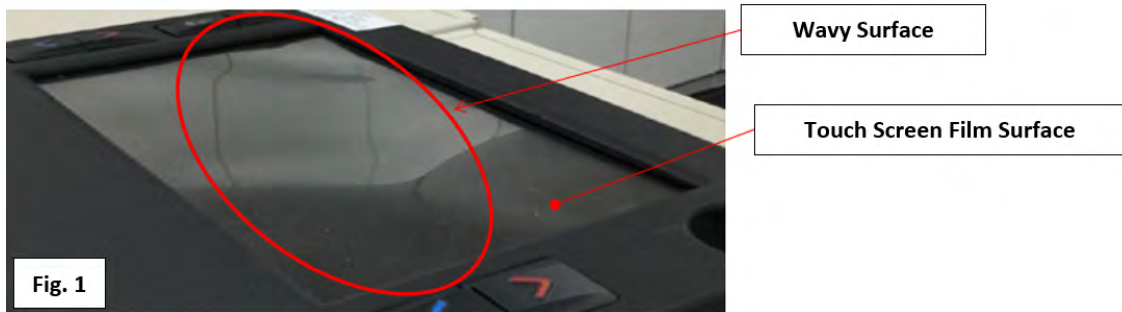
Check for any deformation or waviness of the touch screen surface. Inspect the surface condition diagonally with light reflecting on it at various angles. Is any waviness visible as shown in **Fig. 1** below?

- **If YES:** Replace the CID display component because the surface of the touch screen is deformed.
- **If NO:** Proceed to **Step 2**.

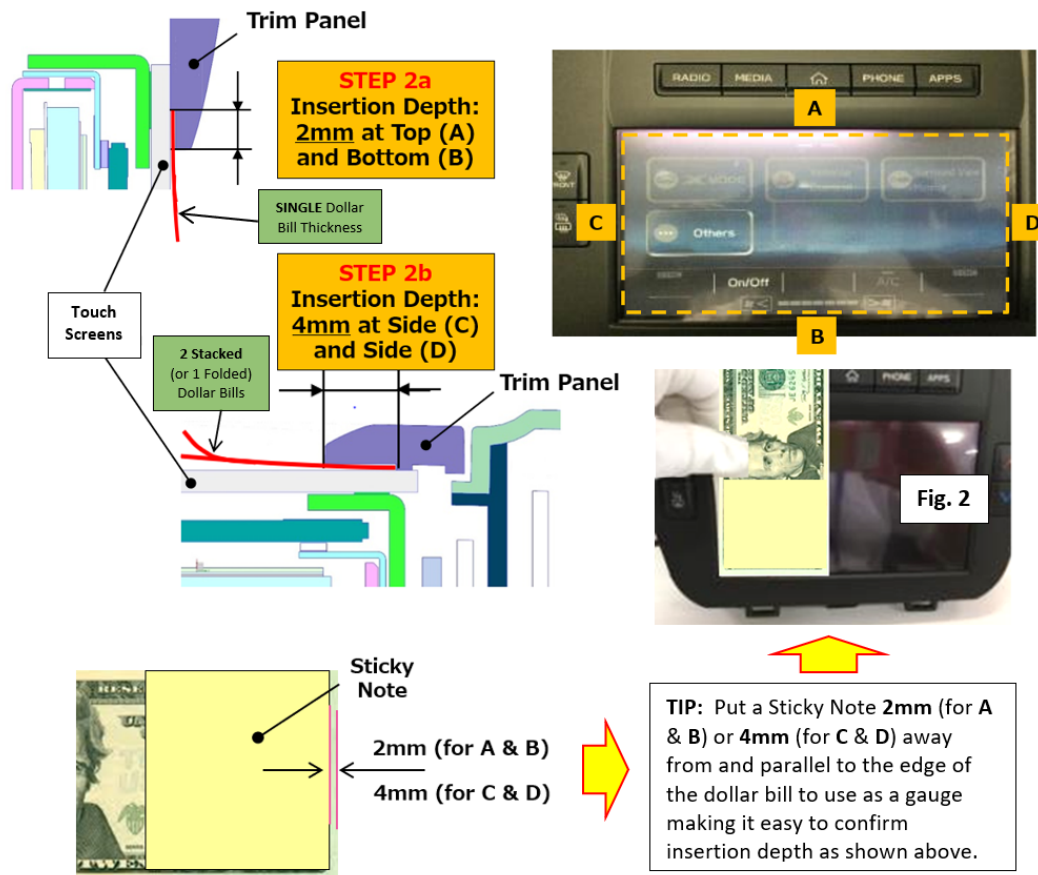
- **2a:** Insert a (preferably a crisp, new) dollar bill into the gaps between the touch screen and the surrounding trim panel along the top (**A**) and bottom (**B**) as shown in the **Fig. 2** example below. The dollar bill should be able to be inserted **2mm** into the full width of both the top and bottom gaps.
- **2b:** Insert a dollar bill folded in half (to provide 2 thicknesses) into the gaps between the touch screen and the surrounding trim panel along the sides (**C**) & (**D**). The folded dollar bill should be able to be inserted **4mm** into the side gaps from top to bottom.

- If the dollar bill can be inserted into the gap **2mm** on the **Top** and **Bottom** and **4mm** on **BOTH** sides, there is no deformation of the touch screen or surrounding trim panel. Proceed to **Step 4**.
- If the dollar bill cannot be inserted, replace the CID because the surrounding trim panel and / or touch screen are likely deformed.

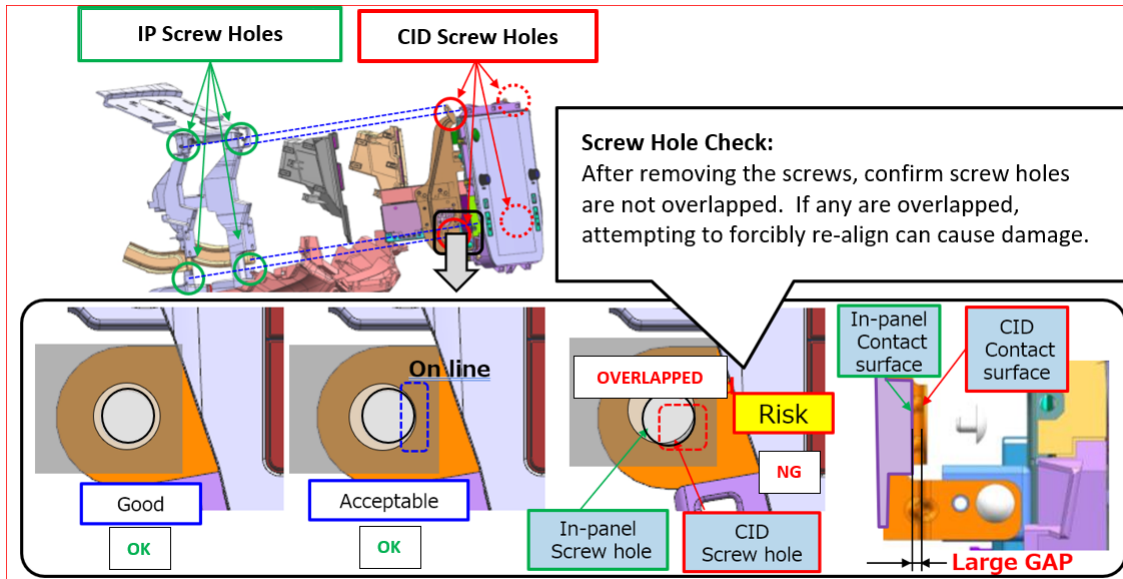
- Inspect the screw holes of the IP and the bracket following the illustrations below. If the screw hole(s) are overlapped, **CAREFULLY** re-align to Acceptable or “**OK**” as shown below.
- Inspect the gap between contact surfaces of the IP and the bracket following the illustration below. If a gap exists between the two contact surfaces, **CAREFULLY** adjust the seating / alignment by changing the tightening order of the retaining screws.

**TIP:** If there is too much mis-alignment, **CAREFULLY** loosen the other three screws, let things settle, then try tightening them again in a different order to see if the alignment improves before installing the final screw or, loosen them all, let things settle then tighten again but in stages so any one hole is not too far offset (beyond **OK**).

- **If YES:** The condition persists, replace the CID.
- **If NO:** The condition no longer persists. Operate the unit for an extended period to confirm a successful repair.
