Warning Message “Engine Control System Malfunction” in Conjunction With Error Memory Entry “P04F000” in the DME Control Unit: Checking Venturi Nozzle in Turbocharger Housing (02/23)

Vehicle Type: **911 (992)**

Concerns: **Venturi nozzle in turbocharger housing**

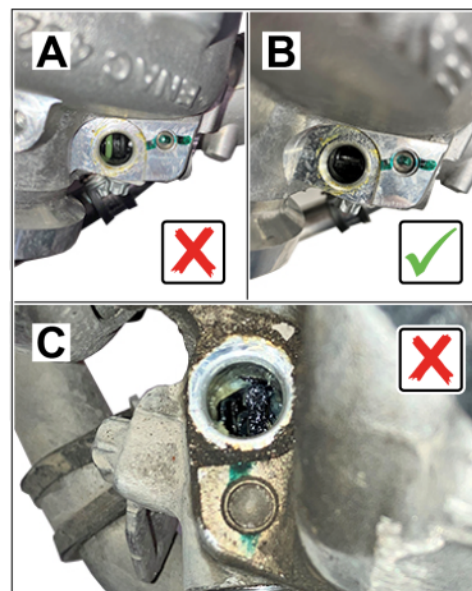
Venturi nozzle in turbocharger

If the Venturi nozzle is NOT installed correctly (as witnessed by the green seal being visible, -A-) and/or there is debris (-C-), please correct the installation and/or clean, respectively. Otherwise (-B-), please proceed to Step 4.

- 3 Check installation position of the Venturi nozzle in the turbocharger via the opening for the tank vent line.

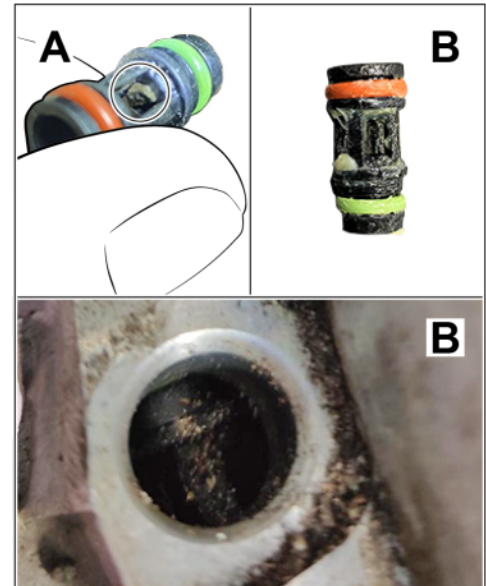
Venturi nozzle dirty

- 6 Check Venturi nozzle for foreign objects ⇒ *Venturi nozzle dirty -A-* or dirt ⇒ *Venturi nozzle dirty -B-*. Remove any foreign objects. Then continue with: ⇒ *Technical Information 'Cleaning and installing Venturi nozzle correctly'*
