Service Bulletin

Bulletin No.: 18-NA-073

Subject: Repair Guidelines for Engine Component Wear

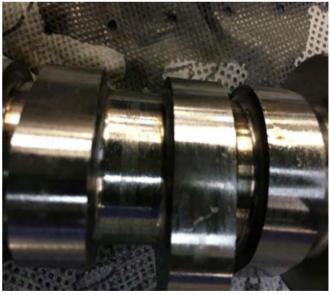
4994025

Example of minor scratching/scoring visible on camshaft lobes and/or camshaft bearing journals. In this example, the scored components can be replaced without need for engine assembly replacement.

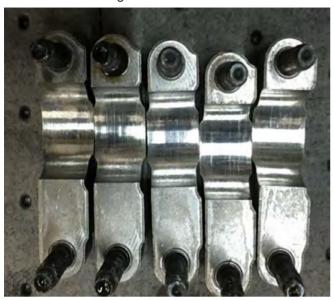
4991477

Example of minor scratching/scoring visible on camshaft bearing caps. In this example, the scored components can be replaced without need for engine assembly replacement.

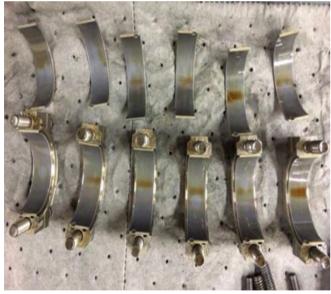
4992132

Example of minor scratching/scoring visible on connecting rod bearings. In this example, the scored components can be replaced without need for engine assembly replacement.

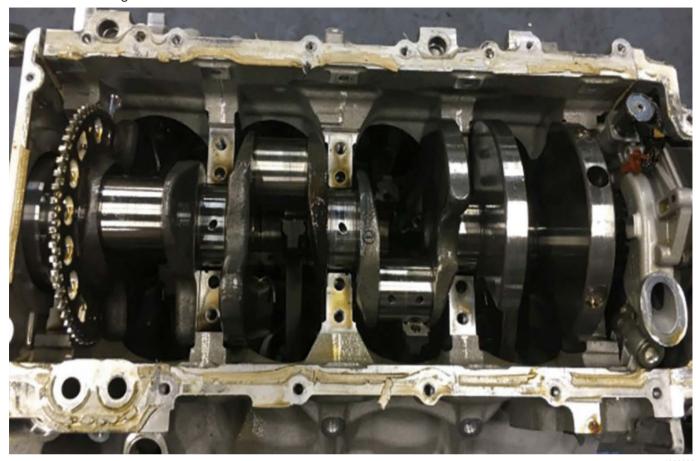
Example of minor scratching/scoring visible on crankshaft. In this example, the scored components can be replaced without need for engine assembly replacement.

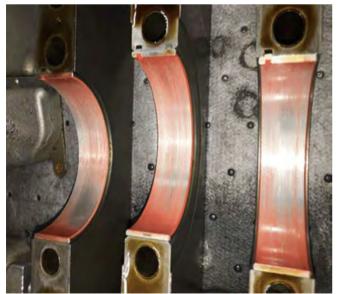
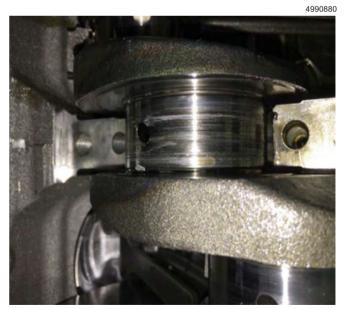
Example of minor scratching/scoring visible on crankshaft. In this example, the scored components can be replaced without need for engine assembly replacement.

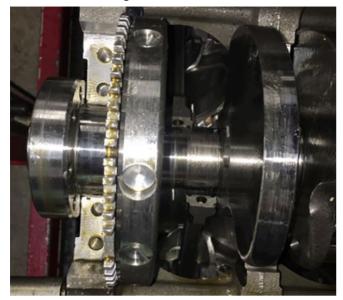
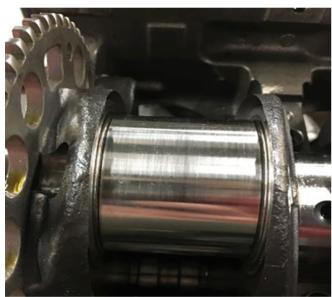
Example of minor scratching/scoring visible on crankshaft. In this example, the scored components can be replaced without need for engine assembly replacement.

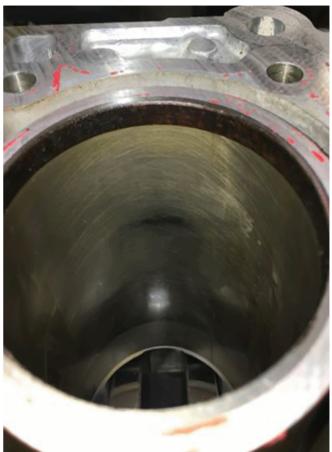
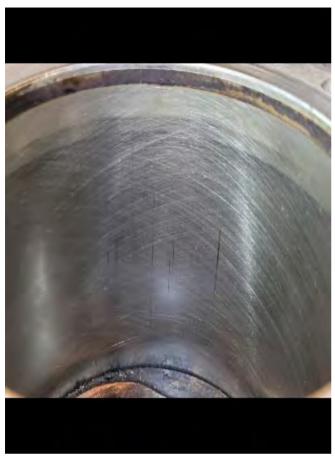
Important: If SI diagnosis leads to an inspection of the cylinder bores and reveals cylinder wall damage (i.e. excessive scoring or out-of-round), an engine replacement may be required. Refer to the Cylinder Bore section in this bulletin.

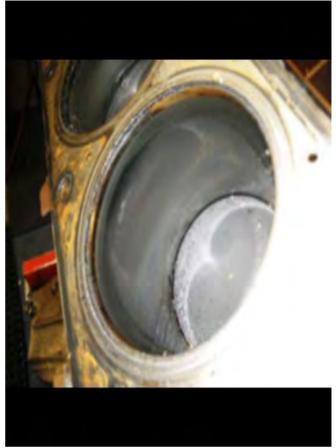
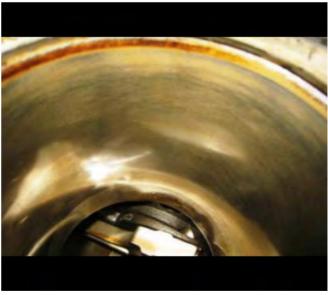
Suspecting an engine block of possible cylinder bore damage, scoring or out of round as the possible cause of engine oil consumption, misfire, cylinder leakage or blow by.

Note: The peak to valley suspecting an engine block of possible cylinder bore damage, scoring or out of round as the possible cause of engine oil consumption, misfire, cylinder leakage or blow by. spec for crosshatch is .65-2.8 microns. Any deviation and the crosshatch will be gone even if a cylinder is suspected of being oversize, we can only confirm that by checking with an air gauge at the engine plant.

- Cylinder damage or scoring The cylinder walls will contain grooves deep enough to catch with a fingernail.
- Out of round cylinder bore Contains areas where the crosshatch is missing or worn from different sections of the cylinder bore. If there is crosshatch all the way around the bore from top to bottom, the cylinder bore is not out of round.

- 3. Dirt intrusion If the filtering system has been compromised, the engine will wear out very quickly. You will find grit in the intake runners and the cylinder bores will look lightly sand blasted. The crosshatch will be faint and there will not be sharpness. At high mileage this may not be Warrantable if the air filtering system has been opened numerous times for service in dusty climates.

- 4. Catalytic converter failure If a converter fails and the brick is broken, the dust can be drawn back into the engine. A block showing this type of failure will have bores that look to be sand blasted. Back cylinders go first if caught early. Otherwise there will be no crosshatch and the engine will need to be replaced.

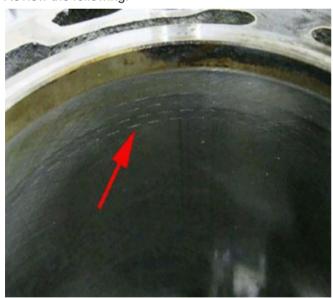
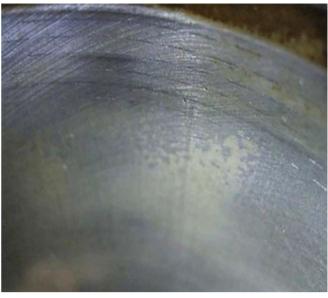
Some technicians may be replacing entire engine assemblies due to marks found at the top of the cylinder bore. These marks are considered normal and are left as a result of a manufacturing laser honing process. **DO NOT** replace the cylinder block or the engine for these normal laser honing marks (refer to PI0725B).

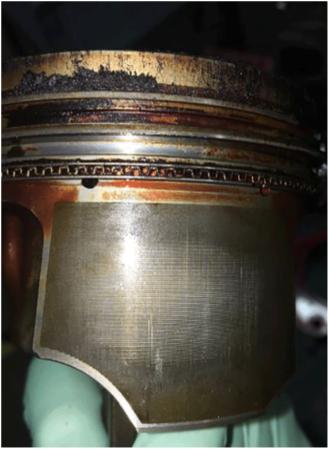
Example of minor scratching/scoring visible on piston. In this example, inspect for broken and/or stuck rings and piston ring lands and cylinder wall for damage. If no cylinder wall damage or other significant damage, components can be replaced without requiring an engine assembly replacement.

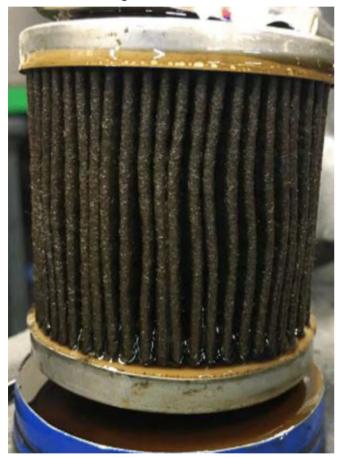
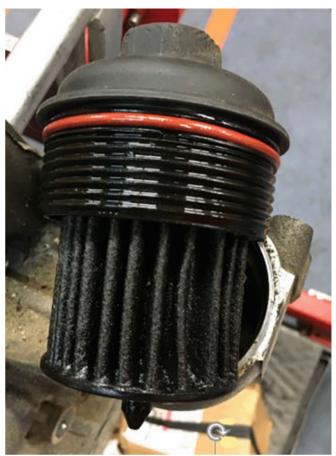
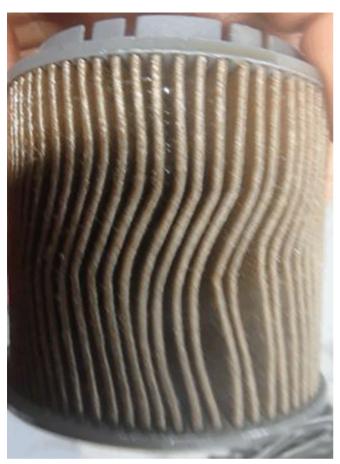
Shown are oil filter pleats with visible metal particles. In this example, minimal amounts of metal particles are visible on oil filter pleats and should not pose a concern.

If excessive amounts of metal particles are observed, or if there is evidence of damaged oil filter pleats, then unfiltered oil with bearing debris may have been pumped into the oil lubrication galleries throughout the engine. This will require further inspection to confirm the degree of contamination and appropriate repair direction. Refer to Service Bulletin #19-NA-256 for HFV6 Gen 1 and Gen 2.
