TECHNICAL SERVICE BULLETIN

Classification:	Reference:	Date:
DA19-011D	NTB19-042D	March 9, 2023

AUTOMATIC EMERGENCY BRAKING WARNING LIGHT BLINKING

APPLIED VEHICLES: 2019-2023 Altima (L34) 2022-2023 Pathfinder (R53)

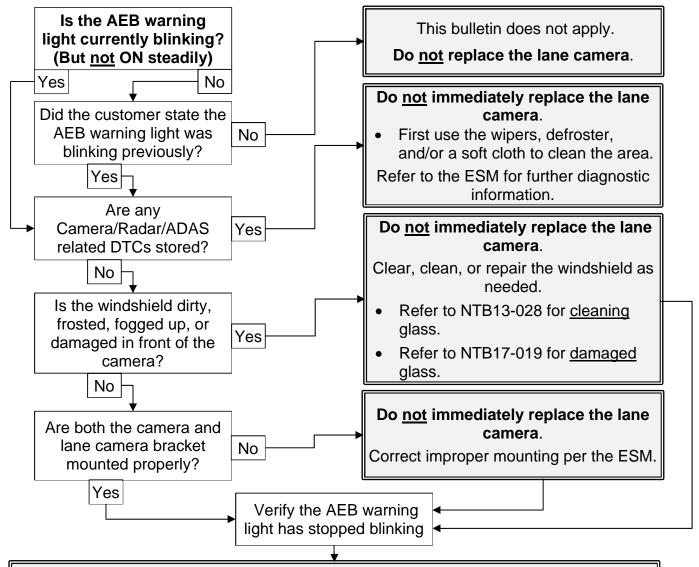
FLOW CHART

A blinking AEB warning light may occur under the following conditions:

- When contamination or foreign material adhere to the lane camera viewing window on the windshield.
- When driving while it is snowing or when frost forms on the lane camera viewing window on the windshield.
- When the lane camera viewing window on the windshield is temporarily fogged up.

Inform the customer the following conditions may cause the AEB warning light to blink:

- Heavy rain or thick fog may cause the light to blink. Good use of wipers and keeping the windshield clean will mitigate some of the issue.
- When contamination or foreign material adhere to the lane camera viewing window on the windshield.
- When driving while it is snowing or when frost forms on the lane camera viewing window on the windshield.
- When the lane camera viewing window on the windshield is temporarily fogged up.

Explain to the customer the difference between contamination detection and a malfunction.

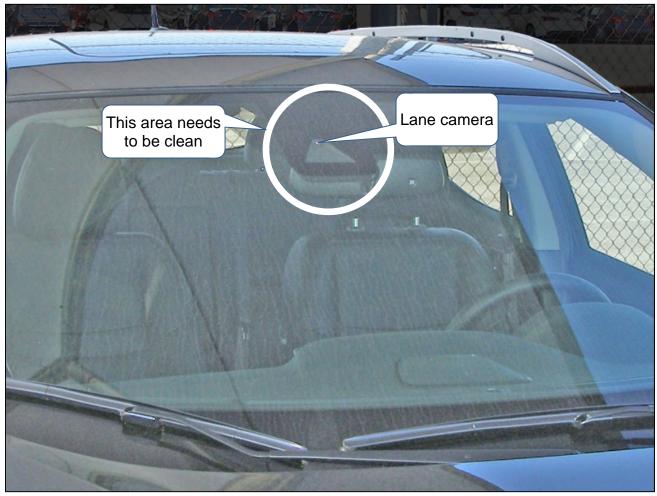
Figure 2

During the following conditions, the AEB warning light may blink/flash. However when these conditions no longer exist, the AEB will resume automatically:

- Strong light is shining from over the front of the vehicle.
- The cabin temperature is over approximately 104°F (40°C) in direct sunlight.
- The radar sensor picks up interference from another radar source.
- When driving on roads without any road structures or buildings (for example: long bridges, deserts, snow fields, driving next to long walls.
