Technical Service Bulletin

SUBJECT:			No: TSB-21-52A-002REV
EXCESSIVE INTERMITTENT MOVEMENT IN DRIVER'S POWER SEAT - REVISED			DATE: March 2023
			MODEL: 2007-19 Outlander, 2018-19 Outlander PHEV, 2011-21 Outlander Sport/RVR
CIRCULATE TO:	<input type="checkbox"/> GENERAL MANAGER	<input checked="" type="checkbox"/> PARTS MANAGER	<input checked="" type="checkbox"/> TECHNICIAN
<input checked="" type="checkbox"/> SERVICE ADVISOR	<input checked="" type="checkbox"/> SERVICE MANAGER	<input checked="" type="checkbox"/> WARRANTY PROCESSOR	<input type="checkbox"/> SALES MANAGER

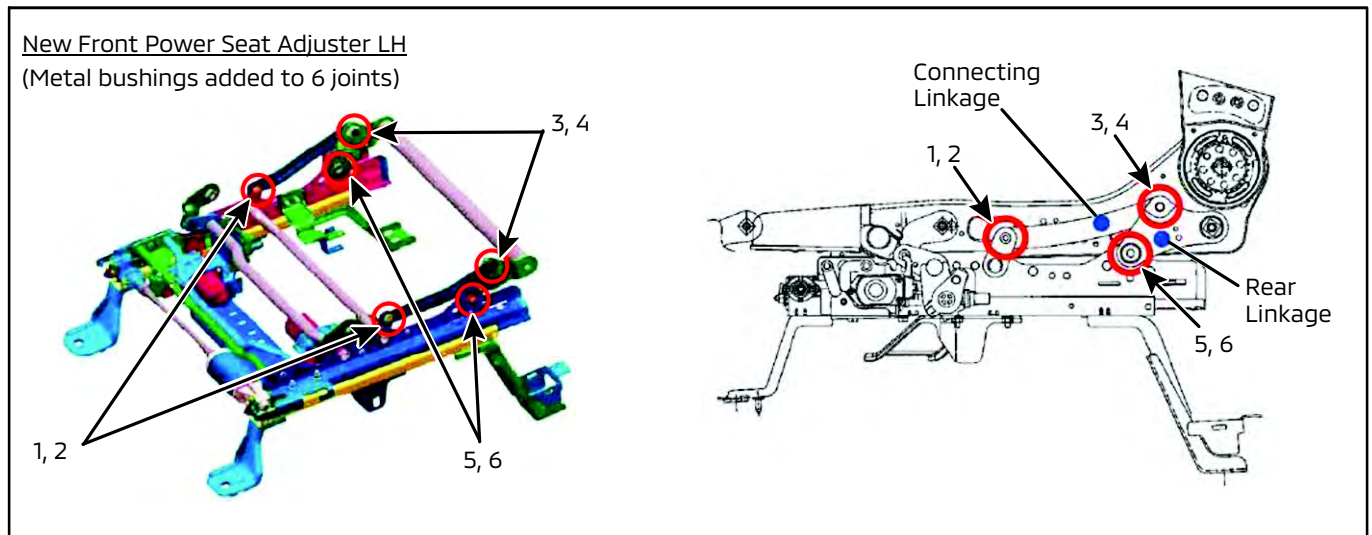
Height adjustment linkages in the seat adjuster assembly may loosen over time with normal driving and allow movement. A new seat adjuster was implemented in production at the supplier from March 2, 2016, and has added metal bushings at the 6 rotational connections on the seat frame, as shown below.

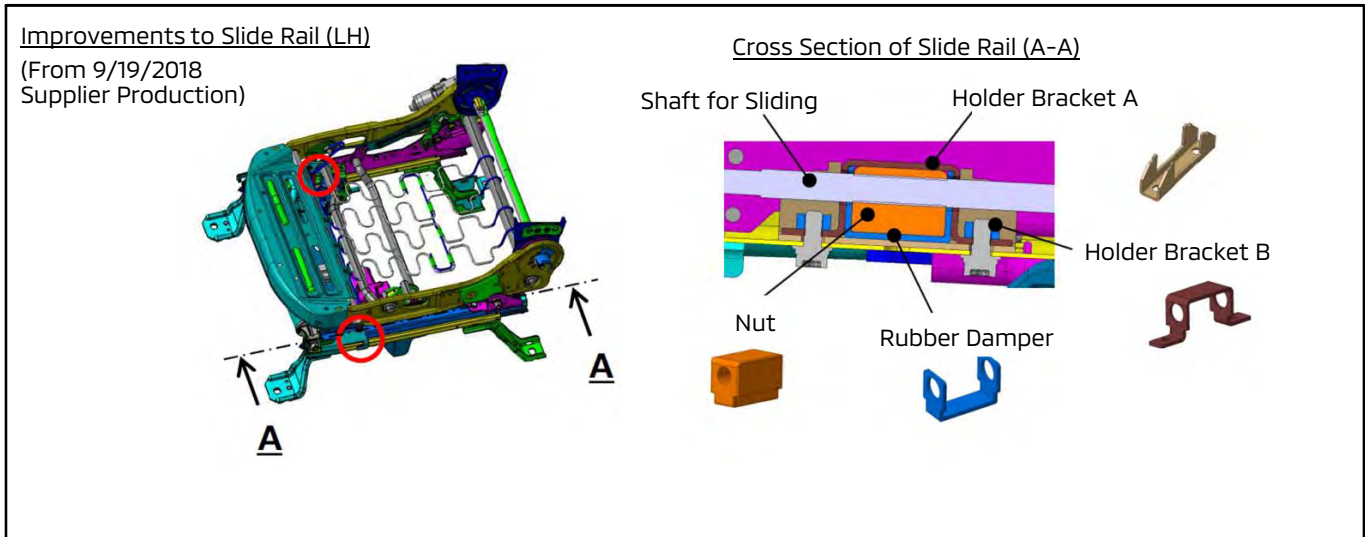
The clearance of the slide rail and rubber damper has also been changed in production at the supplier starting September 19, 2018. Refer to the VINs listed in Affected Vehicles.

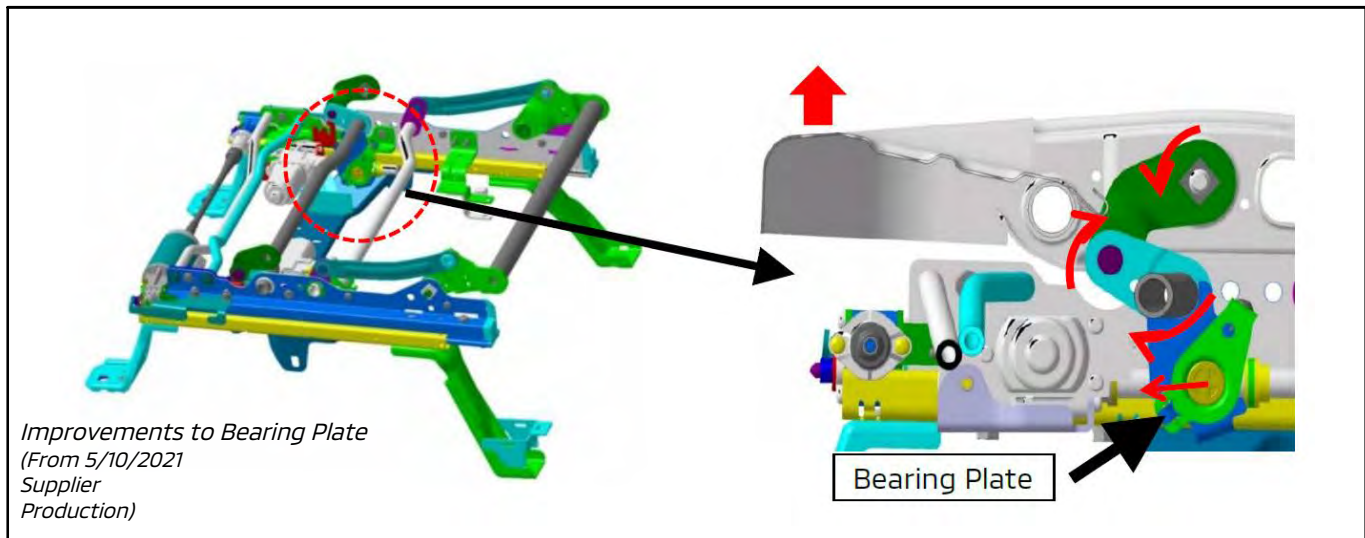
The clearance of the bearing plate hole size has also been changed in production at the supplier starting May 10, 2021. Refer to the VINs listed in Affected Vehicles.
