# TECHNICAL SERVICE BULLETIN

Classification: RS19-004C	Reference: NTB19-071C	Date: March 9, 2023
------------------------------	--------------------------	------------------------

## DTC B00A0-00 STORED

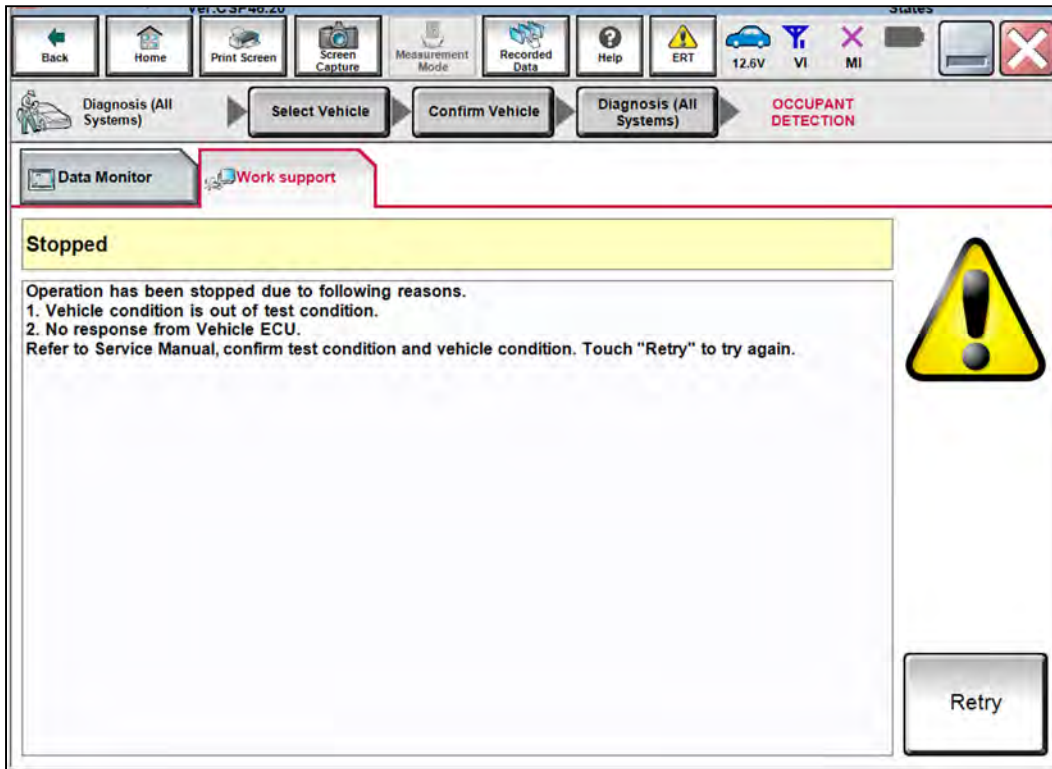
Figure 1

DTC B00A0-00 (OCCUPANT DETECTION SENSOR UNIT) is stored,

OCS zero point reset cannot be performed,

The following screen displays:

1. Check the Occupant Classification System (OCS) control unit using the ODS Analysis tool software.
  - Refer to **SERVICE PROCEDURE** on page 4.

**HINT:** "OCS" also may be referred to as "ODS".
2. Perform "75-Zero RESET".

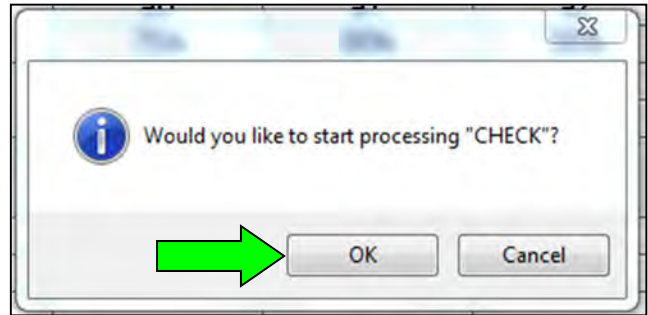
Figure 6

12. Check for code "75h" to show under **CURRENT FAILURE CODE**.

- If code "75h" shows under **CURRENT FAILURE CODE**, go to step 13.
- If code "75h" does not show under **CURRENT FAILURE CODE**, STOP HERE. This bulletin does not apply. Refer to ASIST and the ESM for further diagnostic assistance.

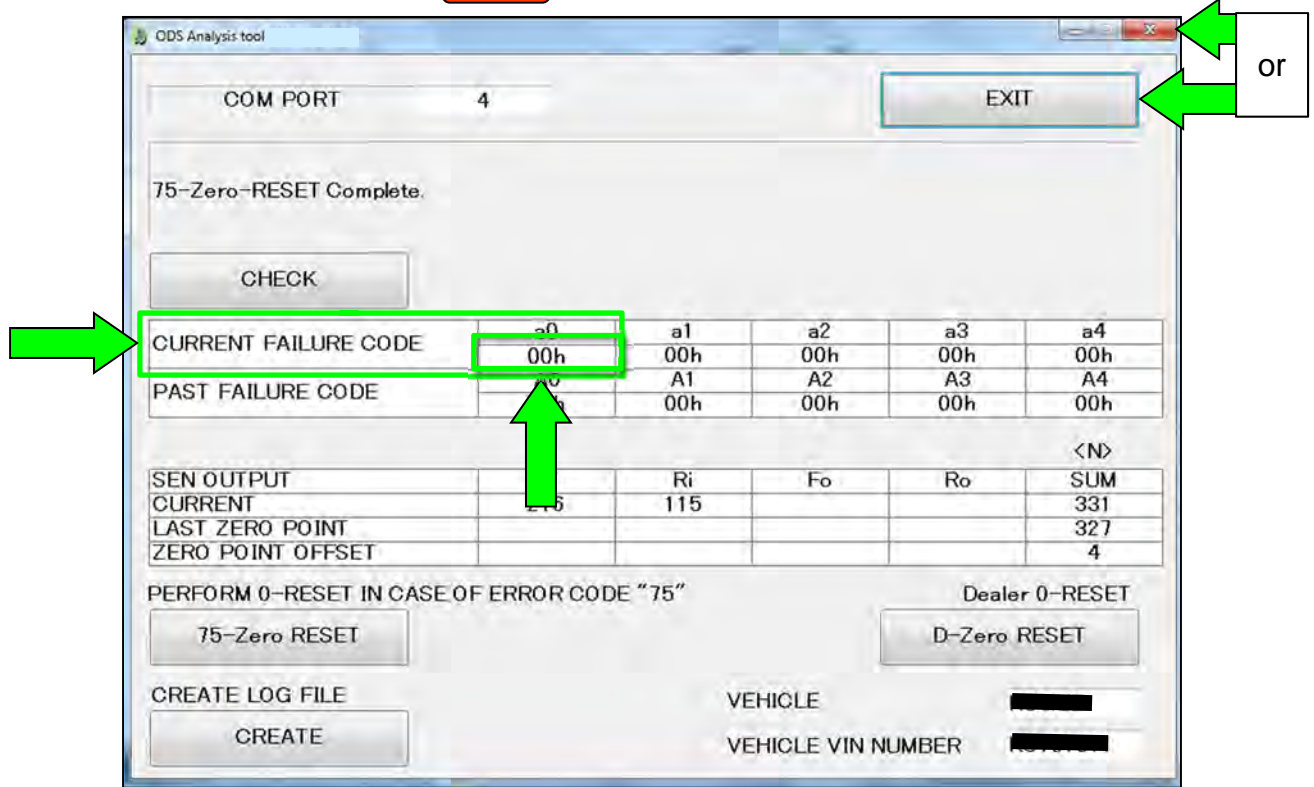
17. When the screen in Figure 10 displays, the 75-Zero reset process is complete.
  - Verify code “75h” is not displayed under **CURRENT FAILURE CODE**.
18. Select either **EXIT** or the

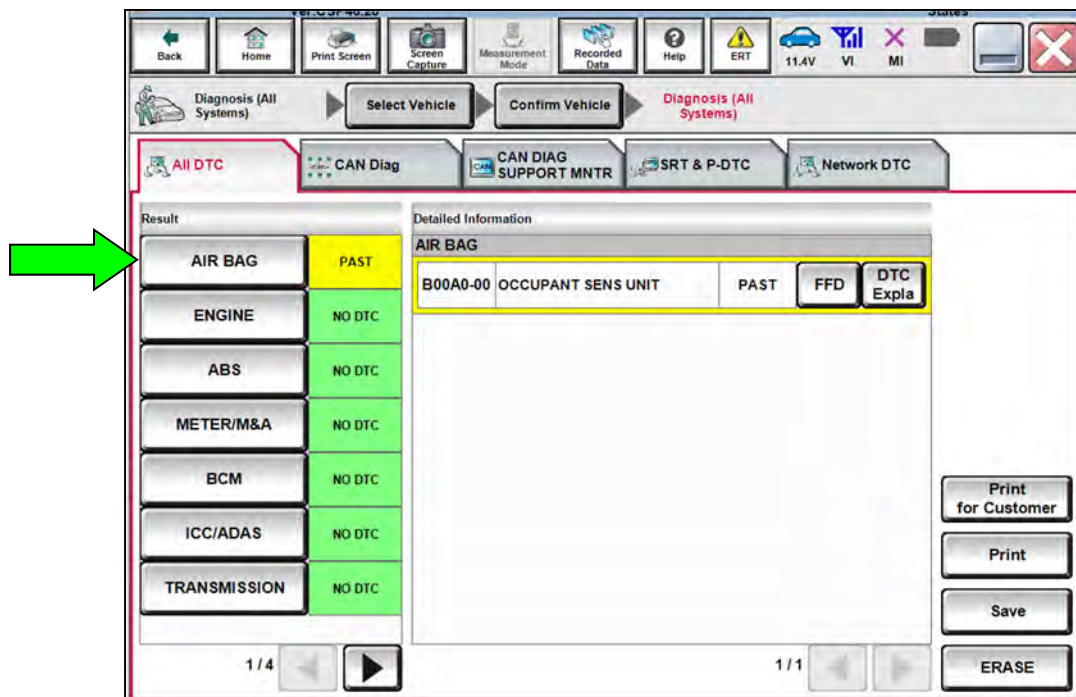
Figure 13

- DTC B00A0-00 should be the only DTC displayed.
- If DTC B00A0-00 is not the only DTC displayed, perform diagnosis and repairs as needed.
