| <b>Tesla, Inc.</b><br>Service Bulletin | | <b><i>Replace RH Body Controller Module To Enable Third-Row Seat USB Power</i></b> | |
| <b>SB-23-17-003</b><br>March 24, 2023 | | | |

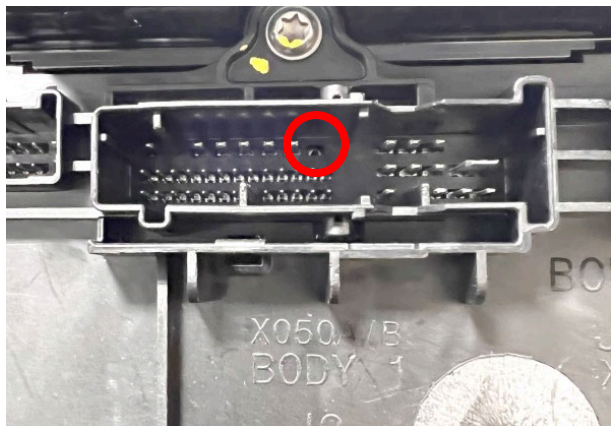
**✗ Figure 1 – Connector X050 missing pin A32**

**NOTE:** Do not install the new RH body controller module if pin A32 is missing.

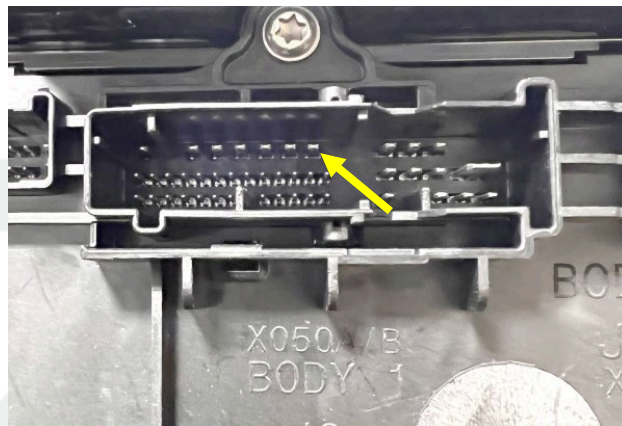
**✓ Figure 2 – Connector X050 with pin A32**

1. Remove the RH body controller module (refer to Service Manual procedure [17152202](#)).
2. Inspect the top center connector X050 of the replacement RH body controller module, and verify that it has a power pin at A32 (Figures 1 and 2).
