| <b>Tesla, Inc.</b><br>Service Bulletin | | <b>Replace Occupant Classification System (OCS) of Front Passenger Seat while Servicing Subcomponents</b> | |
| <b>SB-23-20-002</b><br>March 27, 2023 | | <b>R2</b> | |

Certain Model 3 and Model Y vehicles may need a different Occupant Classification System (OCS) installed in the front passenger seat before servicing its subcomponents.

Replace the front passenger seat OCS component in order to service seat subcomponents.

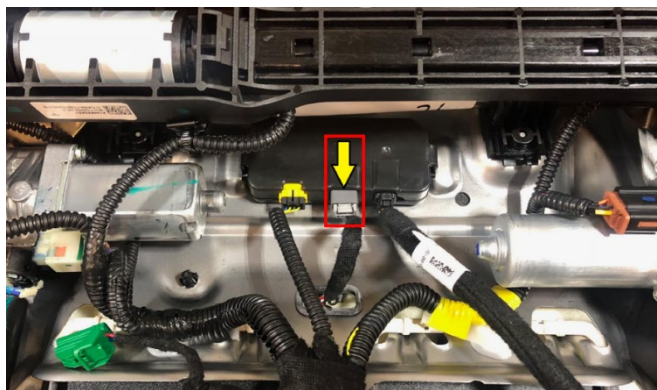
**Figure 1 – Model 3 shown; Model Y similar**

4. Disconnect the front passenger seat OCS sandwich sensor connector (Figure 1).

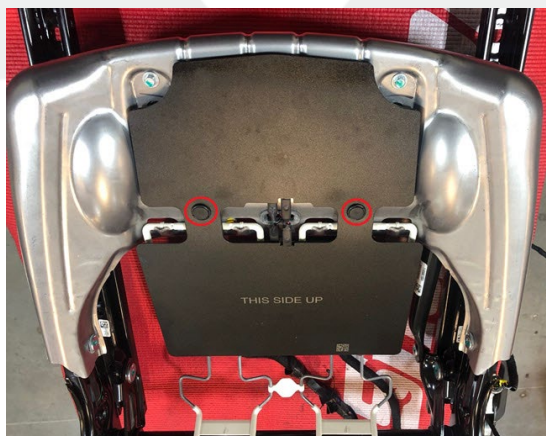
**Figure 2 – Model 3 shown; Model Y similar**

5. Remove the push clips (x2) that attach the front passenger seat OCS sandwich sensor to the seat frame (Figure 2).

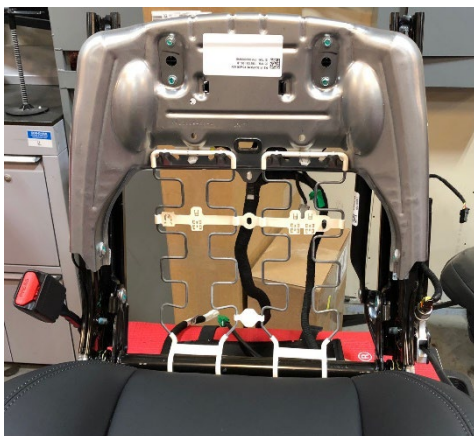
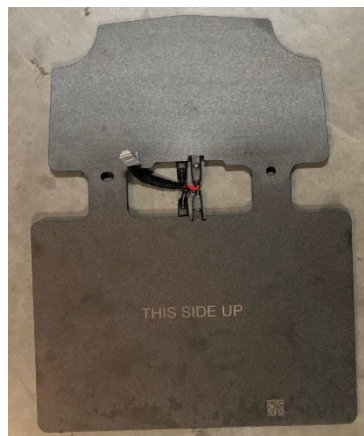
6. Remove and discard the front passenger seat OCS sandwich sensor from the seat frame (Figures 3 and 4).
