# TECHNICAL SERVICE BULLETIN

Classification: HA21-002D	Reference: NTB21-071D	Date: March 31, 2023
------------------------------	--------------------------	-------------------------

## AUTO HVAC CENTER VENT TEMPERATURE DIFFERENCE GREATER THAN 5°C (9°F)

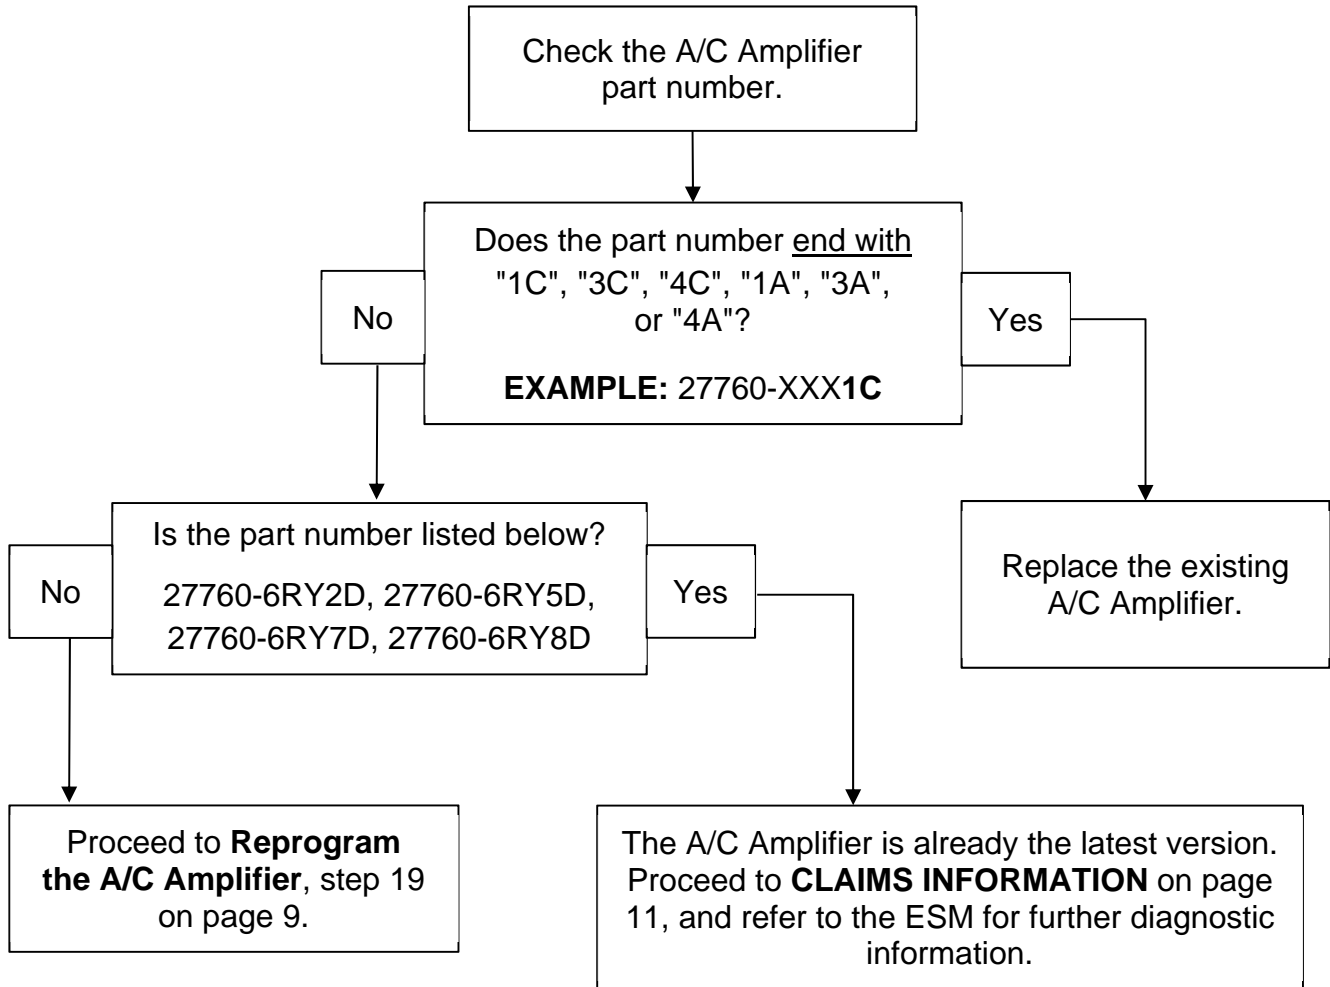
## Part Number Inspection

17. Are the last two characters of the part number "1C", "3C", "4C", "1A", "3A", or "4A"?

18. Is the part number 27760-6RY2D, 27760-6RY5D, 27760-6RY7D, or 27760-6RY8D?

**YES:** Replace the A/C Amplifier.

**YES:** The A/C Amplifier is already the latest version. See **CLAIMS INFORMATION** on page 11, and then refer to the ESM for further diagnostic information.

**NO:** Proceed to step 19 on page 9 to perform **Reprogram the A/C Amplifier**.

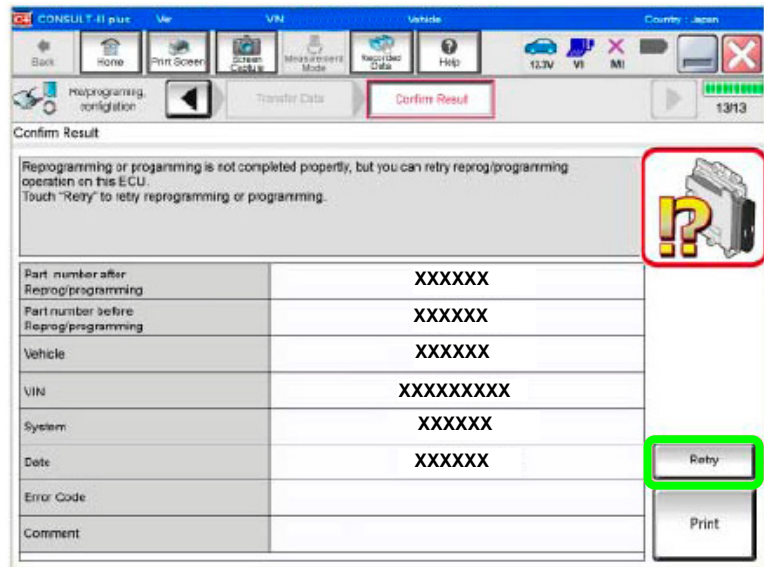
Figure 12

If reprogramming does not complete, and the “!?” icon displays as shown in Figure 12:

- Check battery voltage (12.0 V – 15.5 V).
- Ignition is ON, engine is OFF.
- External Bluetooth® devices are OFF.
- All electrical loads are OFF.
- Select retry and follow the on screen instructions.
- “Retry” may not go through on first attempt and can be selected more than once.

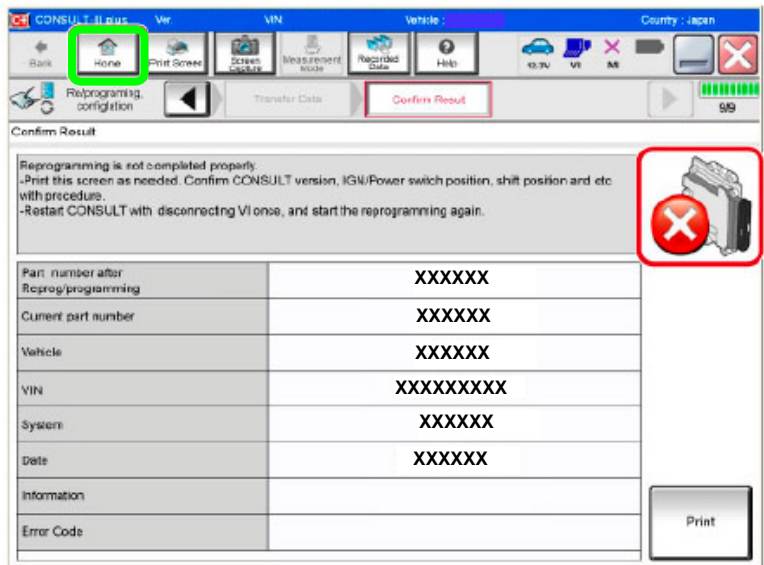
Figure 13

If reprogramming does not complete, and the “X” icon displays as shown in Figure 13:

- Check battery voltage (12.0 V – 15.5 V).
- CONSULT A/C adapter is plugged in.
- Ignition is ON, engine is OFF.
- Transmission is in Park.
- All C-III plus / VI cables are securely connected.
- All C-III plus updates are installed.
- Select Home, and restart the reprogram procedure from the beginning.
