# TECHNICAL SERVICE BULLETIN

| Classification:<br>HA23-002 | Reference:<br>NTB23-022 | Date:<br>March 14, 2023 |

## INTERMITTENT OPERATION OF HVAC BLOWER

**APPLIED VEHICLES:** 2022-2023 Pathfinder (R53)  
**APPLIED DATES:** Built before December 1, 2022

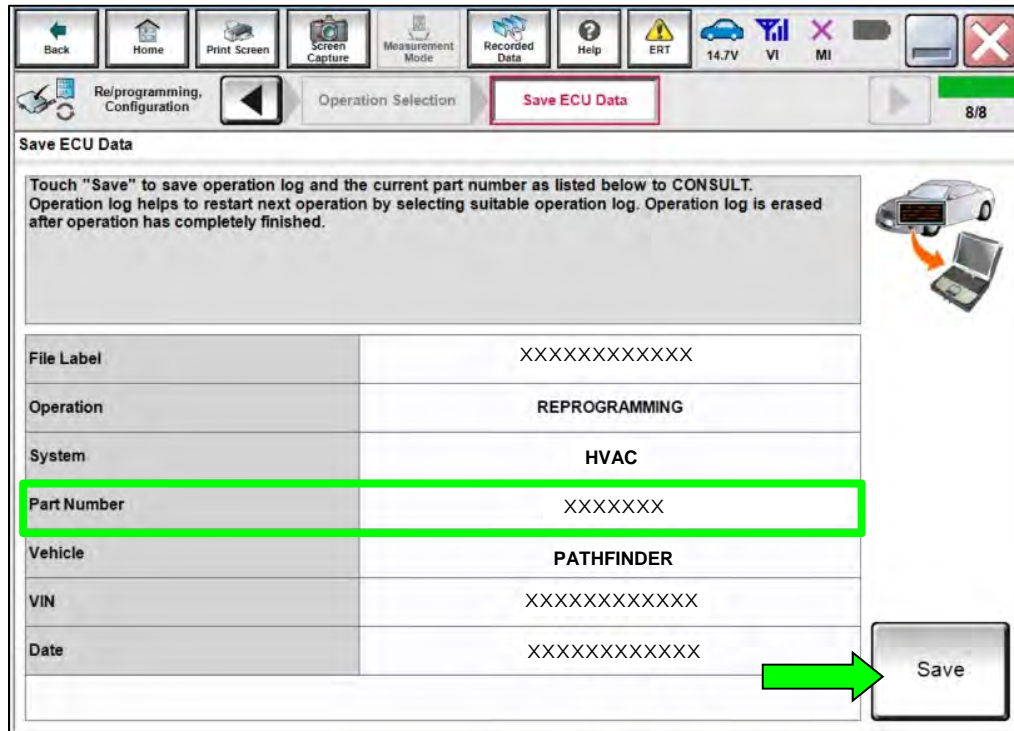
Figure 12

17. Find the A/C Amplifier **Part Number** and write it on the repair order, and then select **Save**.

- If the current **Part Number** matches one of the part numbers in **Table 1**, proceed to step 18 on page 10 to reprogram the A/C Amplifier.
- If the current **Part Number** does not match one of the part numbers in **Table 1**, this bulletin does not apply. Return to ASIST for further diagnostic and repair information.

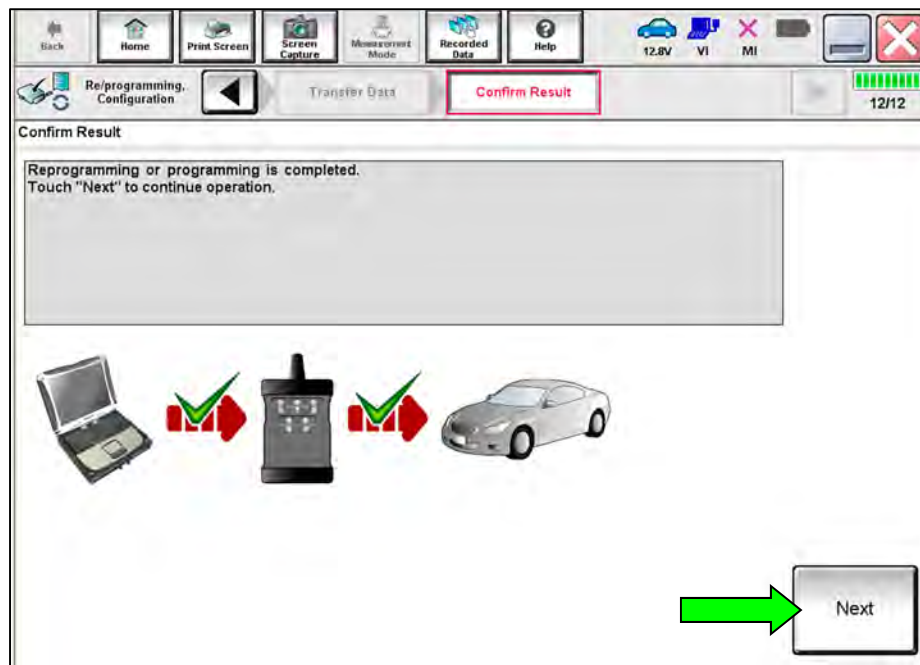
**HINT:** When the screen in Figure 14 displays, A/C Amplifier reprogramming is complete. If the screen in Figure 14 does not display (indicating that reprogramming did not complete), refer to the information on the next page.

21. Follow the on-screen instructions to perform **Erase All DTCs**.
22. Print a copy of the confirmation screen and attach it to the repair order for warranty documentation, and then select **Confirm**.

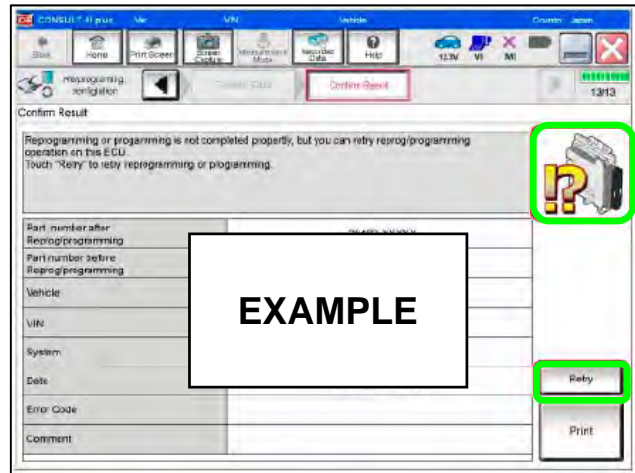
Figure 15

If reprogramming does not complete and the “!?” icon displays, as shown in Figure 15:

- Check battery voltage (12.0 - 15.5 V).
- Ignition is ON, engine OFF. Or if EV in Ready Mode.
- External Bluetooth® devices are OFF.
- **All** electrical loads are OFF.
- Select **Retry** and follow the on screen instructions.
- Retry may not go through on first attempt and can be selected more than once.

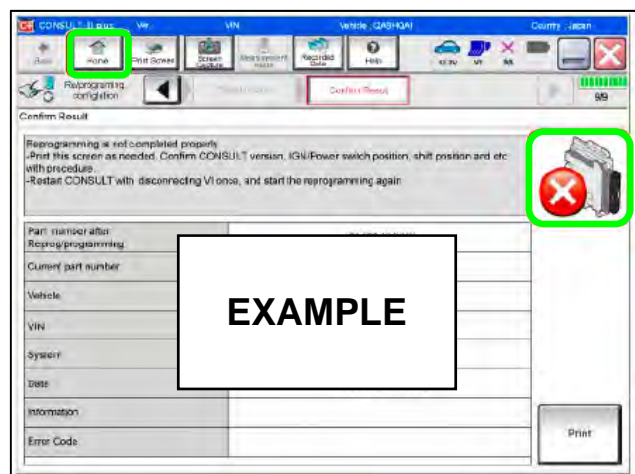
Figure 16

If reprogramming does not complete and the “X” icon displays, as shown in Figure 16:

- Check battery voltage (12.0 - 15.5 V).
- CONSULT A/C adapter is plugged in.
- Ignition is ON, engine OFF. Or if EV in Ready Mode.
- Transmission is in Park.
- All CONSULT VI cables are securely connected.
- All C-III plus updates are installed.
- Select **Home**, and restart the reprogram procedure from the beginning.
