# Service Bulletin

Bulletin No.: 19-NA-256

**Subject:** Diagnostic Tips for Knocking, Rattle, Squeak and/or Squeal Type Noise from Engine – Engine Replacement Recommendations for HFV6 Gen 1 and Gen 2

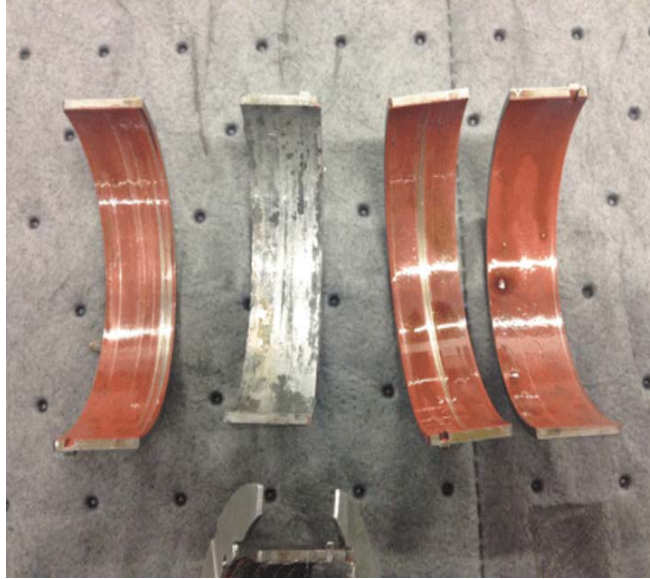
3961446

1. Verify there is metal in the engine oil by removing the oil pan.
2. Remove the main or rod bearing caps:
  - If the main and/or rod bearing are not the cause of the debris, refer to SI for further diagnostics.

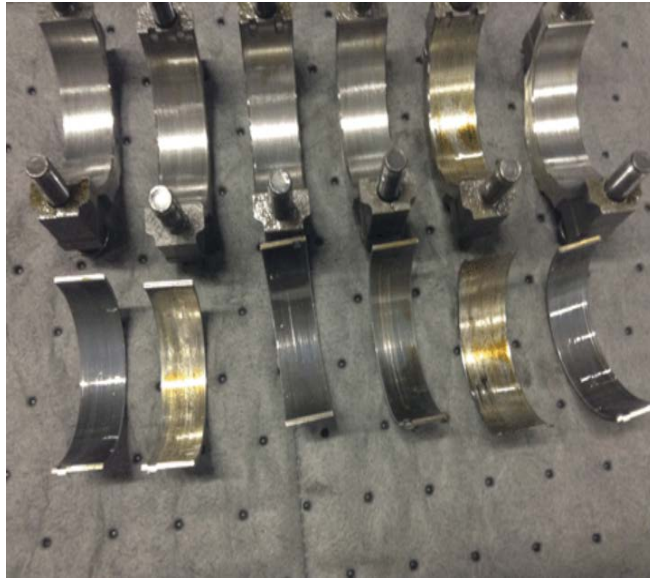
3961447

- If the main and/or rod bearings are found to be the cause of the debris, before deciding whether to replace the engine or repair it, refer to the Service Procedure below before making that determination.

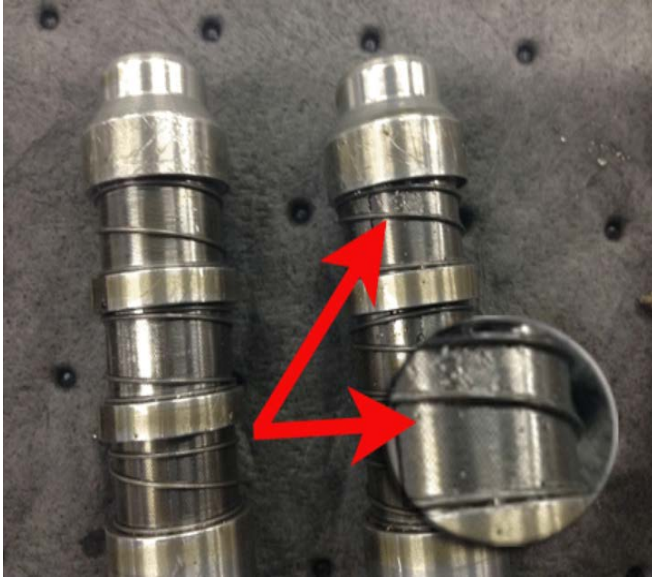
3961448

1. Inspect the oil control solenoids for metal debris. This shows the oil filter is in by-pass and unfiltered oil with bearing debris was pumped into the oil lubrication galleries, throughout the engine.

Any of the above 3 instances would be cause to replace the engine instead of repair.

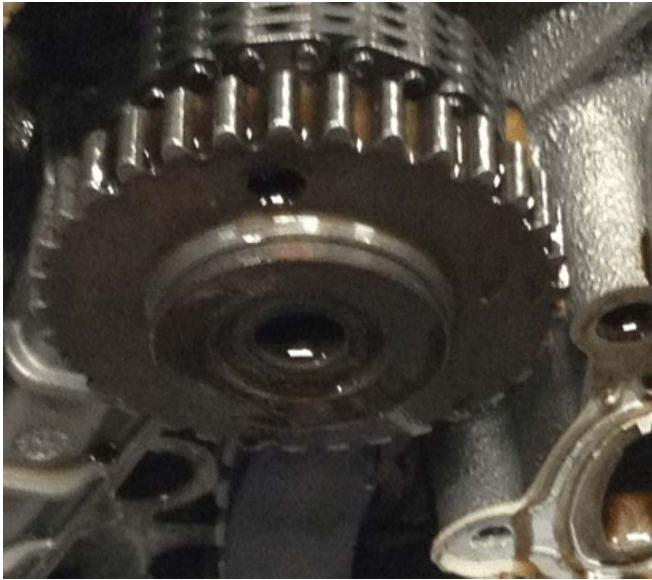
3961452

3. Inspect the timing chain idler sprockets for stiffness when turning (Should turn smooth and free).
