Service Bulletin

Bulletin No.: 22-NA-067

Subject: Poor Engine Performance, PCV Bypass Hose and Charge Air Cooler (CAC) Restricted for LUV Engines, Malfunction Indicator Lamp (MIL) Illuminated - DTC P0299, P0234, P0236, P2261, P2227, P00C7 Set

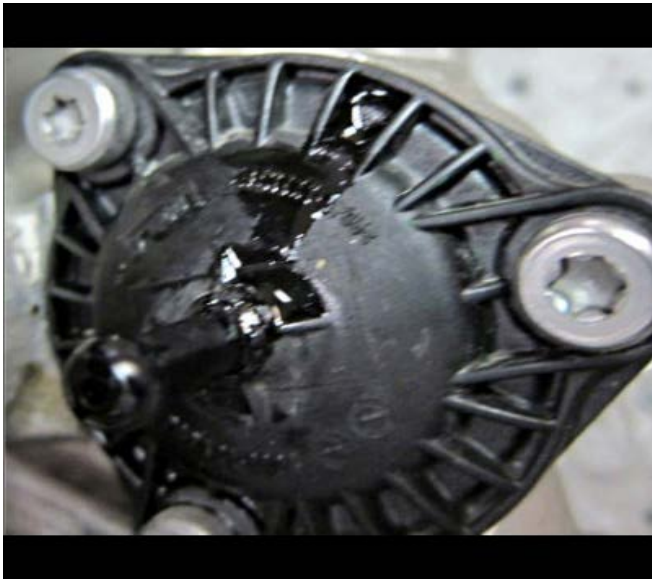
5590615

1. Inspect the charge air bypass valve for ice/oil/water/sludge build-up in the vacuum side port.

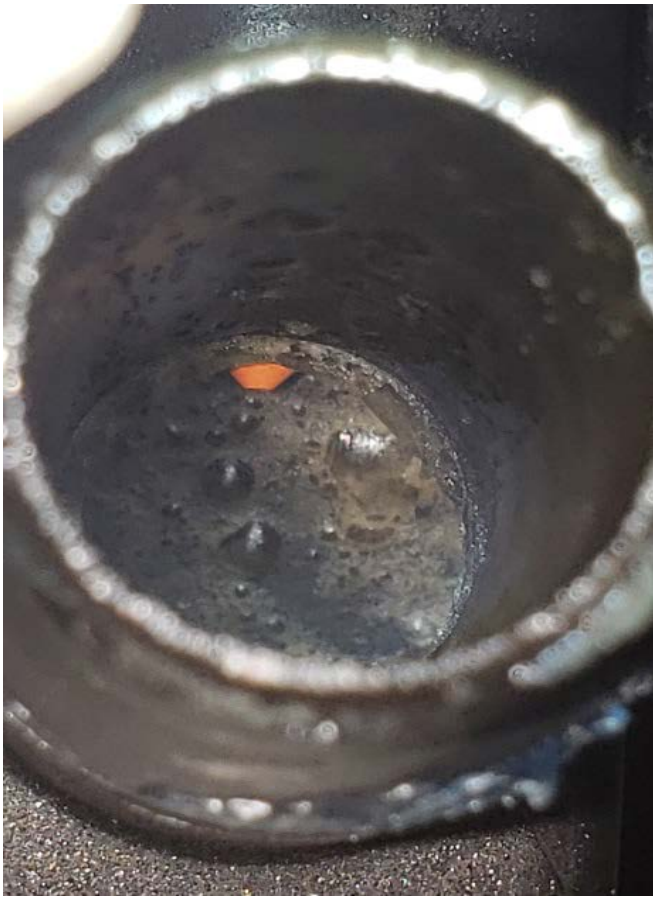
5286434

3. Inspect the vacuum ports of the intake manifold for ice/water/oil/sludge accumulation.

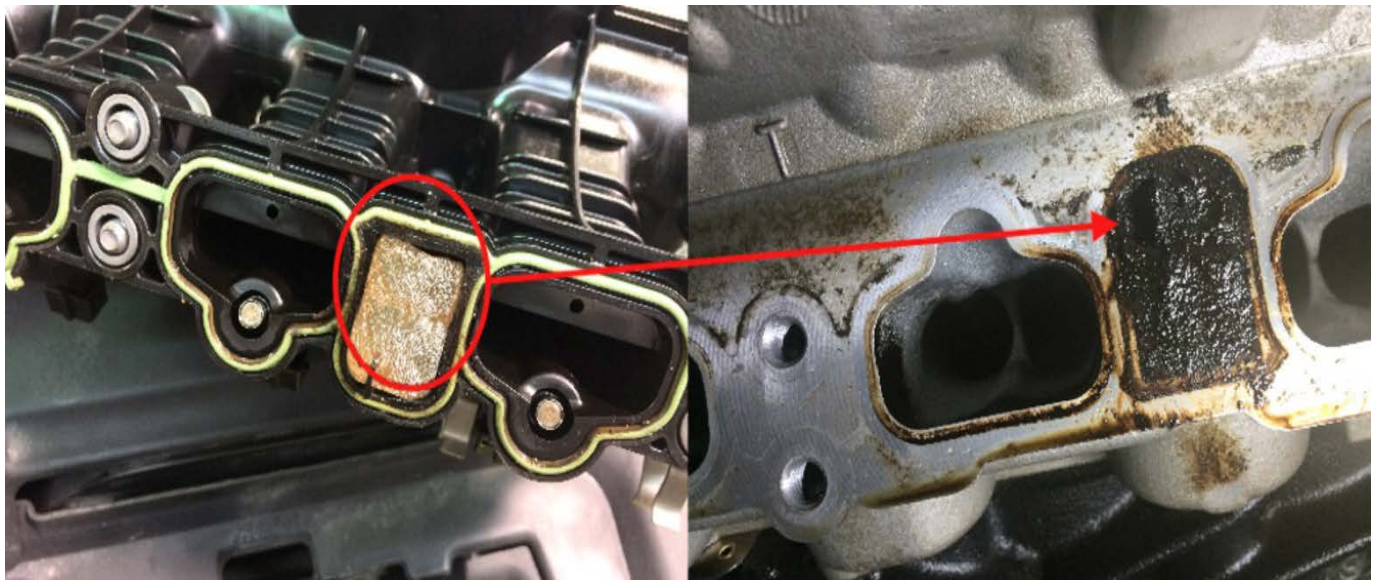
5286457

4. Inspect the PCV intake runner for blockage (carbon/oil/water/sludge/ice) build-up blocking the cylinder head as shown above.

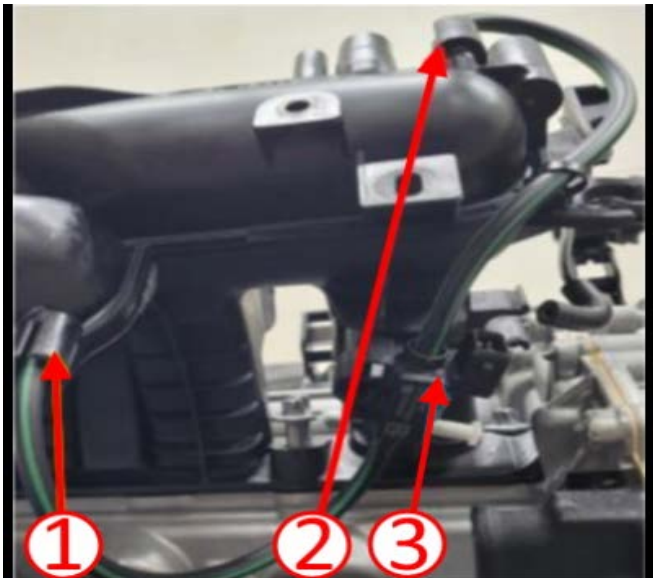
6145032

Old Design Intake Manifold

- Bypass Valve Vacuum (1)
- Intake Positive Pressure Port (2)
- Solenoid/Electrical Connector (3)

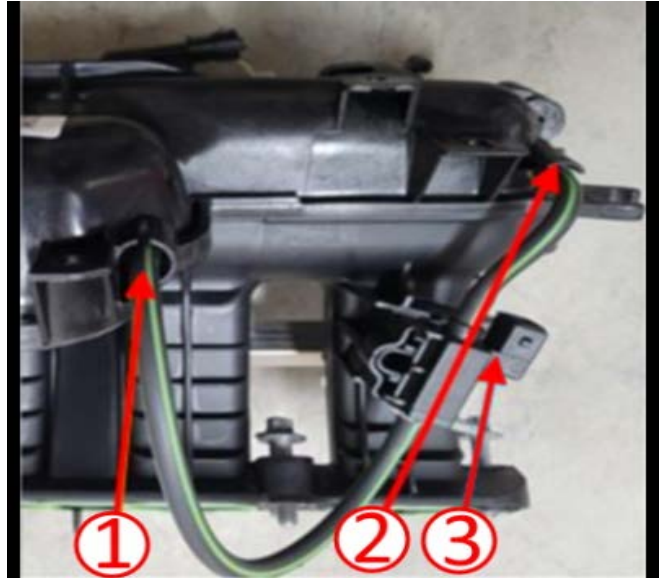
6145033

New Design Intake Manifold

- Bypass Valve Vacuum (1)
- Intake Positive Pressure Port (2)
- Solenoid/Electrical Connector (3)

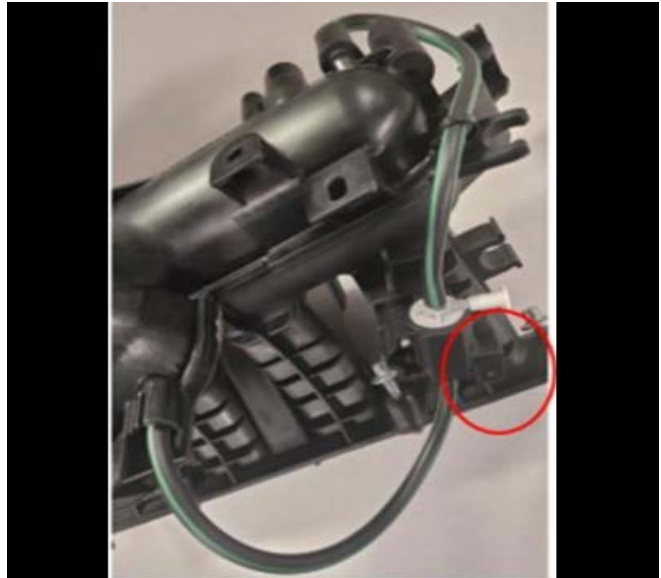
6145028

New Design Intake with incorrect solenoid installation.

Note: The electrical receptacle location. Remove and re-install the lines and solenoid as they are retained to the intake if installed incorrectly. Tabs reversed, the solenoid is keyed and will not be seated in retainers.

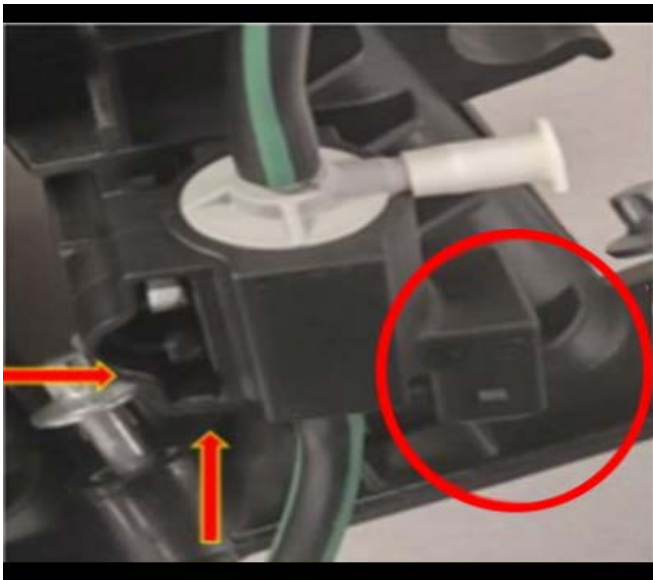
6145030

New Design Intake with solenoid retainers not seated and the electrical connector facing the cylinder head. Keyed section of intake not level with solenoid body.
