Service Bulletin

Bulletin No.: 23-NA-031

Subject: Squeaking Noise, Vehicle Will Not Charge, Accessory Drive Belt Damaged, Crank/No Start, Battery Light On, Drive Belt Came Off, Noise Under Hood and/or Charge Lamp Illuminated on the Drivers Information Center (DIC)

Brand:	Model:	Model Year:		Build Date:		Engine:	Transmission:
		from	to	from	to		
Cadillac	Escalade Models	2023	2023	SOP	October 6,2022	LT4

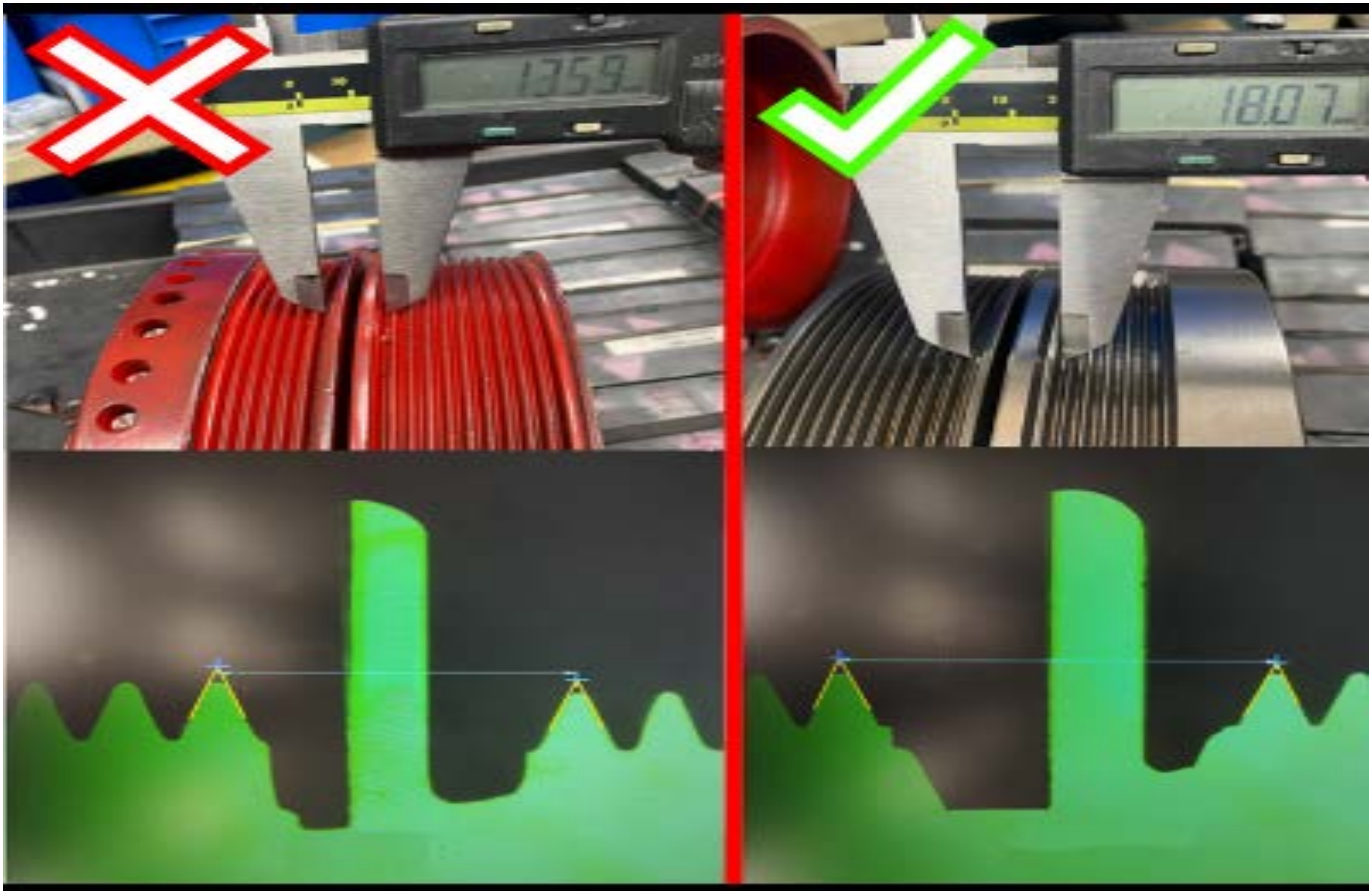
6287125

Involved Region or Country	North America, Europe, Middle East, Israel, Palestine, Japan, Cadillac Korea (South Korea)
Condition	<p>Some customers may comment on one or more of the following conditions:</p> <ul style="list-style-type: none"> • Squeaking noise • Vehicle will not charge • Accessory drive belt damaged • Crank/No Start • Battery light On • Drive belt came off • Noise under hood • Charge Lamp illuminated on DIC <p>Note: Check vehicle history to see if the belt has been previously replaced for the same concern.</p> <p>Some technicians may find during inspection the accessory drive belt is damaged or has come off.</p>
Cause	This condition may be caused by a mis-machined crankshaft damper where the 6 rib belt track was machined too far forward relative to the 10 rib Supercharger belt track, causing the 6 rib belt to run off the front of the pulleys.
Correction	<p>To determine if the damper is suspect, measure the damper rib distance. Refer to Additional Information.</p> <p>If the measurement is narrower than 18mm , the damper and accessory drive belt will need to be replaced.</p>

Good parts should measure 18mm +/- 1mm across ribs as shown in the graphic above.

Note: Before installing the NEW damper, ensure that the measurement is within specification.

Refer to *Accessory Drive Primary Belt Replacement* in the Service Manual.
