TECHNICAL SERVICE BULLETIN

Soft Top Roof – Rear Window Scratching Paint On Rear Quarter Panel

23-2117

Ford 2021-2022 Bronco

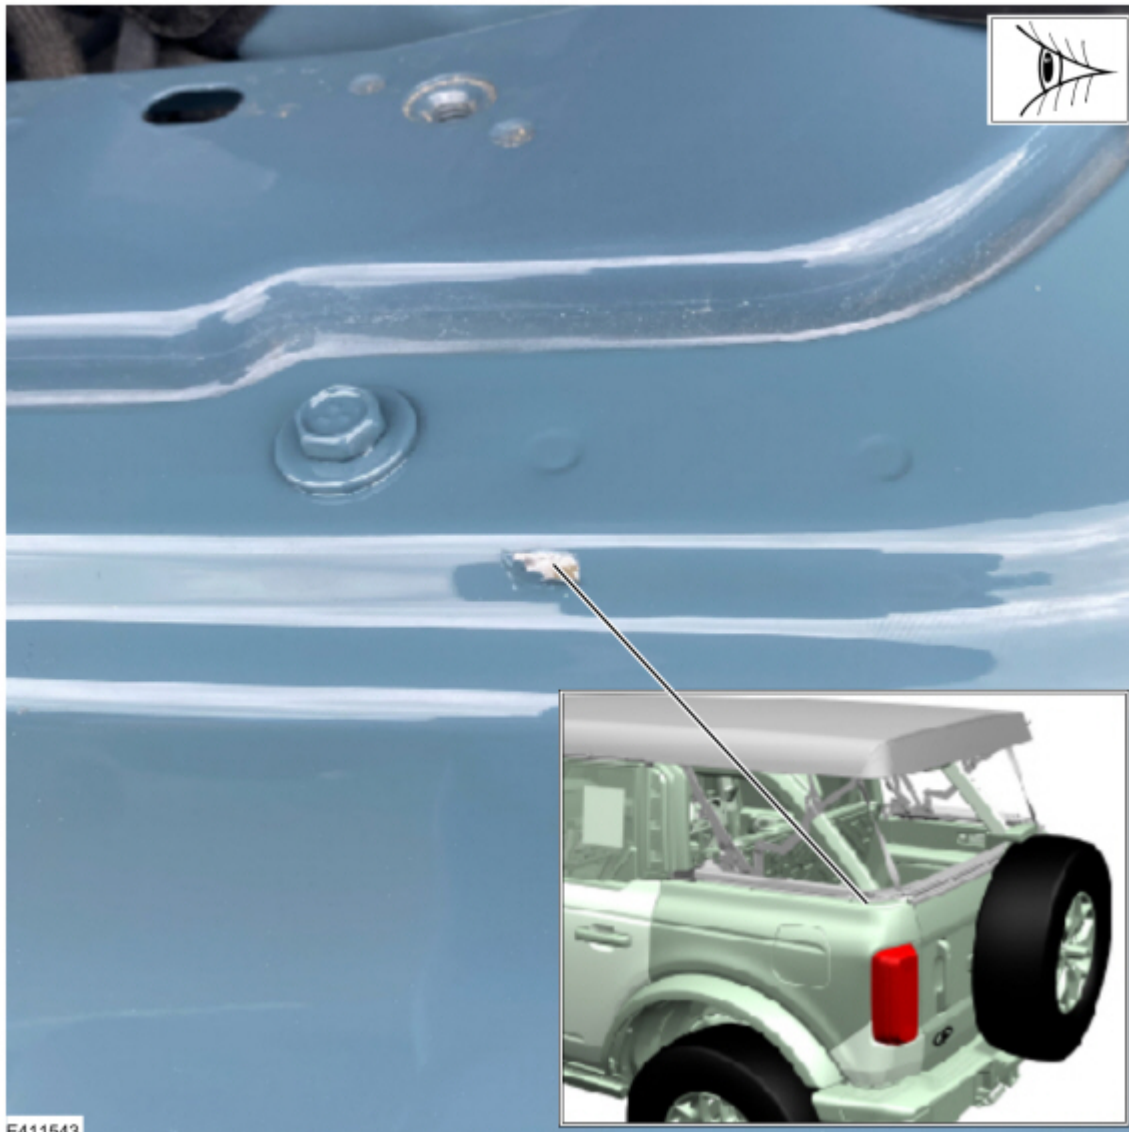
Issue: Some 2021-2022 Bronco vehicles may exhibit paint damage on the rear quarter panel due to contact with the rear window assembly (D-pillar). This may be due to an oversized washer being used during production. To correct the condition, repair the paint damage to the rear quarter panel and replace the rear window assembly.

1. Remove the rear window and both rear quarter window assemblies. Refer to the Workshop Manual (WSM), Section 501-18A > Removal and Installation > Soft Top Assembly.
2. Does the vehicle have paint damage on the rear quarter panel like the damage shown in Figure 1?

Figure 1 – Left/rear shown, right/rear similar.

- (1). Yes – proceed to Step 3.
- (2). No – this article does not apply.

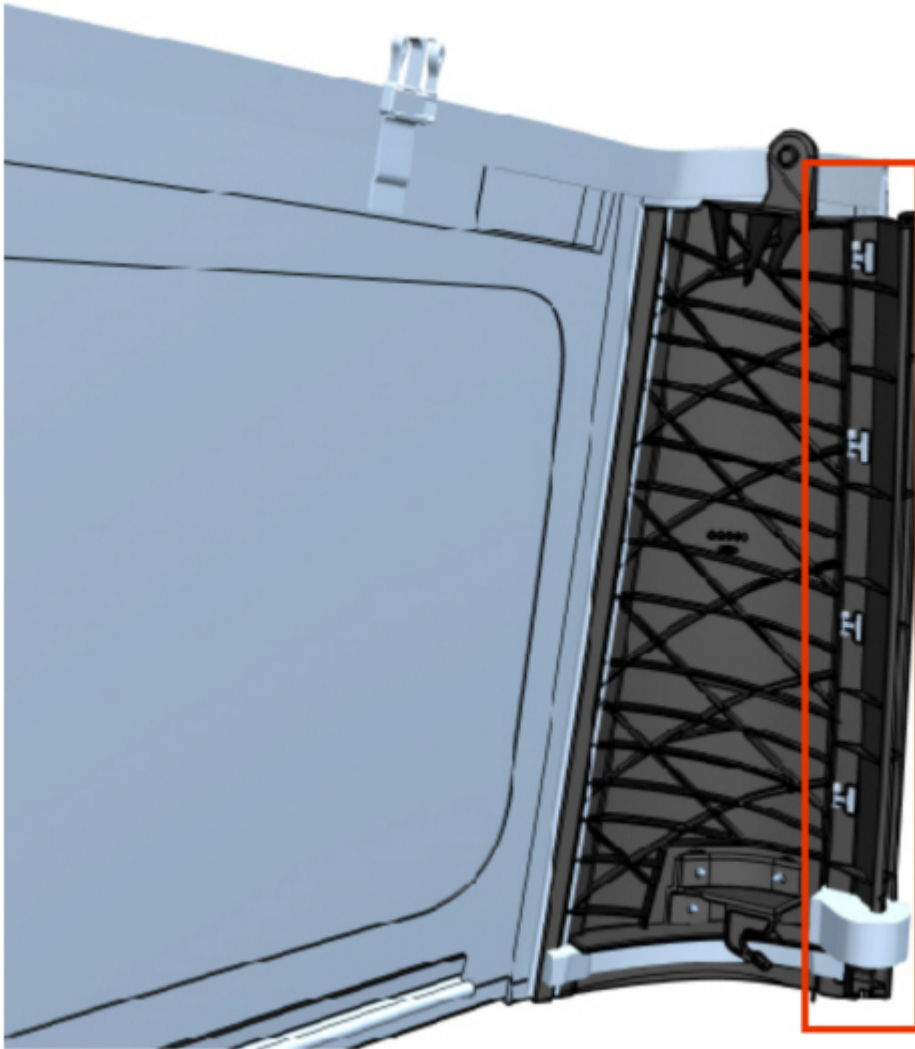
E411544

3. Are metal rivets and washers installed on the rear window D-pillars? (Figure 2)

Figure 2 – Left/rear shown, right/rear similar.

NOTE: Metal Rivets with metal washer backings were added to Bronco soft top rear window production in early 2022. When inspecting the rear window D-pillars, each D-pillar may have 0, 3 or 5 metal rivets with washer backings installed depending on when it was built. All versions are acceptable.

- (1). Yes – proceed to Step 4.
- (2). No – this article does not apply.

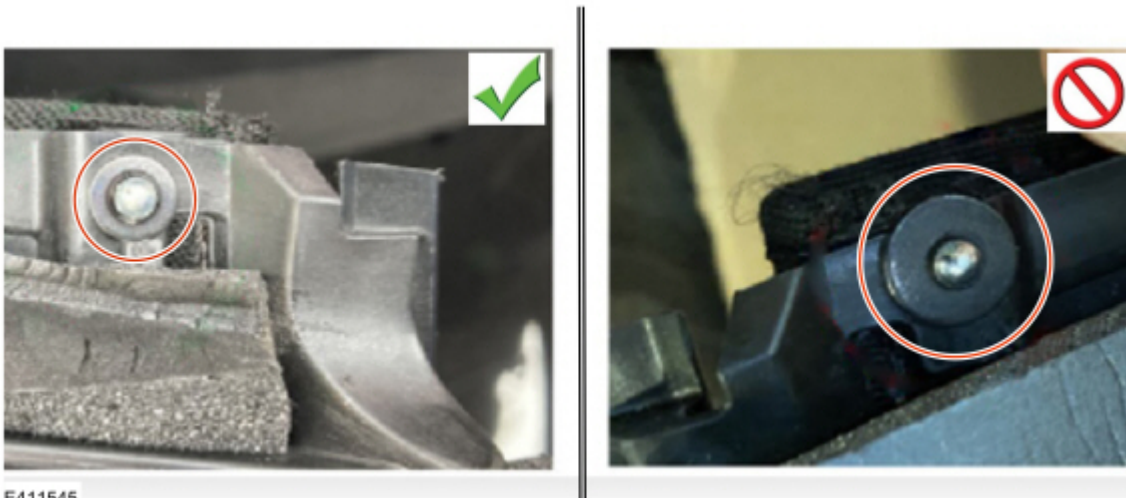
E411545

4. Are any of the metal washers (used for metal rivet backings) protruding past the plastic edge of the rear window D-pillars? (Figure 3)

Figure 3 – Showing an acceptable and unacceptable metal washer size and location.

- (1). Yes – repair all paint damage to the rear quarter panel(s) and replace the rear window assembly.
- (2). No – this article does not apply.
