GLOBAL SAFETY FIELD INVESTIGATIONS
DCS6529
URGENT - DISTRIBUTE IMMEDIATELY

Subject: N222385490 - Customer Satisfaction Program
Power Outlet Retrofit with RPO 08R

Models: 2023 Chevrolet Silverado 1500
2023 GMC Sierra 1500

N222385490 Power Outlet Retrofit

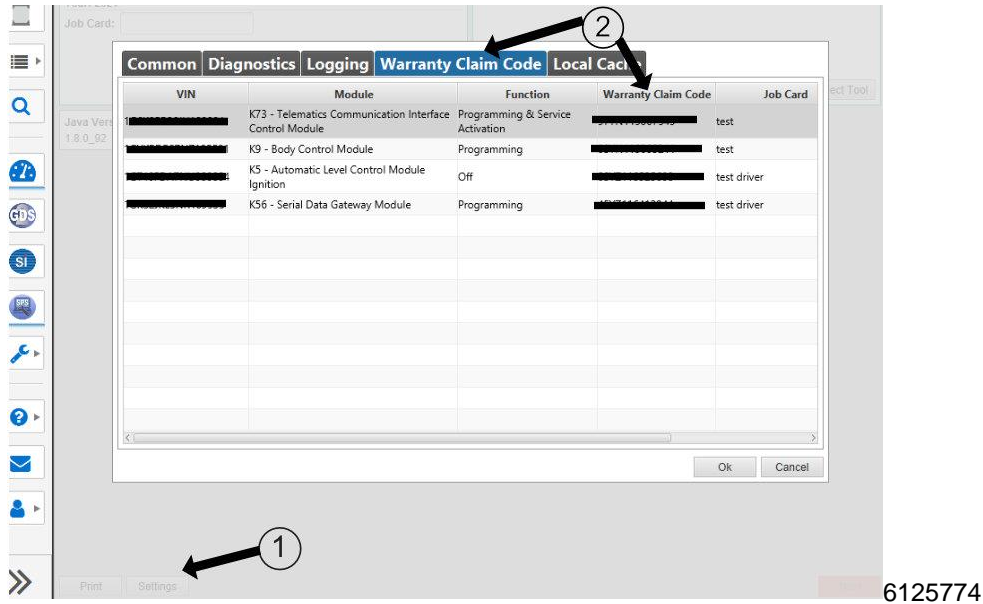
If the Warranty Claim Code was not recorded on the Job Card, the code can be retrieved in the SPS2 system as follows:

1. Open TLC on the computer used to program the vehicle.
2. Select and start SPS2.
3. Select Settings (1).
4. Select the Warranty Claim Code tab (2).

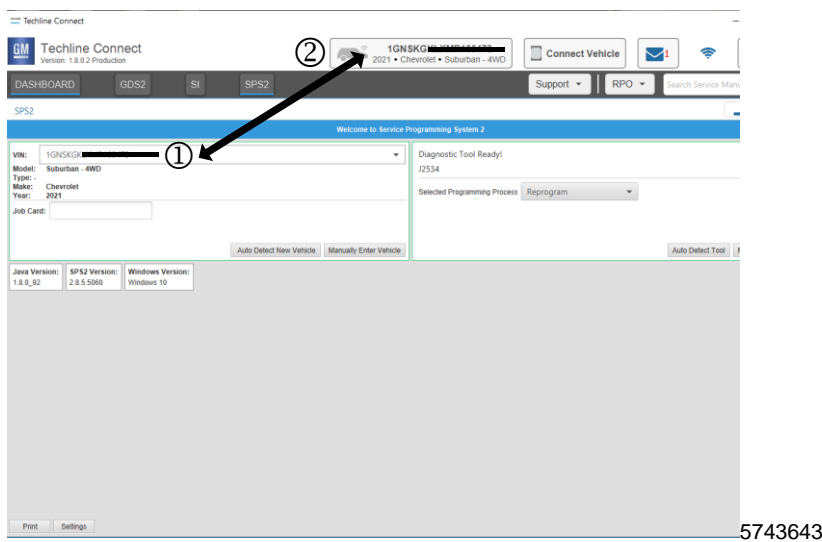
Caution: Be sure the VIN selected in the drop-down menu (1) is the same as the vehicle connected (2) before beginning programming.

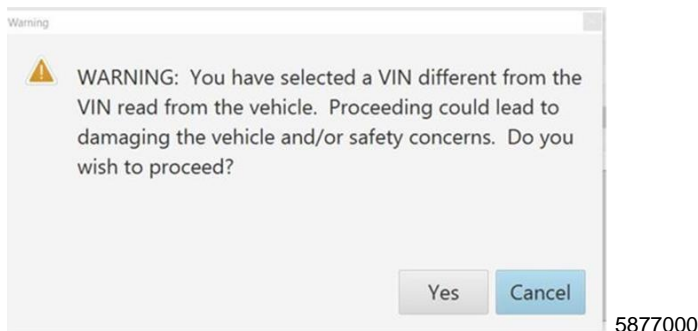
Important: If the vehicle VIN DOES NOT match, the message below will be shown.
