Service Bulletin

Bulletin No.: 21-NA-151

Subject: Front Headlamp Protective Tape Peeling

Brand:	Model:	Model Year:		VIN:		Engine:	Transmission:
		from	to	from	to		
Cadillac	XT4	2019	2023	—	—	All	All

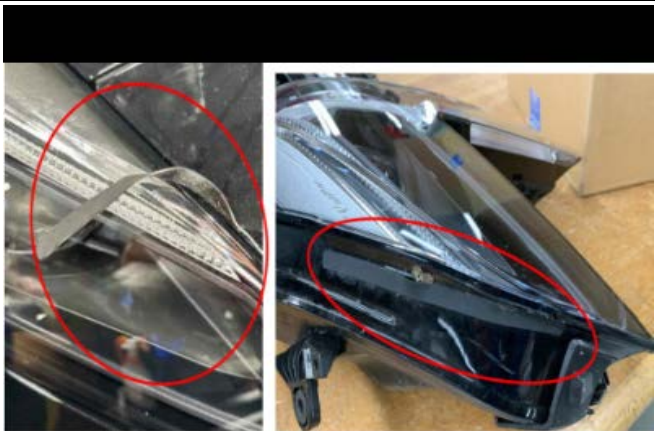
</div> <p style="text-align: right; font-size: small;">6300616</p> <p>Some customers may comment that the protective tape is peeling on either, or both sides, of the front headlamps.</p>
Cause	The cause of the condition may be that the original protective tape may not have had sufficient adhesion properties.
Correction	<p>Note: A newly designed protective tape has been released for service that has better adhesion. The strips are released as a service kit, so only one kit is necessary per vehicle. Do not replace the headlamp for this concern.</p> <p>Install the redesigned protective tape following the steps in the Service Procedure below.</p>
