Rear Outrigger Hose Inspection

Units Affected: Certain LS60 aerial devices built from July 2018 to April 2022. Verify your unit is affected by reviewing the attached list or accessing Altec Connect.

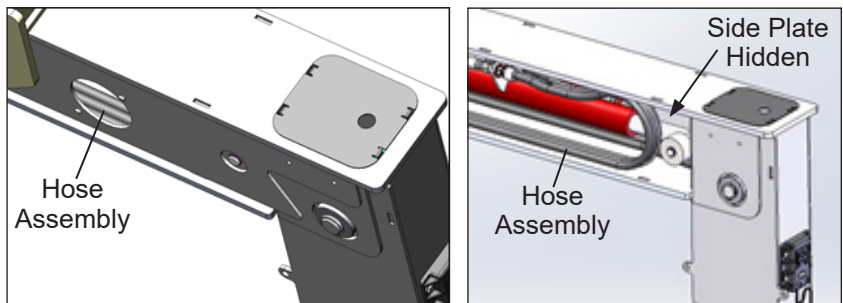
Figure 2 — Inspecting Bonded Hose Assembly

4. Use a flashlight to inspect and identify the bonded hose assembly lying on the bottom plate inside the horizontal leg, using whichever access hole gives the best view of the hose (refer to Figure 2).

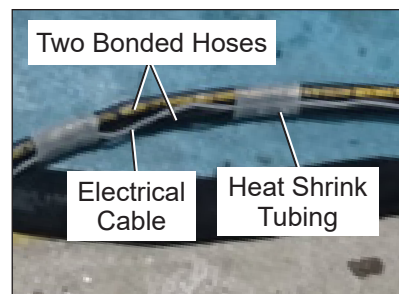
Figure 3 — Dual Bonded Hose

Background: The rear out and down outriggers on the affected units may contain a dual bonded hose with an externally attached electrical cable in the horizontal leg to operate the hydraulic cylinder and proximity interlock sensor in the vertical leg. Altec has learned that the hose/cable assembly can have a reduced life expectancy due to abrasion sustained during extension and retraction of the horizontal leg. Altec has developed a product improvement using a triple bonded hose with the electrical cable contained inside the center hose of the assembly.

- If the hose assembly is a dual bonded hose with an electrical cable secured along the outside of the hoses by sections of heat shrink tubing (refer to Figure 3), mark "Yes" for the street side hose in Figure 5.

Customer Action: Inspect the rear outriggers using the Inspection Procedure beginning on page 2, or contact Altec to perform this inspection. If the inspection shows that one or both outriggers contain the original hose design, order and install the Tri-Bond Hose Assembly Kit specified in the Inspection Procedure, or schedule the installation of the specified kit by Altec. Complete the inspection no later than 30 days from the receipt of this notice. Complete any required repair no later than the next preventive maintenance interval or 120 days from the completion of the inspection, whichever comes first.

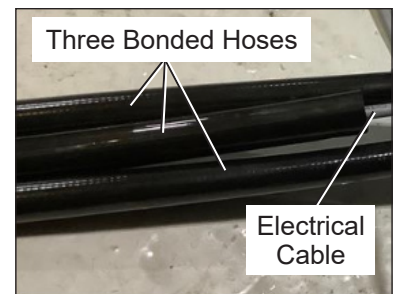
Figure 4 — Triple Bonded Hose

- If the hose assembly is a triple bonded hose with no electrical cable visible on the outside (refer to Figure 4), mark "No" for the street side hose in Figure 5.
