Service Bulletin

Bulletin No.: 23-NA-047

Subject: Dust, Snow or Water Around Fuel Filler Area

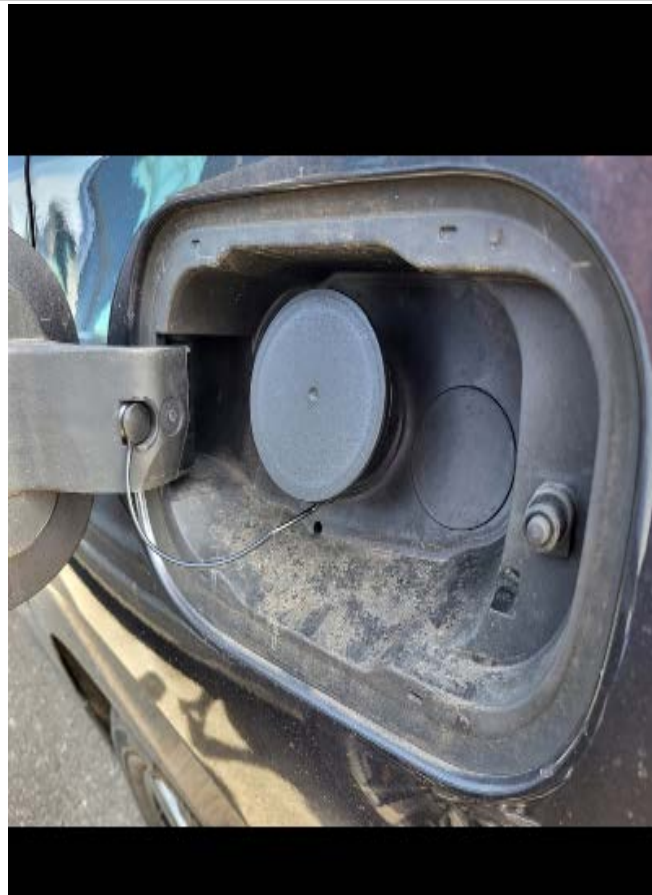
6295094

Involved Region or Country	United States, Canada, Mexico, Europe, Middle East, Israel, Palestine, Brazil (Mercosur), Chile (West), Ecuador (West), Paraguay (West), Peru (West), Cadillac Korea (South Korea), Thailand (ASEAN), Australia/New Zealand, Egypt, Other Africa
Additional Options (RPOs)	
Condition	Some customers may comment on an excess amount of dirt, snow or water that can build up around the fuel filler neck, and it may get into the fuel filler neck.
Cause	The cause of the condition may be when trucks are operated in a high amount of dirt, dust or snow which can migrate to the filler cap area.
Correction	Notify the customer that GM has made available a gas cap for drivers that operate in these environments. This will help to protect the fill area and the fuel system. This should NOT be charged to warranty. It is customer pay if they want to add the cap.

The cap pushes over the outside of the filler neck, and the tether is retained in the hole in the filler door arm, as shown in the photo.
