Service Bulletin

Bulletin No.: 22-NA-098

Subject: Armrest Does Not Lock in Position and Slides Back and Forth

Brand:	Model:	Model Year:		Vehicle Build Breakpoint Date:		Engine:	Transmission:
		from	to	from	to		
Chevrolet	Tahoe Models Suburban	2021	2023	—	—		
GMC	Yukon Models

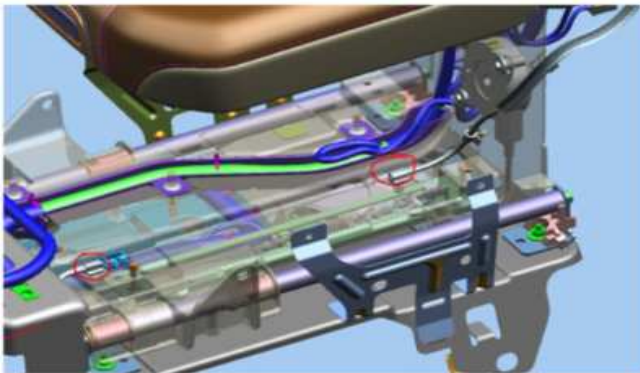
Involved Region or Country	North America
Condition	Some customers may comment on the armrest sliding back and forth and that the armrest does not lock in the intended position.
Cause	<div>

</div> <div>6065371</div> <p>The cause of the condition may be due to the clip popping out during cycling.</p>
Correction	Verify clip is installed fully and clean areas around clip to fully correct seat.
