Service Bulletin

Bulletin No.: 23-NA-027

Subject: Poor Engine Performance, Engine Misfires, Malfunction Indicator Lamp (MIL) Illuminated - DTC P0201, P0202, P0203, P0204, P0205, P0206, P0207, P0208, P0300, P0301, P0302, P0303, P0304, P0305, P0306, P0307, P0308 Set

Brand:	Model:	Model Year:		VIN:		Engine:	Transmission:
		from	to	from	to		
Chevrolet	Silverado 2500HD/3500HD	2017	2023	-	-	L5P	-
	Silverado 4500HD, 5500HD and 6500HD	2019				L5D	
GMC	Sierra 2500HD/3500HD	2017				L5P

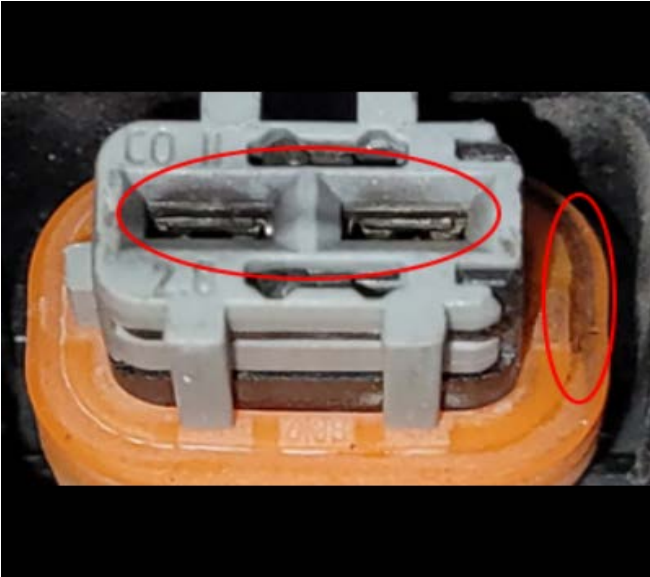
6279590

1. Using Diagnostic Test Probe J-35616-35 (VT), test all the electrical connectors. Refer to *Probing Electrical Connectors in SI*.
 - ⇒ While testing these connectors, examine the connector for indications of fretting or black powder on the connector or connector seal as shown in the graphic above.
2. If any connectors fail the probe test or the visual inspection, replace that connector. Refer to *Wire to Wire Repair in SI*.

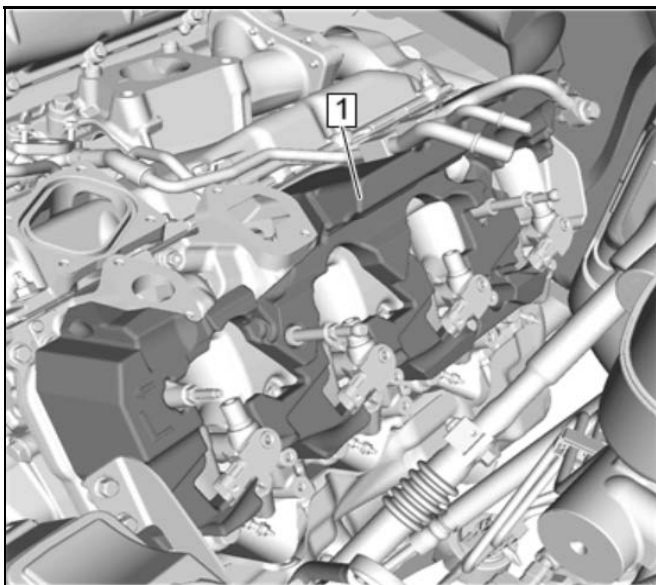
4599048

Note: Examine the underside of the deadener (1) for evidence of wire contact.

5. Prior to installing the deadener, verify that the wire routing doesn't come into contact with said deadener.
