Service Bulletin

Bulletin No.: 23-NA-058

Subject: Cold Start Rattle Noise from the Engine Compartment, Malfunction Indicator Lamp (MIL) Illuminated - DTC P0299 Set

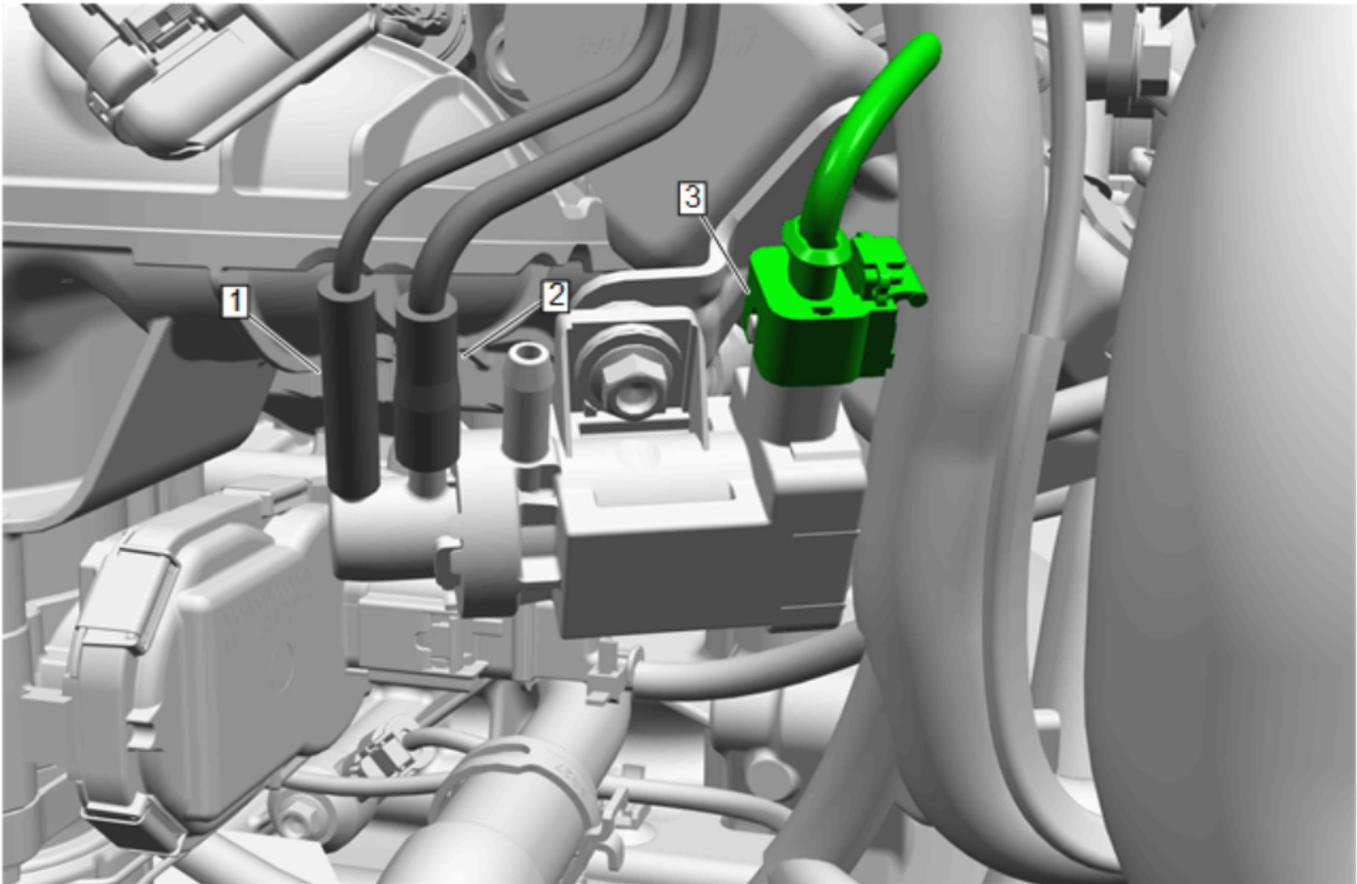
5392518

Check Vacuum Supply from the Vacuum Pump

1. Disconnect the Turbocharger Wastegate Actuator Vacuum Control Solenoid Valve Hose (1) from the Turbocharger Wastegate Regulator Solenoid Valve.
 2. Utilizing EN-23738-A Vacuum Pump with an integral vacuum gauge, connect said pump to the Turbocharger Wastegate Actuator Vacuum Control Solenoid Valve Hose.

3. Engine at operating temperature at idle.
 4. Verify the tool reading: EN-23738-A Vacuum Pump = -50 kPa (-0.5 bar, 15 in Hg).
 - If the desired pressure/vacuum cannot be achieved or does not hold steady:

- ⇒ Ignition/Vehicle » Off.
- ⇒ Test or replace the component: Vacuum Pump Assembly and related hoses.
- If the desired pressure/vacuum can be achieved and holds steady:

- Engine » Off.
 - Reconnect the Turbocharger Wastegate Actuator Vacuum Control Solenoid Valve Hose to the Turbocharger Wastegate Regulator Solenoid Valve and refer to Check Wastegate Vacuum Regulator Valve Function.

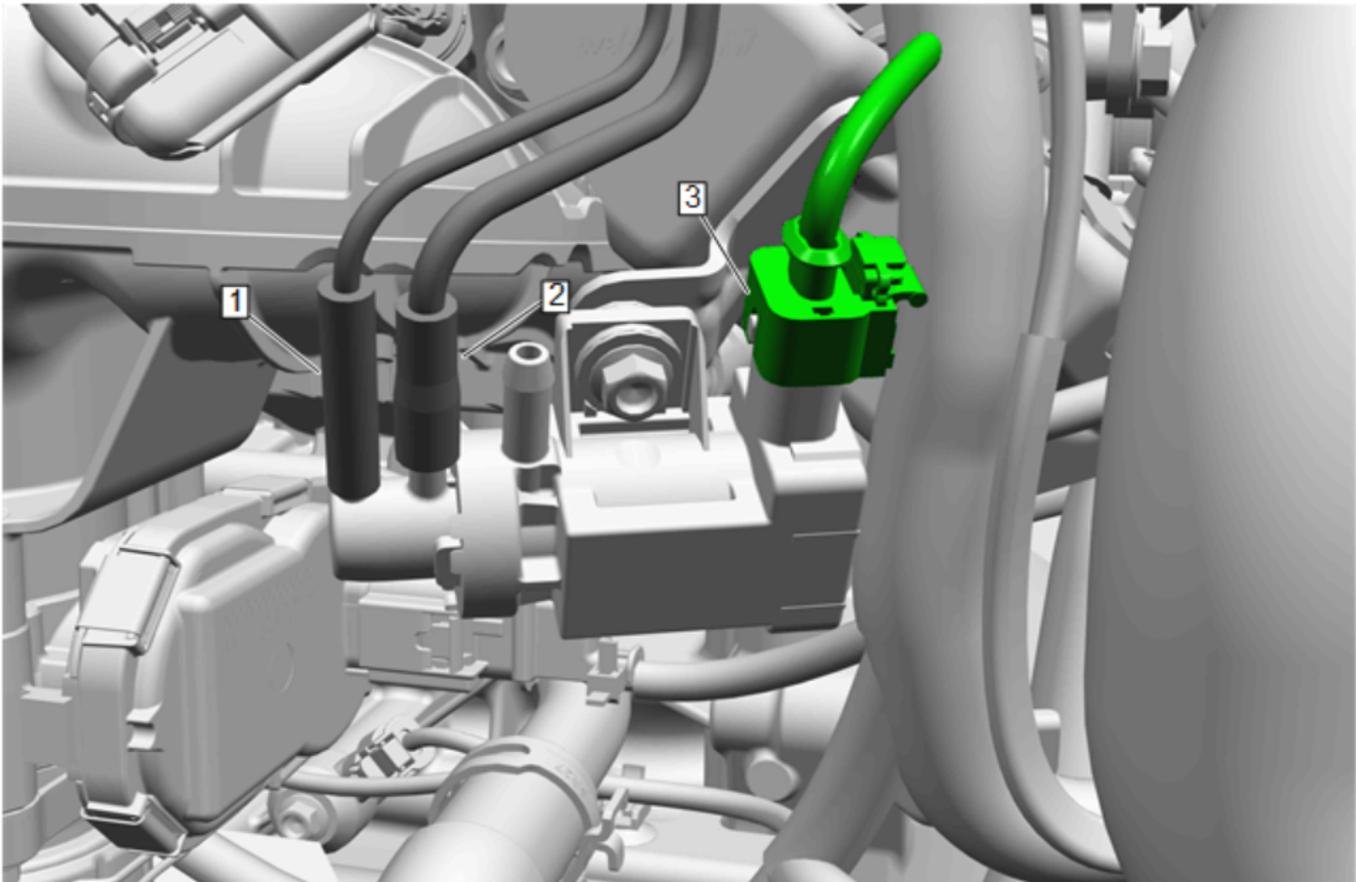
5392518

Check Wastegate Vacuum Regulator Valve Function

1. Disconnect the Turbocharger Wastegate Actuator Vacuum Tank Solenoid Valve Tub (2) from the Turbocharger Wastegate Regulator Solenoid Valve.
 2. Connect the EN-23738-A Vacuum Pump to the Turbocharger Wastegate Solenoid Valve Actuator supply port.

3. Engine at operating temperature at idle.
 4. Verify the tool reading: EN-23738-A Vacuum Pump = Less than -17 kPa (-0.17 bar, 5 in Hg).
 - If -17 kPa (-0.17 bar, 5 in Hg) or greater.

- If less than -17 kPa (-0.17 bar, 5 in Hg).
- ⇒ Engine Speed Greater than 5000 RPM — For 2 s.
- ⇒ Verify the tool reading: EN-23738-A Vacuum Pump = Greater than -50 kPa (-0.5 bar, 15 in Hg).

- If Greater than -50 kPa (-0.5 bar, 15 in Hg). The Turbocharger Wastegate Regulator Solenoid Valve has been validated to be functioning correctly and proceed to Turbocharger Inspection.

- ⇒ Test or replace the component: Turbocharger Wastegate Regulator Solenoid Valve. Refer to *Turbocharger Wastegate Regulator Solenoid Valve Removal* in the Service Manual and *Turbocharger Wastegate Regulator Solenoid Valve Installation* in the Service Manual.

- If less than -50 kPa (-0.5 bar, 15 in Hg).
- ⇒ Test or replace the component: Turbocharger Wastegate Regulator Solenoid Valve. Refer to *Turbocharger Wastegate Regulator Solenoid Valve*

Removal in the Service Manual and *Turbocharger Wastegate Regulator Solenoid Valve Installation* in the Service Manual.
