Preliminary Information

PIT5750C Diagnostic Tip - Intermittent Parasitic Battery Draw / Dead Battery / Slow Crank / Radio Stays On or Fades Slowly After RAP Cancel / Heated Seats Inop (LIN Bus)

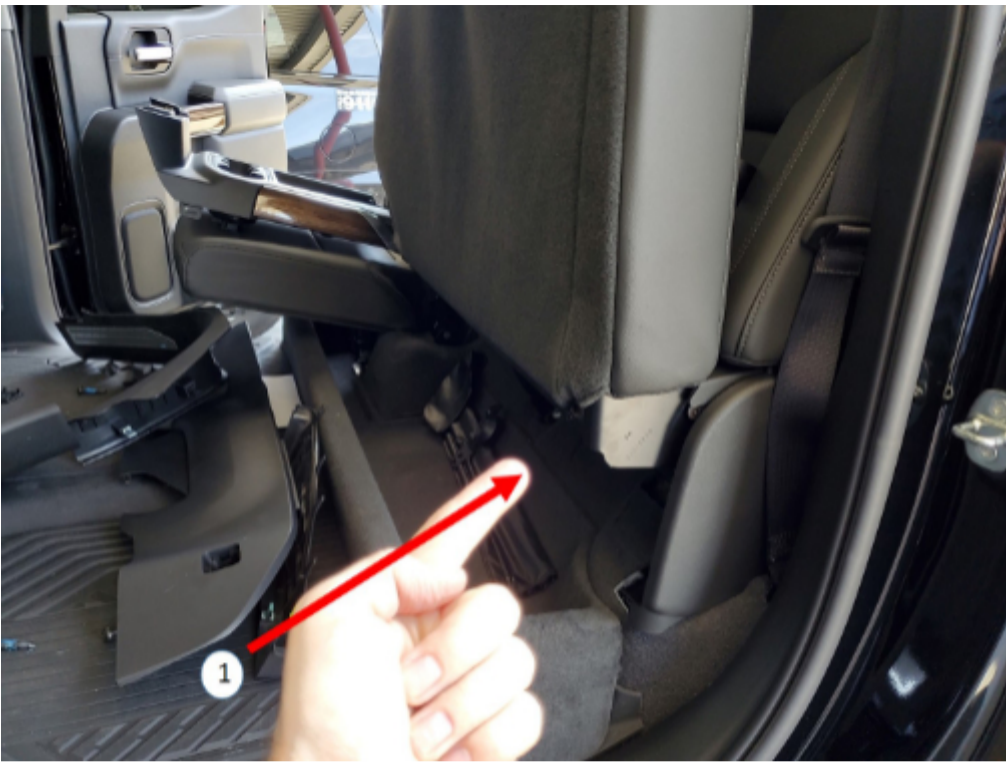
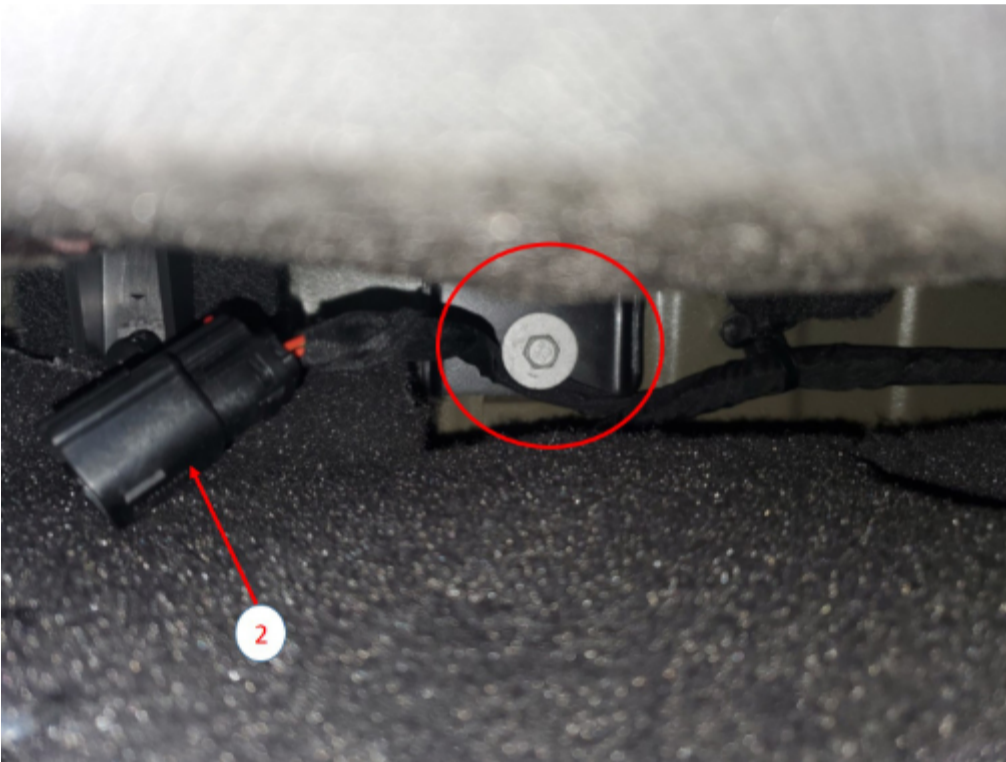
Involved Region or Country	North America
Condition	<p>Some customers may comment of a dead battery. In addition to the dead battery, they may comment on any of the following items:</p> <ul style="list-style-type: none"> - Slow engine crank - Auto Start/Stop feature inoperative, if equipped - Radio stays on or fading out very slowly after ignition is turned off and RAP has been cancelled - Front or rear heated seats inoperative - DTC's U1524, U1526, U1555, U155D
Cause	<p>The cause of these concerns could be the BCM staying awake due to an input from a LIN Bus. It can be difficult to diagnose these types of cases. Many are misdiagnosed as the BCM being at fault and it is then unnecessarily replaced. There are two known areas that have been found, which can short out LIN Bus circuits 6133 and/or 4115 for the front/rear heated seats (example Document ID 4938095). If this happens, it can cause the BCM to stay awake and draw down the battery.</p> <p>NOTE: Even if a truck is NOT equipped with rear heated seats, these circuits are still in the harness.</p>

1. Inspect under the left rear seat (1) for the body harness being pinched where the seat back is attached to the back of cab, as shown below. Call out 2 is connector X370 and this picture was taken from a truck which did not have rear heated seats. In this scenario, LIN Bus circuit 6133 was shorted to the B+ circuit in the harness.

If any issues are found then follow SI Wiring and Connector repair instructions to correct the concern.

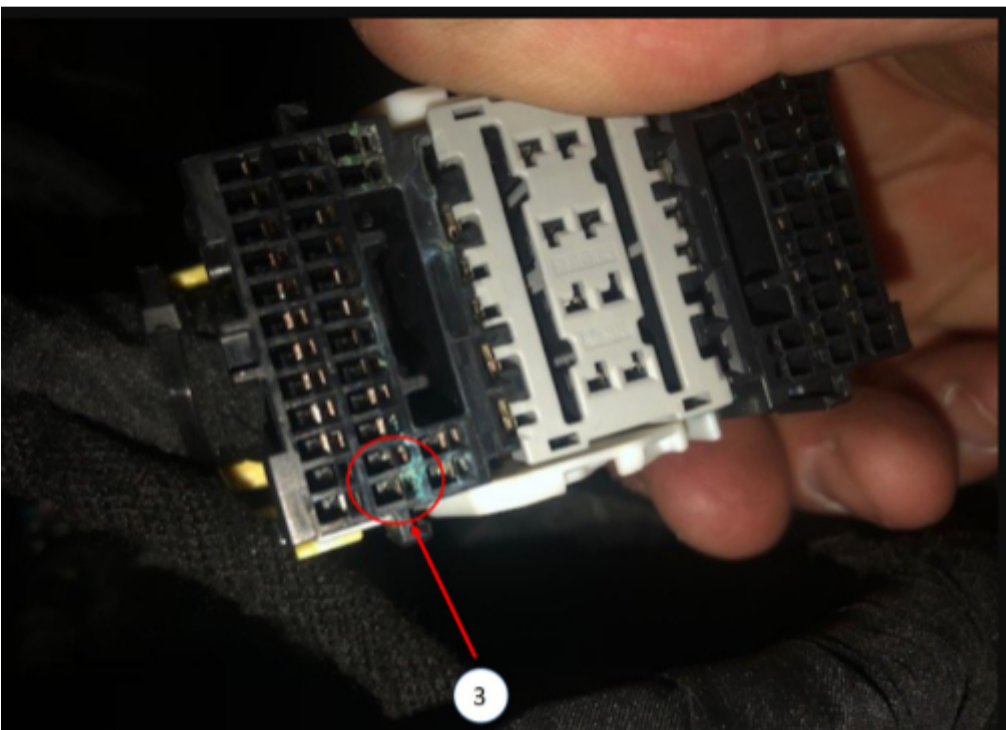
2. Inspect connector X225 for terminal issues/corrosion (3), as shown below. In this scenario, the LIN Bus circuit 4115 was corroded and shorting to other terminals in the connector. If corrosion is found at X225 inspect for a water leak. One known leak location is the A pillar grommet for the door pass through connector not being fully seated.
