Bulletin No.: PIP5911

Preliminary Information

PIP5911 SES LIGHT ON – P066A P066C P066E P067A P067C P067E P068C P068E

| Brand: | Model: | Model Years: | VIN: | | Engine: | Transmissions: |
|---|---|---|---|---|---|---|
| Chevrolet | Silverado 2500HD 3500HD | 2024 | All | All | 6.6L (RPO L5P) | All |

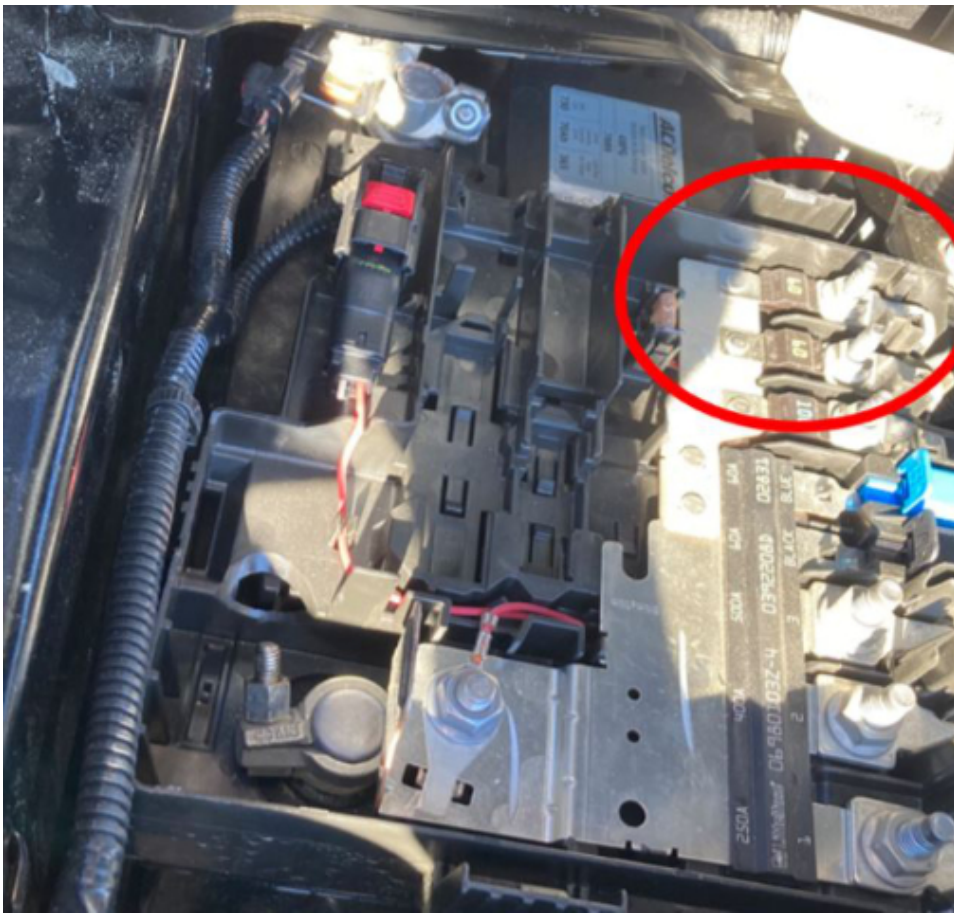
| Cause | <p>Blown fuse F5 (F5BA) will result in Cylinder 1, 4, 6 & 7 all setting DTCs simultaneously</p> <p>Blown fuse F6 (F6BA) will result in Cylinder 2,3,5 and 8 all setting DTCs simultaneously</p> <p>Terminal damage in X950D 55-way connector will result in individual P0671 P0672 P0673 P0674 P0675 P0676 P0677 P0678 DTCs setting.</p> |

Do not replace or disturb glow plugs before checking BDU (Battery Distribution Unit Fuse Assembly) and for bent terminal in X960D 55-way connector.

Be sure to check for 12V on BDU ring terminal while wiggling the cable.

Some blown fuse conditions will intermittently make contact.

If fuse is intermittent or blown, replace the BDU assembly.

DO NOT OVERTORQUE OR STRESS BDU FUSE.

10 mm nut is torqued to 6 Nm ; 13 mm nuts torqued to 15 Nm.

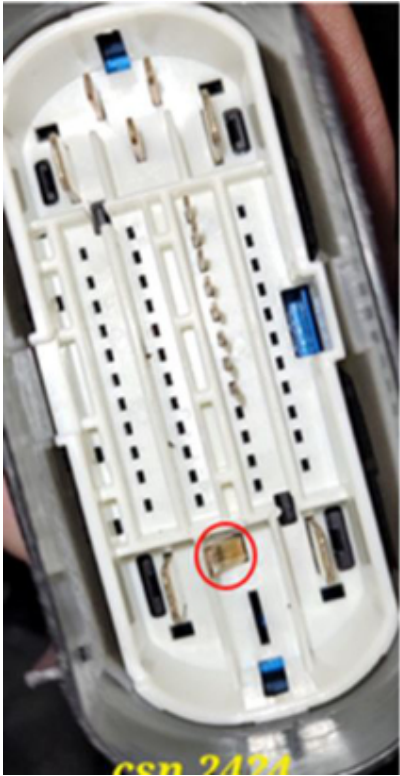
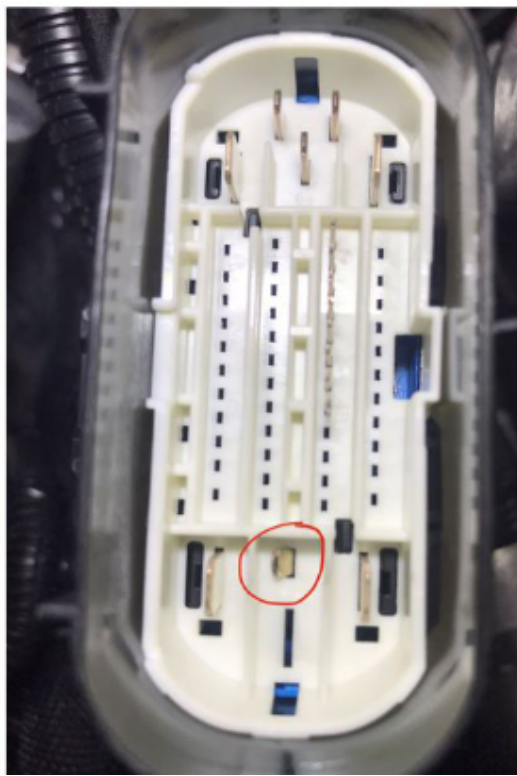
X950D connector can be separated by disengaging the red CPA and squeezing the corners of the connector.

Look for bent terminals in X950D that may result in individual P0671 P0672 P0673 P0674 P0675 P0676 P0677 P0678 DTCs setting.
