# Preliminary Information

## PIP5652A Rattle Noise From Front of Engine With or Without DTCs P0011, P0014, P0016, P0017

| Brand: | Model: | Model Years: | VIN: | | Engine: | Transmissions: |
|---|---|---|---|---|---|---|
| Cadillac | XT4 | 2019 | All | All | 2.0 LSY | All |

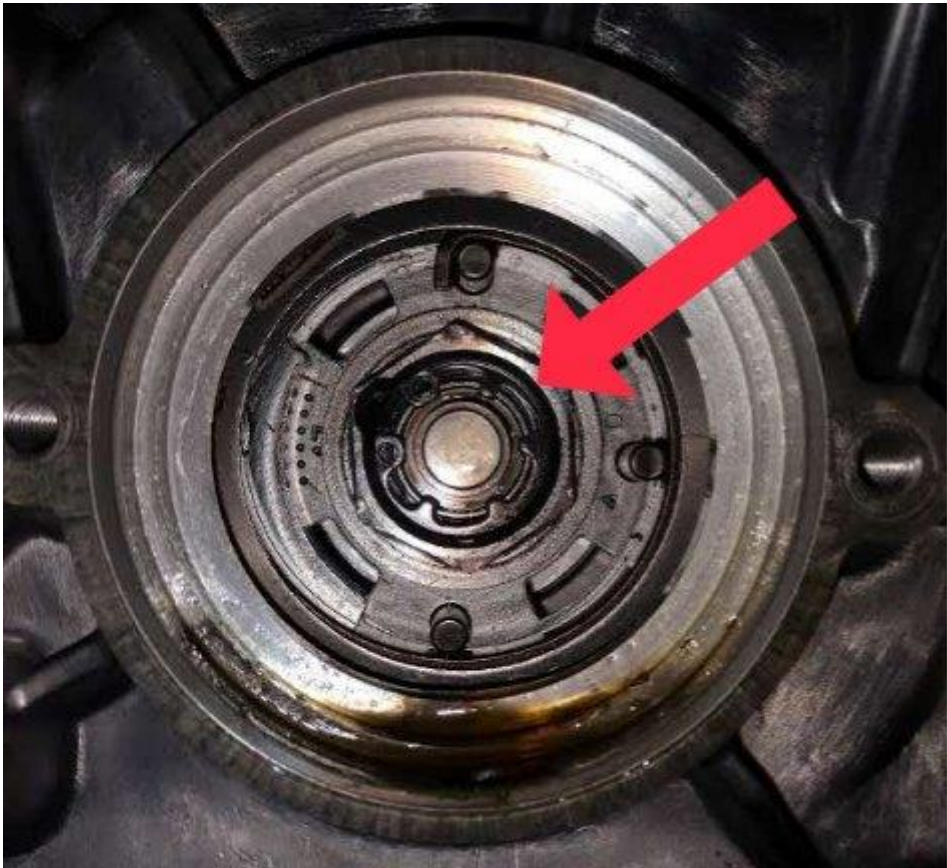
A stuck or collapsed timing chain tensioner may cause damage to the oil control valve assemblies in either Camshaft Sprocket Bolt.

Check for a missing, out of position or damaged Camshaft Position Actuator Valve snap ring. (see picture below)

If the Snap Ring for either Camshaft Sprocket bolt is missing, out of position or damaged, replace both Camshaft Sprocket Bolts following the latest SI documents and perform the timing chain tensioner / guide inspections listed below.

If both Snap Rings are in the correct position, perform the timing chain tensioner and guide inspections listed below.

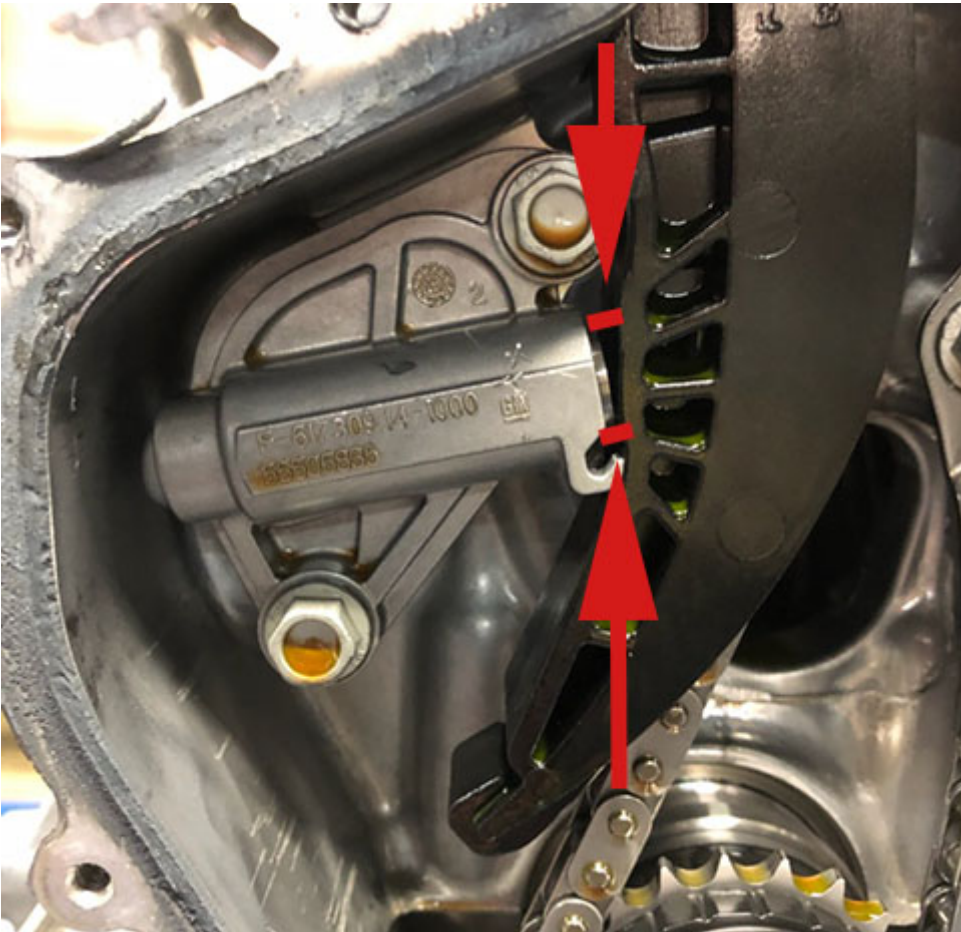
| Cause: | Timing chain tensioner may be stuck or collapsed. |

Remove the lower engine front cover assembly and inspect the timing chain tensioner for an air gap between the tensioner plunger and timing chain guide. (see picture below)

If the timing chain tensioner is found to be stuck or collapsed, replace the Timing Chain Tensioner, inspect the three timing chain guides for excessive wear or damage and replace as necessary.

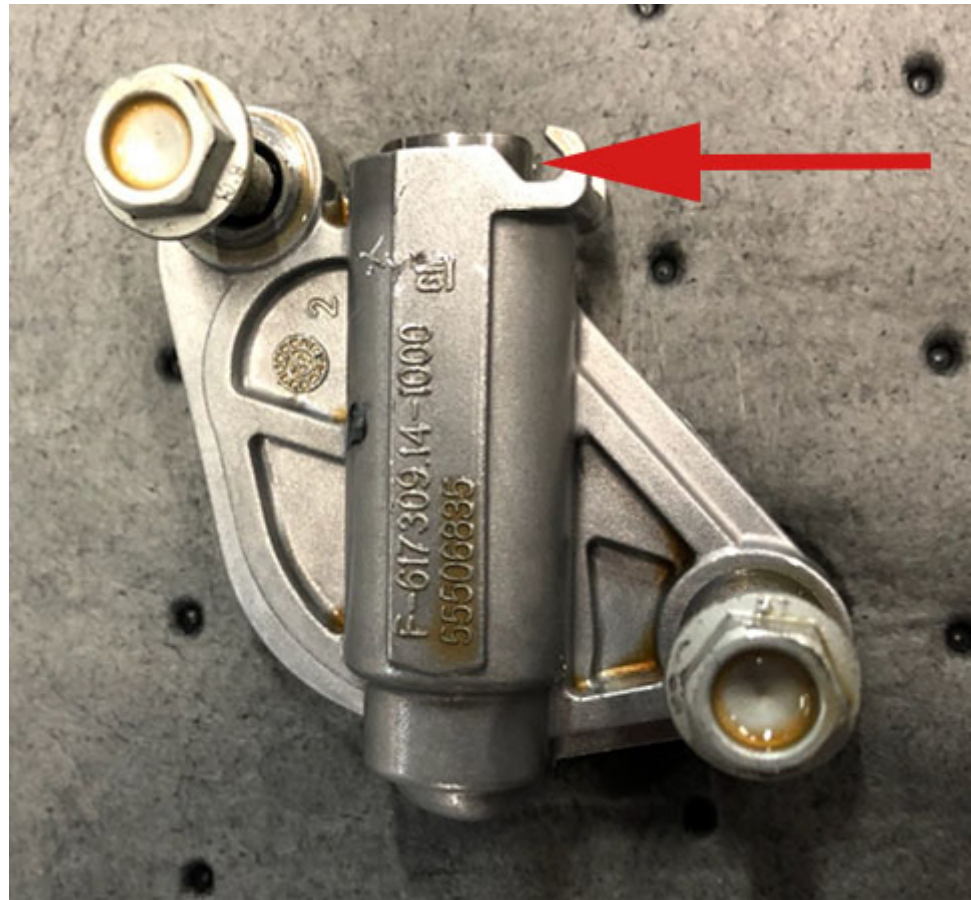
Photo below shows the timing tensioner removed from engine. Note the plunger is stuck in body of tensioner.
