Under Floor Wire Harness for Motor Generator - Connector Cover has Missing or Damaged Appearance

Highlander HV/RAV4 HV/RAV4 Prime/Venza

2021-2022	Venza HV	2021-2022	Highlander HV
2021-2022	RAV4 Prime	2021-2022	RAV4 HV

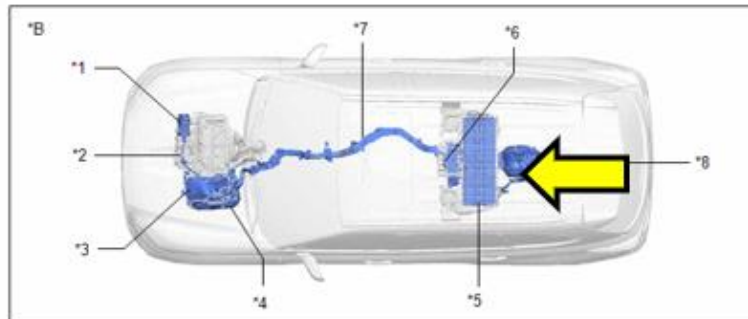
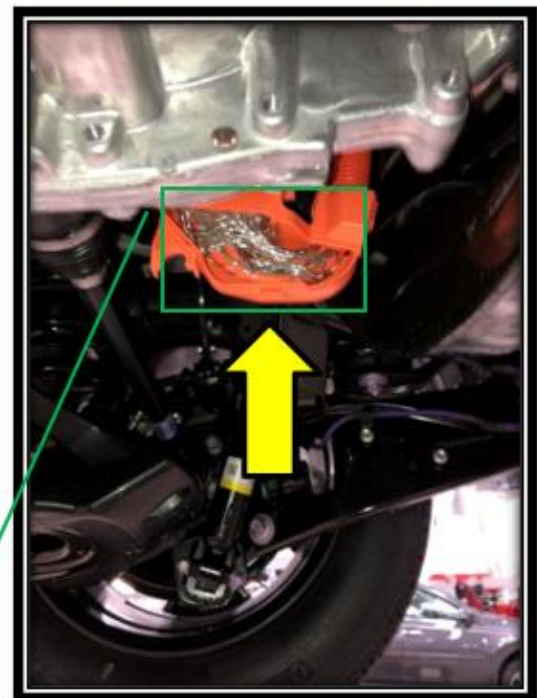
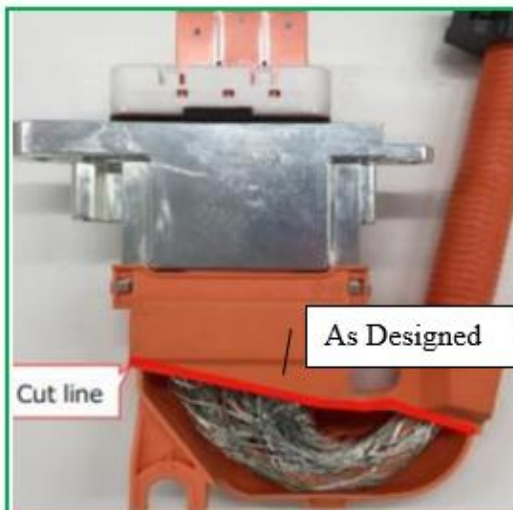
On some 2021-2022MY Highlander HV, RAV4 HV, RAV4 Prime and Venza models, the connector cover for the Under Floor Wire Harness for the Rear Motor Generator may have the appearance of being damaged or missing. Please review the image below to see the connector cover condition.

This appearance is normal and is part of the connector cover design. No repairs are needed.
