Audio Head Unit Software Update (Denso-Ten)

Service Category Audio/Visual/Telematics

Section Audio/Video

YEAR(S)	MODEL(S)	ADDITIONAL INFORMATION
2023	bZ4X, Corolla, Corolla Hatchback, Corolla HV, Crown

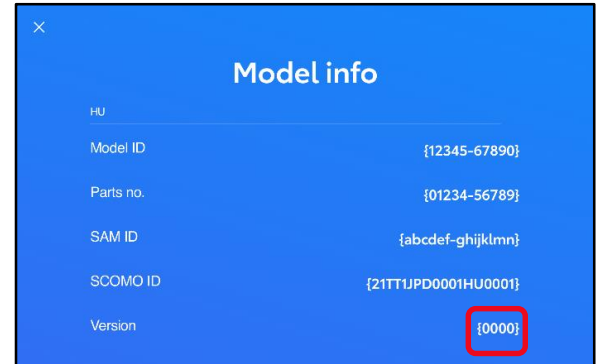
Figure 2.

7. Is the software version the same or earlier than indicated in the Introduction? (Refer to Table 1 below.)

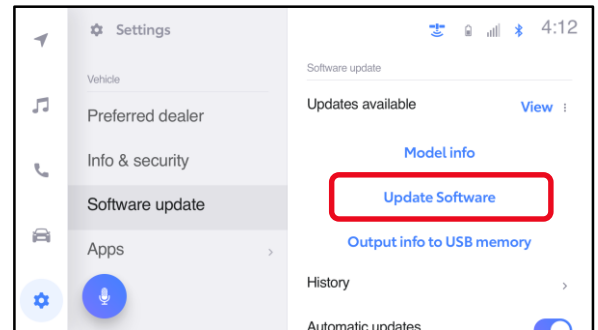
Figure 5.

The "Update Software" button may NOT be available IMMEDIATELY after inserting the USB flash drive. The head unit is unzipping the software update file, and it may take up to 10 minutes for this button to become available.

11. Select Update Software.

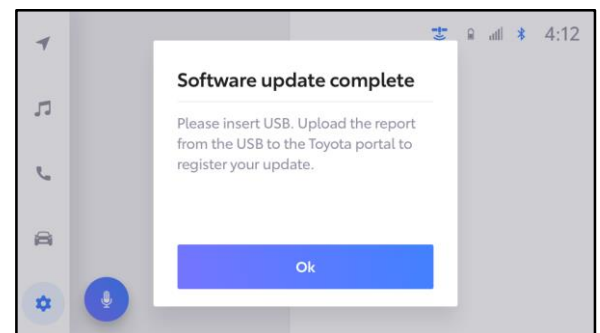
- A. When the update is complete, “Install Complete” will show on the head unit, as shown in Figure 9.
- B. The “Software update” pop-up message may also appear, as shown in Figure 10.

If you are prompted to upload a report as shown in Figure 10, insert a blank USB to remove the .JSON files. These files are NOT needed at this stage of the process.
