Snow Intrusion Preventing Front Door From Fully Opening

YEAR(S)	MODEL(S)	ADDITIONAL INFORMATION
2016 - 2023	Tacoma

Some 2016 – 2023 model year Tacoma vehicles may exhibit a condition where snow or ice builds up between the right or left front door and front fender, preventing the front door from fully opening. Follow the Repair Procedure in this bulletin to address this condition.

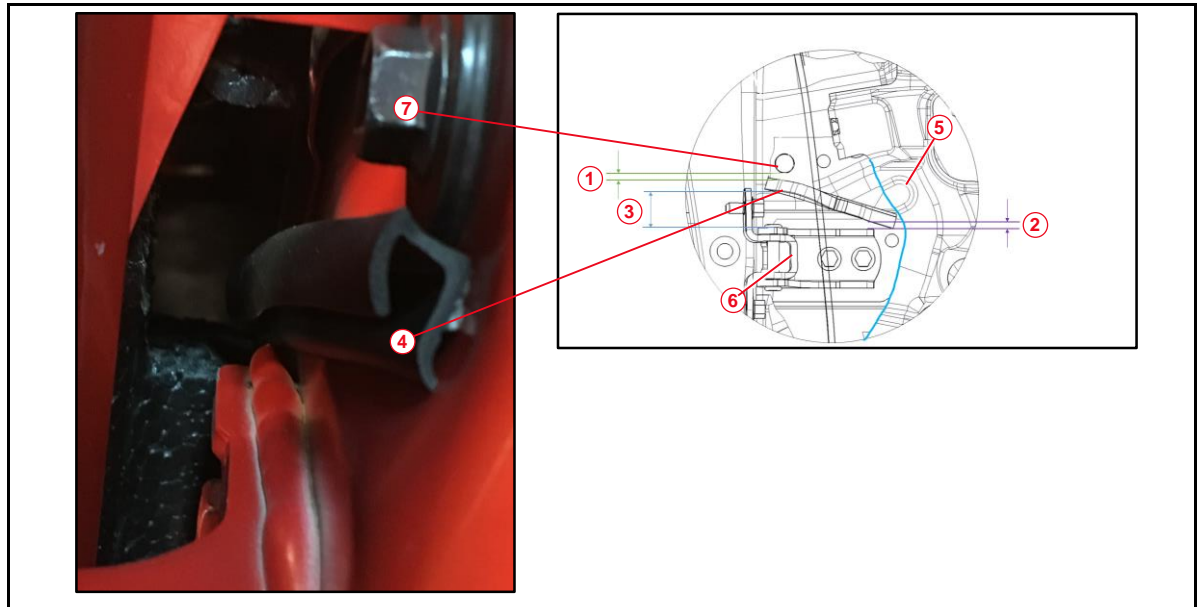
Figure 4.

Figure 4 shows an example of a no-good orientation of the weatherstrip extrusion section that should look like a “u,” not an “n.” The open channel will be facing up.

8. Install the weatherstrip extrusion from the door opening side.
 - A. Pull back 1/3 of the tape for temporary placement. Then starting at the front fender well, remove the rest of the tape to press the weatherstrip fully onto the body side outer panel.
 - B. Refer to the installation reference points as shown to apply the weatherstrip extrusion section.

9. Apply continuous pressure to the weatherstrip extrusion to ensure proper adhesion (approximately 20 – 30 seconds).
10. Allow to fully cure and keep the vehicle between 60°F – 100°F for AT LEAST 20 minutes.
