SIM 61 02 23

GEAR SELECTOR SWITCH (GWS) BUTTONS OR INDICATOR LIGHTING MALFUNCTION

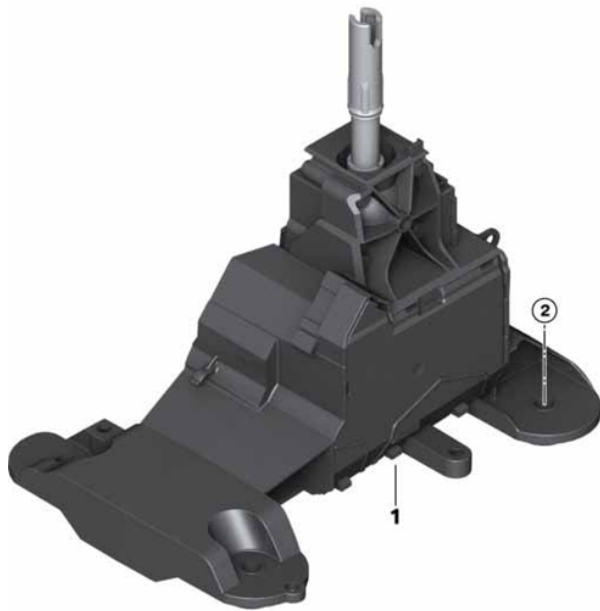
1. Perform a vehicle test using ISTA, read fault memory and diagnose any relevant faults.
2. Replace the Shift box (Selector Lever), refer to repair instructions **25 16 056 “Removing and installing/replacing gearshift lug”**.
3. Utilizing ISTA, clear any fault codes induced by the defective ribbon cable.
4. Perform a sleep cycle until the hazard warning switch light goes out, this can take up to 30 minutes.

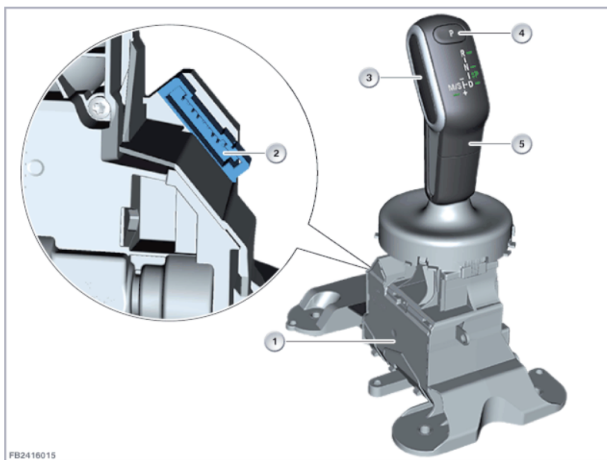
5. Wake the vehicle and verify the effectiveness of the repair by testing the functionality of the GWS.

Does the GWS operate as designed? (Buttons, lighting, etc.)

6. Replace the gear selector switch (GWS), refer to repair instructions **61 31 327** “**Removing and installing/replacing gear selector switch gearshift lever knob**”.
