## STAR ONLINE PUBLICATION

Case Number: S2319000002

Release Date: February 2023

**Symptom/Vehicle Issue:** Service Electric Power Steering Message On Cluster. Electric Power Steering Light On After Recent Service.

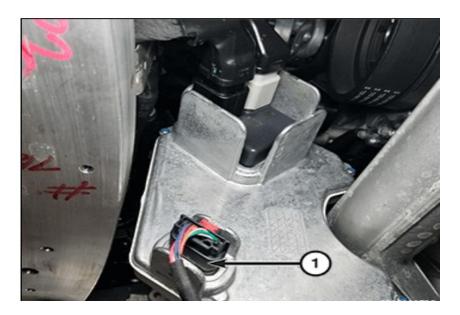
In addition, do not disconnect or remove the steering torque sensor connector. It is not intended to be serviced and permanent damage to the EPS can result. See Fig 1.

Fig 1. EPS torque sensor connector location.
