Technical Service Bulletin (TSB)
First Row Headrest Damaged And/ Or Will Not Adjust

REFERENCE:	TSB: 23-019-23 GROUP 23 - Body	Date:	February 1, 2023	REVISION:	-
VEHICLES AFFECTED:	2022 (WS) Grand Wagoneer/Wagoneer Built on or after June 4, 2021 (MDH0604XX) and on and before July 10, 2022 (MDH0710XX).	MARKET APPLICABILITY:			
		<input checked="" type="checkbox"/> NA		<input type="checkbox"/> MEA	
		<input type="checkbox"/> SA		<input type="checkbox"/> IAP	
		<input type="checkbox"/> EE		<input type="checkbox"/> CH	
CUSTOMER SYMPTOM:	First Row Headrest Damaged And/ Or Will Not Adjust.				
CAUSE:	<ul style="list-style-type: none"> Inspect for damage and check adjustability of headrest and replace as necessary.

This bulletin involves inspecting and possibly replacing the first row active headrests.

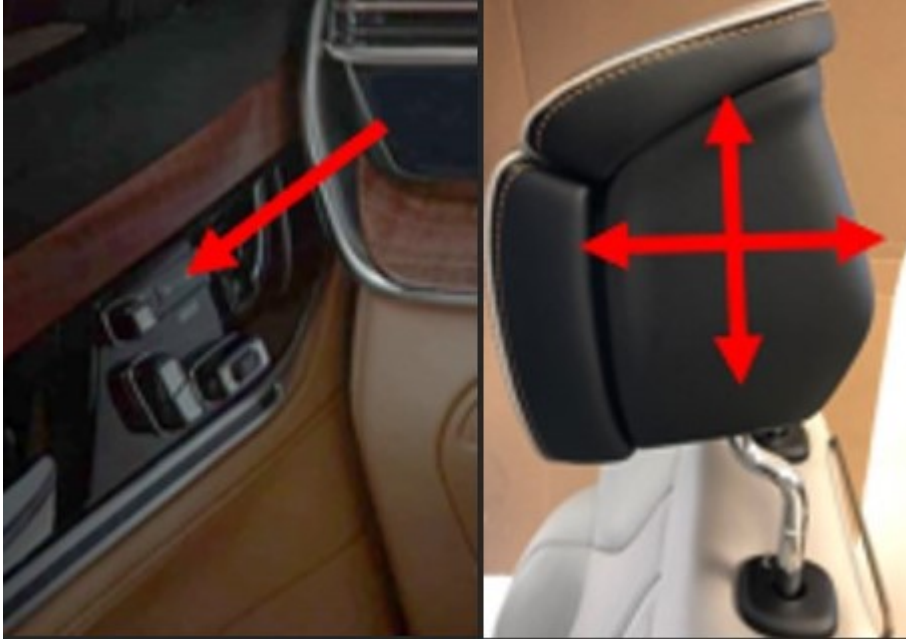
Fig. 1
Power Headrest

- Press the fore/aft and up/down buttons on door to operate the power headrest. Verify uninterrupted movement and distances ([Fig. 1](#))

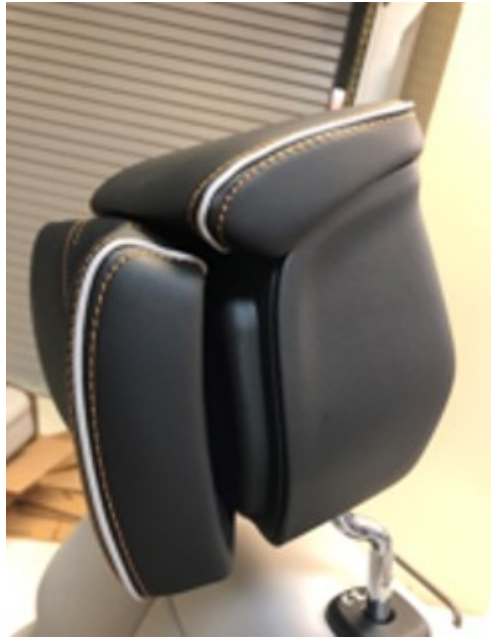
Fig. 2
Comfort Wings Movement

- Check movement and function of comfort wings. Verify uninterrupted movement and distances. (Fig. 2) .

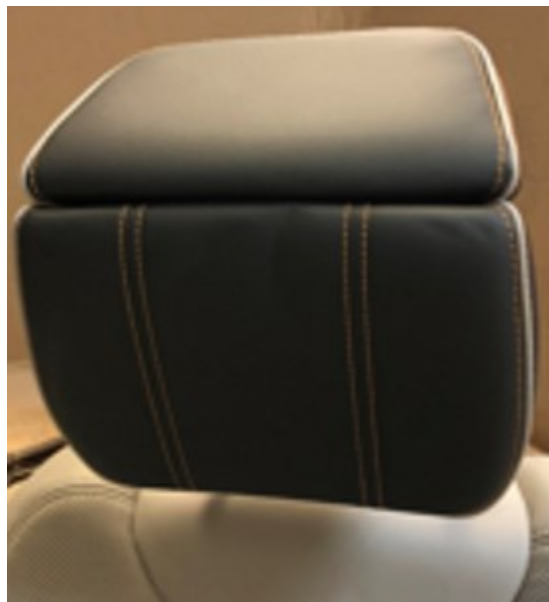
Fig. 3
Inspect Headrest

- Inspect headrest for knicks/cuts/damage or separation (Fig. 3) .

1. Replace the headrests. Refer to the detailed procedures listed in DealerCONNECT>Service Library under: 23 - Body / Seats, Front / Headrest, Front / Removal and Installation.
2. Does the headrest operate properly?
 - YES>>> This bulletin has been completed, use LOP (23-20-48-9Q) for one headrest or (23-20-48-9R) for both headrests.
 - NO>>> Further normal seat diagnosis may be necessary.
3. Verify any other customer seat concerns with the latest available bulletins. Refer to all applicable published service bulletins for detailed repair procedures and labor times regarding updating the seat concerns.

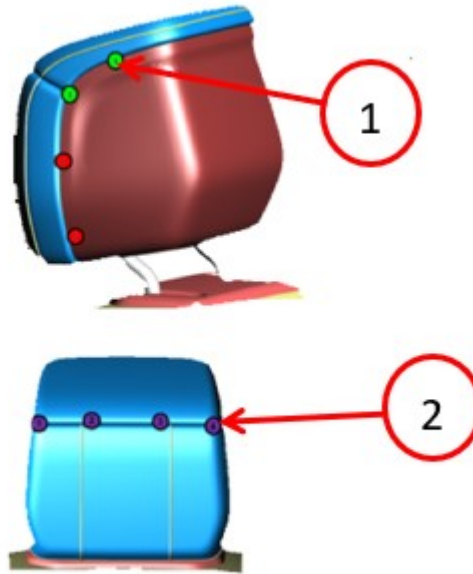
Fig. 4
Headrest Closed Gap Specs

- Inspect headrest gap tolerances using a feeler gauge (Fig. 4) (Fig. 5) .

- 1 - Bezel to Headrest A/A Gap: Net + 0 mm
 - 2 - Headrest Upper To Front U/D Gap: Net + 0 mm
-

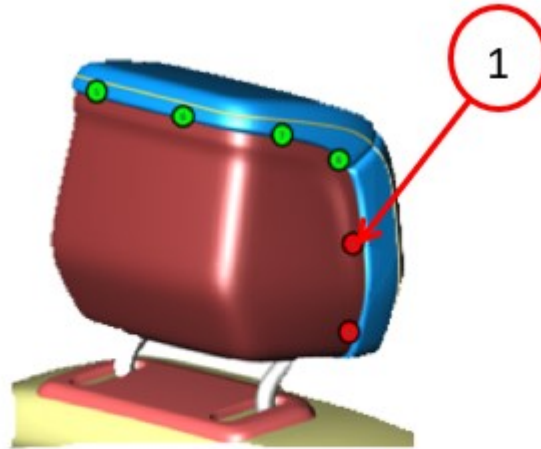
Fig. 5
Bezel To Headrest After Actuation

- 1 - Bezel To Headrest After Wing Actuation A/A Gap < 7 mm
-

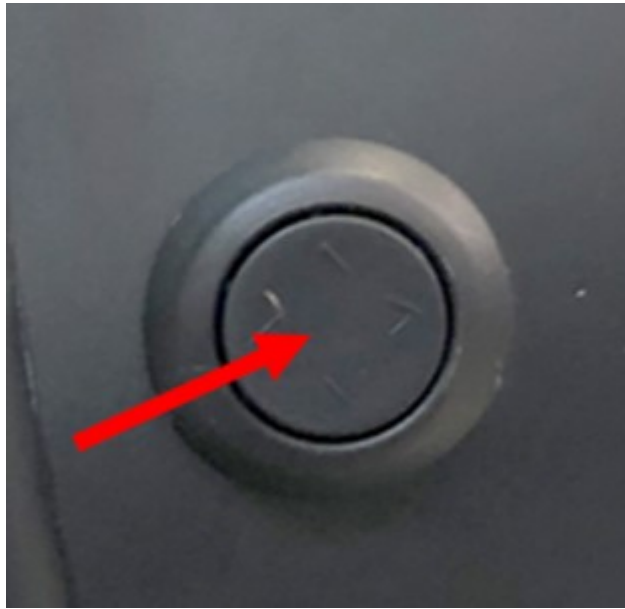
Fig. 6
Manual Headrest Button

- Press button on manual headrest. Verify the button doesn't stick or movement obstructed (Fig. 6) .

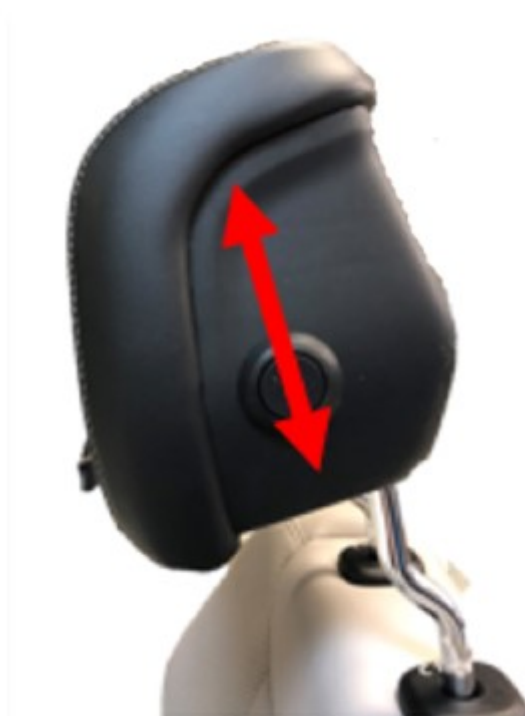
Fig. 7
Manual Headrest Up/Down Movement

- Check function of headrest up/down operation. Verify distances and uninterrupted movement (Fig. 7) .

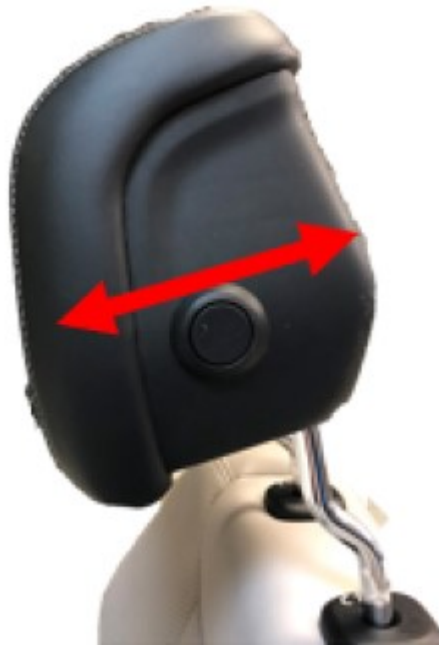
Fig. 8
Manual Headrest Fore/Aft Movement

- Check function of headrest fore/aft operation. Verify distances and uninterrupted movement (Fig. 8) .

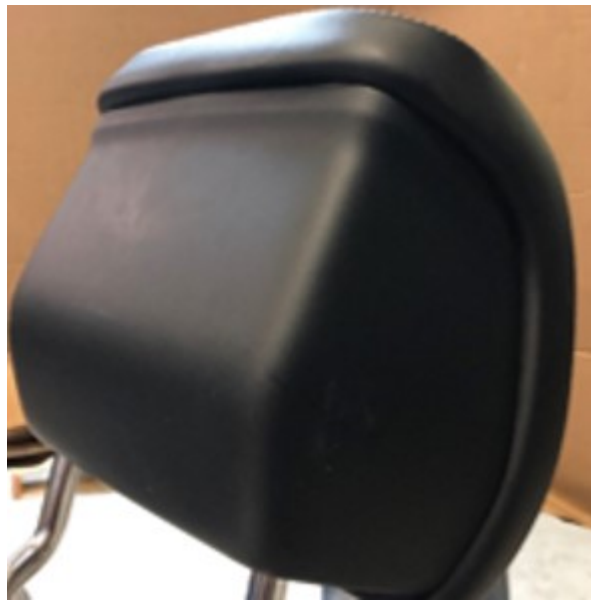
Fig. 9
Inspect Headrest

- Inspect headrest for knicks/cuts/damage or separation (Fig. 9) .

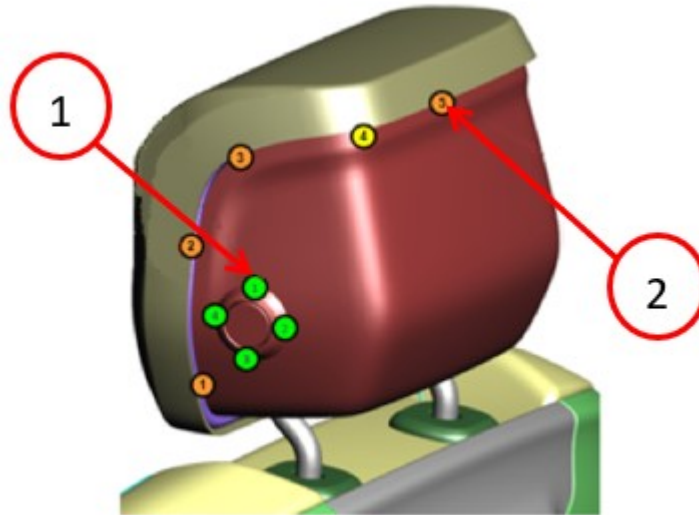
Fig. 10
Headrest Button And Bezel Gap Specs

- Inspect headrest gap tolerances using a feeler gauge (Fig. 10) (Fig. 11) .

- 1 - Button Bezel To Headrest A/A Gap: Net + 0.5 mm
2 - Bezel To Headrest A/A Gap: Net + 0 mm
-

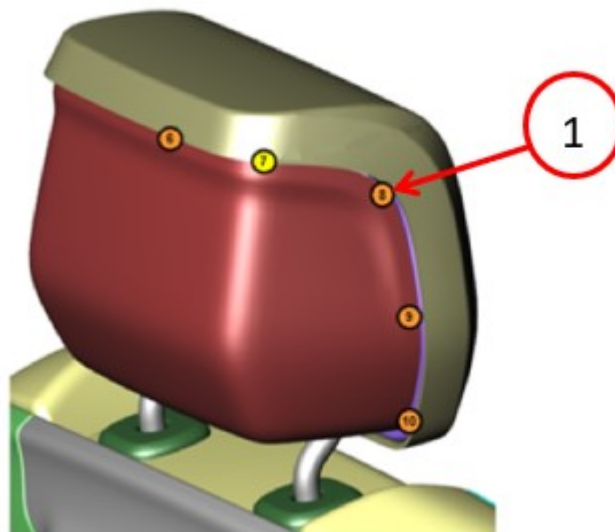
Fig. 11
Bezel To Headrest

- 1 - Bezel To Headrest A/A Gap: Net + 0.25 mm
-
