**Technical Service Bulletin (TSB)**  
**Second Row Middle Seat Belt Does Not Retract**

<b>REFERENCE:</b>	<b>TSB:</b> 23-018-23 <b>GROUP</b> 23 - Body	<b>Date:</b>	February 1, 2023	<b>REVISION:</b>	-
<b>VEHICLES AFFECTED:</b>	2022 (WS) Grand Wagoneer/Wagoneer Built on or after January 1, 2022 (MDH0101XX) and on and before July 22, 2022 (MDH0722XX) equipped with the Eight Passenger Seating (Sales Code CYF).			<b>MARKET APPLICABILITY:</b>	
				<input checked="" type="checkbox"/> NA	<input type="checkbox"/> MEA
				<input type="checkbox"/> SA	<input type="checkbox"/> IAP
				<input type="checkbox"/> EE	<input type="checkbox"/> CH
<b>CUSTOMER SYMPTOM:</b>	Second row middle seat belt does not retract.				
<b>CAUSE:</b>	<b>Either the:</b> <ul style="list-style-type: none"> <li>• The plastic bezel was misaligned at assembling station.</li> <li>• The guide holes do not align.</li> <li>• Holes on the frame are out of position 3 mm (tol ±0.5 mm).</li> </ul>

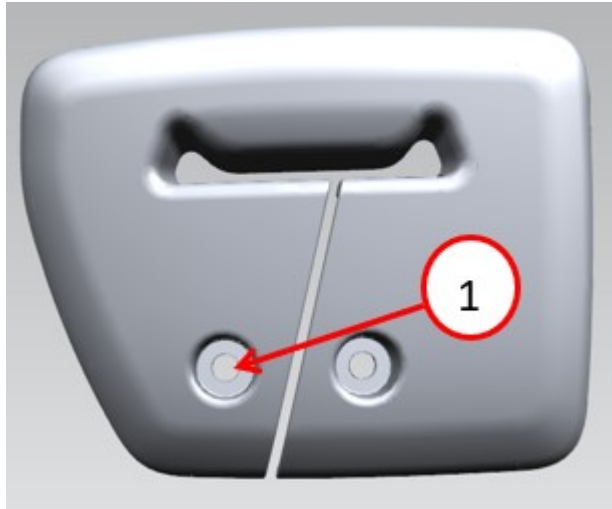
**Fig. 2**  
**Seat Belt Guide Plate**

1 - Hole to Modify

2. Remove seat belt guide plate and increase this hole diameter to 8mm (5/16") ( Fig. 2) .

3. Reinstall plate and ensure belt retraction operation.
4. Verify any other customer seat concerns with the latest available bulletins. Refer to all applicable published service bulletins for detailed repair procedures and labor times regarding updating the seat concerns.
