NUMBER: 23-021-23

Forward Facing Camera - Active Lane Management Inoperable

2022 (WL) Jeep Grand Cherokee

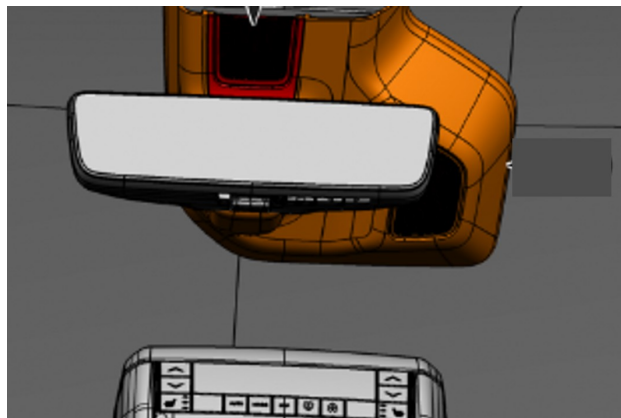
Fig. 1
Mirror Sensor Cover

- The active lane management system will not work.
- "Active lane Management unavailable service required" message on the cluster.

1. Is the vehicle on the RSU VIN list?
 - YES>>> Proceed to [Step 2](#).
 - NO>>> This Bulletin does not apply. Normal diagnosis should be performed.
2. Replace the sensor cover on the mirror ([Fig. 1](#)) . **(Service library can also be used for reference for the sensor cover only, the camera does not need to be removed)**. Refer to the detailed service procedures available in DealerCONNECT> Service Library under: Service Info>08 - Electrical / 8B - Driver Assistance / Assistance System Components / Cameras / Removal and Installation >Long Range Camera - Front.
 - a. Using a trim stick or suitable tool, remove the inside rearview mirror sensor cover and discard .
 - b. Reinstall the new rearview mirror sensor cover and snap into position ([Fig. 1](#)) .

NOTE: Long range camera front programming and calibration must be performed after the mirror sensor cover is replaced.

3. Program the Long Range Camera Front (LRCF) programming and calibration routine. Refer to the detailed service procedures available in DealerCONNECT> Service Library under: Service Info>08 - Electrical / 8B - Driver Assistance / Programming and Calibration / Programming and Calibration. Long Range Camera Front.
