Technical Service Bulletin (TSB)
Dual Pane Sunroof Wind Deflector Fabric Net Separating From The Frame

REFERENCE:	TSB: 23-022-23 GROUP 23 - Body	Date:	February 2, 2023	REVISION:	-
VEHICLES AFFECTED:	2022 (WL) Grand Cherokee This bulletin applies to vehicles built on or after November 01, 2021 (MDH 1101XX) and on or before June 24, 2022 (MDH 0624XX) equipped with Dual-Pane Panoramic Sunroof (Sales Code GWJ).			MARKET APPLICABILITY:	
				<input checked="" type="checkbox"/> NA	<input type="checkbox"/> CH
				<input type="checkbox"/> EE	<input checked="" type="checkbox"/> IAP
				<input checked="" type="checkbox"/> SA	<input checked="" type="checkbox"/> MEA
CUSTOMER SYMPTOM:	Customers may comment on the following: <ul style="list-style-type: none"> The dual-pane sunroof wind deflector fabric net is separating from the frame. 				
CAUSE:	Wind deflector frame alignment features out of tolerance.

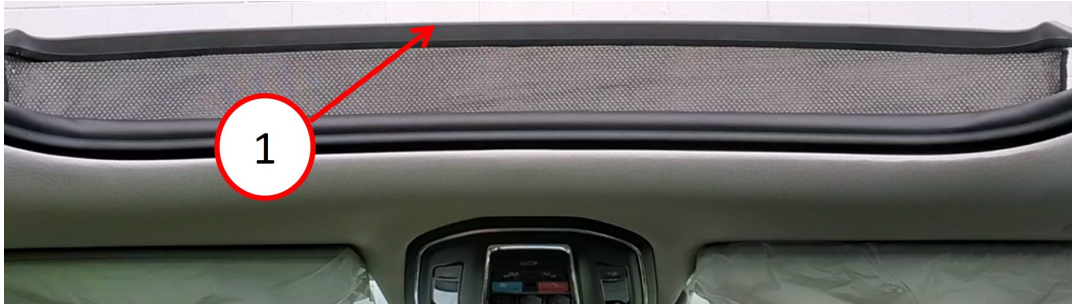
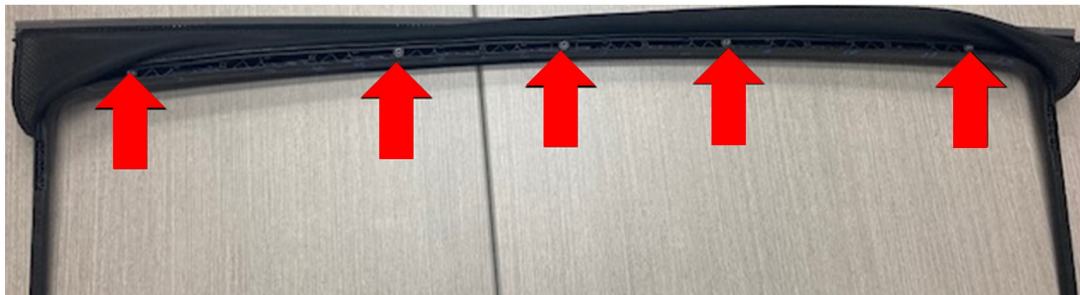
Fig. 1

NOTE: The sunroof wind deflector fabric net is separating from the top part of the dual-pane sunroof wind deflector frame (Fig. 1) . Use of an inspection mirror may be needed to inspect the wind deflector fabric net.

Top Part Of The Dual-Pane Sunroof Wind Deflector

1 - Top Part Of The Dual-Pane Sunroof Wind Deflector Frame To Inspect

- 1. Replace the dual-pane sunroof wind deflector. Refer to the detailed service procedures available in DealerCONNECT> Service Library under: Service Info>23 - Body / Sunroof, Dual-Pane / Deflector, Wind / Removal and Installation.

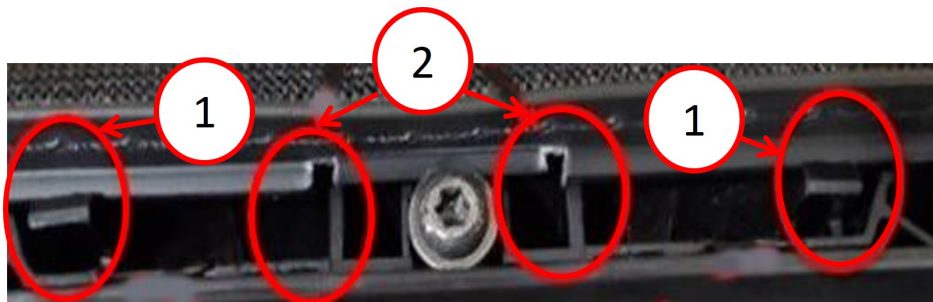
Fig. 2

1. Open the dual-pane sunroof and verify if the sunroof wind deflector fabric net is separating from the top frame, showing disengaged tabs and misaligned notches (Fig. 2) .

Dual-Pane Sunroof Wind Deflector Separation Conditions

1 - Disengaged Tabs
2 - Misaligned Notches

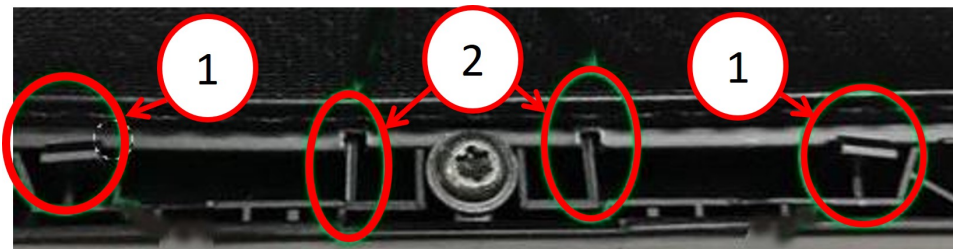
Fig. 3

NOTE: (Fig. 3) is what a dual-pane sunroof wind deflector will look like WITHOUT these conditions.

Correct Functioning Dual-Pane Sunroof Wind Deflector Fabric Net

- 1 - Both Tabs Are Engaged Correctly
 - 2 - Both Notches Are Aligned Correctly
-
