<b>REFERENCE:</b>	<b>TSB:</b> 31-001-23 <b>GROUP</b> 31 - Collision Bulletins	<b>Date:</b>	February 3, 2023	<b>REVISION:</b>	31-002-22
<b>VEHICLES AFFECTED:</b>	2019 - 2023 (DT) RAM 1500 Pickup 2020 - 2023 (JT) Jeep Gladiator 2019 - 2023 (BV) Jeep Renegade 2015 - 2020 (4C) Alfa Romeo 4C 2017 - 2020 (BA) FIAT 124 Spider (Convertible) 2013 - 2019 (FF) FIAT 500 2017 - 2023 (GA) Alfa Romeo Giulia 2018 - 2023 (GU) Alfa Romeo Stelvio 2014 - 2023 (KL) Jeep Cherokee 2013 - 2016 (PF) Dodge Dart 2013 - 2017 (ZD) Dodge Viper 2013 - 2023 (DS) RAM 1500 Pickup 2013 - 2022 (WK) Jeep Grand Cherokee 2013 - 2023 (WD) Dodge Durango 2017 - 2023 (RU) Chrysler Pacifica 2015 - 2018 (BU) Jeep Renegade 2018 - 2023 (JL) Jeep Wrangler 2015 - 2023 (LA) Dodge Challenger 2013 - 2014 (LC) Dodge Challenger 2013 - 2023 (LD) Dodge Charger 2013 - 2023 (LX) Chrysler 300 2017 - 2023 (MP) Jeep Compass 2015 - 2017 (UF) Chrysler 200 2013 - 2020 (JC) Dodge Journey 2013 - 2014 (JS) Chrysler 200 /Dodge Avenger 2013 - 2020 (RT) Dodge Grand Caravan 2013 - 2016 (RT) Chrysler Town & Country 2019 - 2023 (D2, DD, DF, DJ and DP) RAM Heavy Duty Trucks	<b>MARKET APPLICABILITY:</b>	<input checked="" type="checkbox"/> NA <input checke

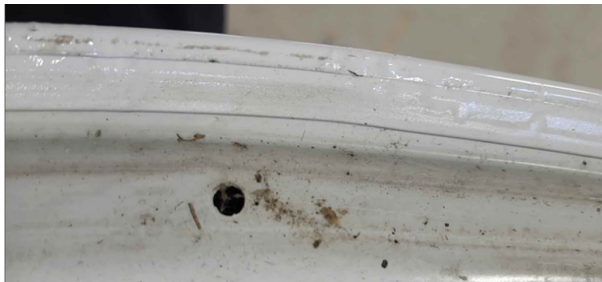
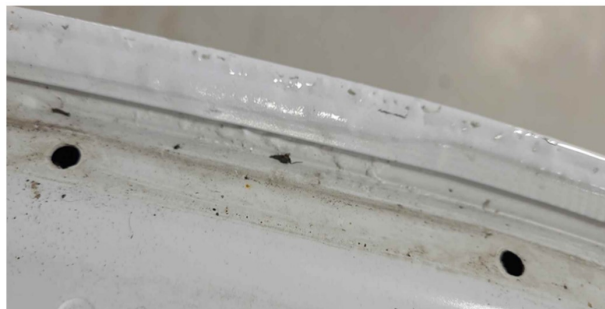
**Fig. 1**  
**Hem Flange Area Example**

**NOTE:** This bulletin does not apply to corrosion in the hem flange area; this will require panel replacement (Fig. 1) .

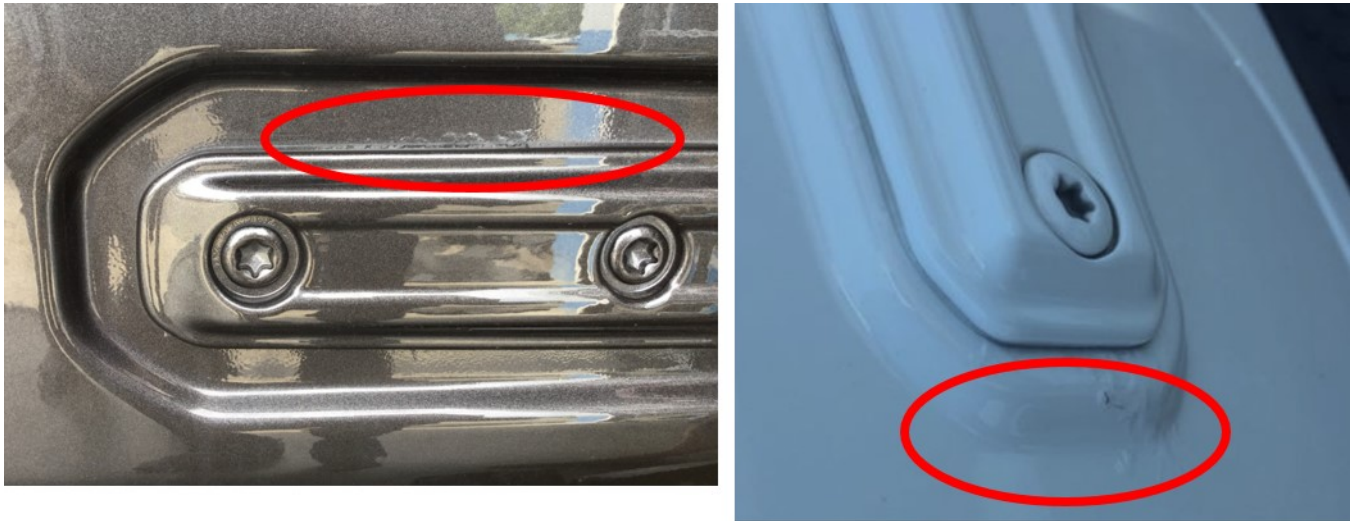
**Fig. 2**  
**Examples of Bubbling**

Aluminum corrosion or bubbling on the doors and/or hinges (Fig. 2) .

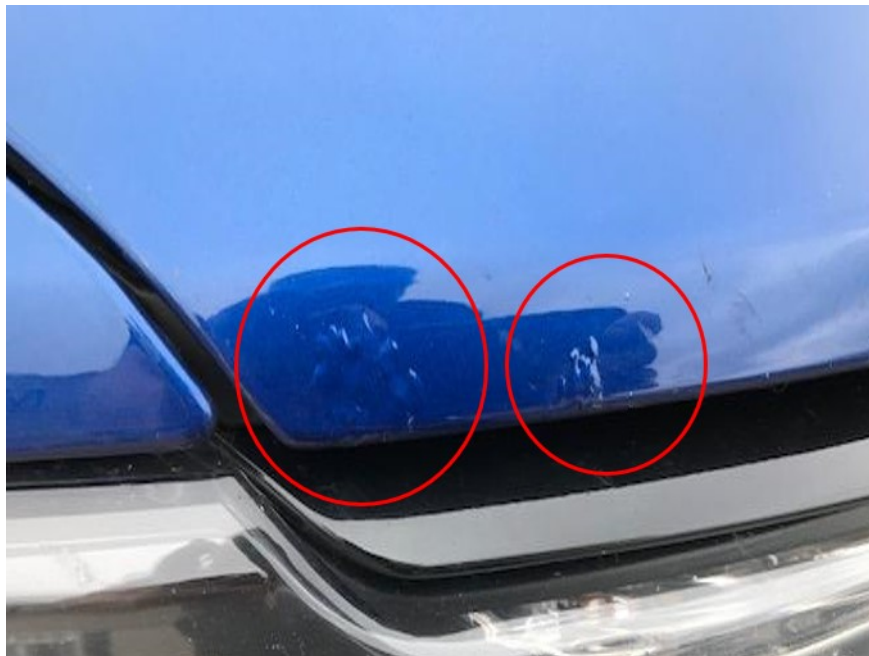
**Fig. 3**  
**Examples of Corrosion Along Leading Edges**

Aluminum corrosion along the leading edge of hood or other exterior surface areas of the doors, fenders or liftgates (Fig. 2) or (Fig. 3) .

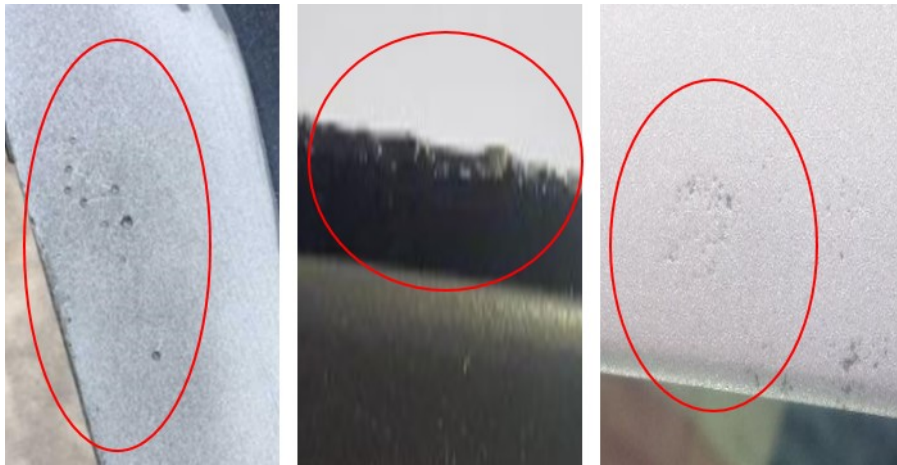
**Fig. 4**  
**Corrosion Examples**

2. After digital imaging or Regional Office approval and removing the initial blistered paint from the panel surface with 80 grit grinding disc, is severe pitting exhibited that cannot be removed with sandpaper, 3M Clean and Strip Disc or equivalent (Fig. 4) ?

- YES>>> Replace the panel.
- NO>>> Proceed to [Step 1](#) of the repair procedure.
