REFERENCE:	TSB: 23-026-23 GROUP 23 - Body	Date:	February 10, 2023	REVISION:	-
VEHICLES AFFECTED:	2023 (WL) Grand Cherokee This bulletin applies to vehicle built on or after December 10, 2022 (MDH1210XX) and on and before December 12, 2022 (MDH1212XX).	MARKET APPLICABILITY:			
		<input checked="" type="checkbox"/> NA	<input checked="" type="checkbox"/> MEA	<input type="checkbox"/> SA	<input type="checkbox"/> IAP
		<input type="checkbox"/> EE	<input type="checkbox"/> CH		
CUSTOMER SYMPTOM:	Either or both front door inside trim panels are loose or have a gap at the doors.				
CAUSE:	<ul style="list-style-type: none"> The 10 Push fasteners that secure the inside door trim panel to the door have not been fully seated into the door during assembly.

This bulletin involves re-securing the front door trim panels to the doors.

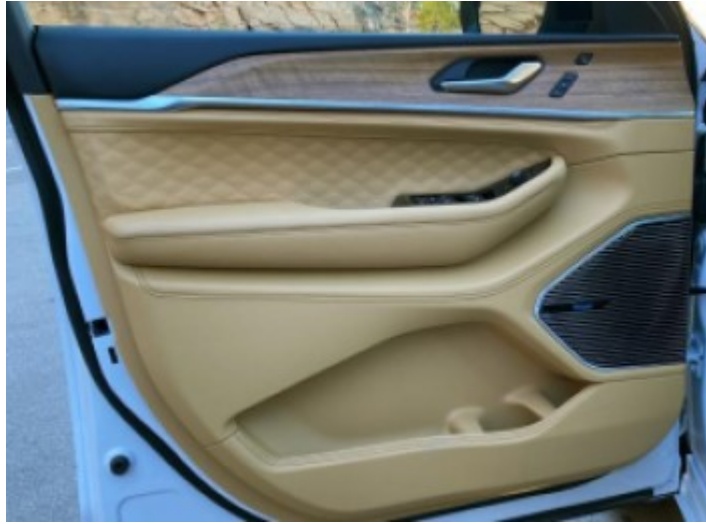
Fig. 1
Front Door Trim Panel

1. Door inside trim panels are not secured to the doors (Fig. 1) .
