REFERENCE:	TSB: 23-029-23 GROUP 23 - Body	Date:	February 25, 2023	REVISION:	23-024-22
VEHICLES AFFECTED:	2021 - **2023** (WL) Jeep Grand Cherokee 2021 - 2022 (WK) Jeep Grand Cherokee 2022- **2023** (WS) Grand Wagoneer/Wagoneer 2021 - **2023** (KL) Jeep Cherokee 2021 - **2023** (DT) RAM 1500 Pickup 2021 - **2023** (WD) Dodge Durango 2021 - **2023** (MP) Jeep Compass **2021 - 2023 (MV) Jeep Compass** 2021 - **2023** (JT) Jeep Gladiator 2021 - **2023** (JL) Jeep Wrangler **2019 - 2023 (BV) Jeep Renegade**	MARKET APPLICABILITY:			
CUSTOMER SYMPTOM:	Some customers may report that on occasion, vehicle exterior head lamp assemblies are fogged with a light layer of condensation on the inside of the lenses (Fig. 1).				
CAUSE:	Head lamp condensation.

This bulletin is to communicate the procedure for head lamp condensation clearing.

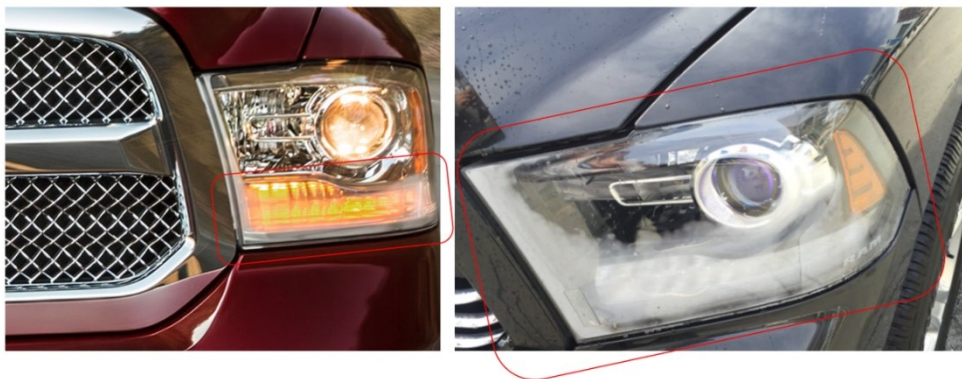
Some customers may report that on occasion, vehicle exterior headlamp assemblies are fogged with a light layer of condensation on the inside of the lenses (Fig. 1). This may be reported after the lamps have been turned on and brought up to operating temperature, turned off, and then rapidly cooled by cold water (such as rain, or the water from a vehicle wash). Lens fogging can also occur under certain atmospheric conditions after a vehicle has been parked outside overnight (i.e., a warm humid day followed by clear cool night). This will usually clear as atmospheric conditions change to allow the condensation to change back into a vapor. Turning the head lamp on will usually accelerate this process.

Fig. 1
Fogged Head lamps

A lamp that exhibits condensation/fogging should be evaluated in a service bay environment according to the following steps:

1. Dry all water from the outside surface of the lens.
2. Operating the lamps for 20 minutes by:
 - Starting the vehicle engine.
 - Turning on the vehicle lights and turn on the hazard lights.

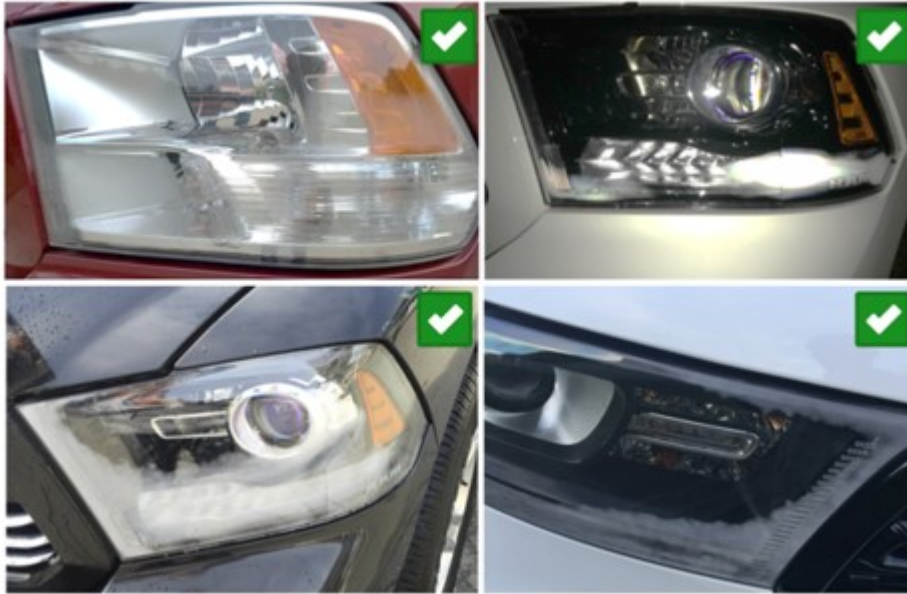
If the condensation/fogging has begun to clear (Fig. 2) from the lamp lens after 20 minutes with the lamps operating, this indicates the lamp sealing has not been breached, and the lamp does not need to be replaced.

Fig. 2
Condensation/Fogging Begun To Clear

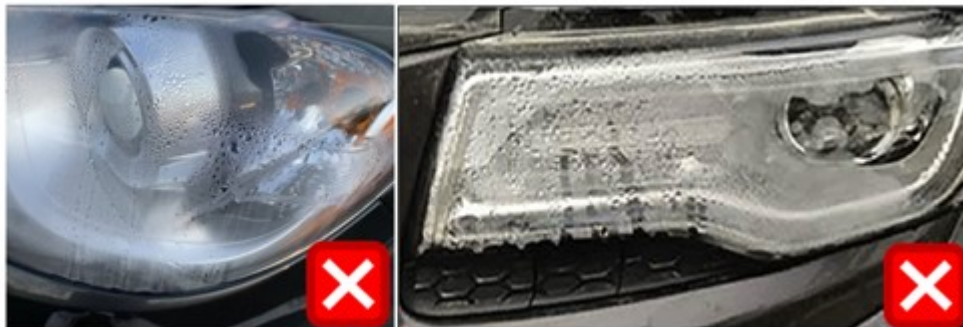
If the condensation/fogging has not begun to clear after 20 minutes with the lamps operating, or the lamp has large amounts of water droplets visible on most internal surfaces, this indicates a problem with the lamp sealing that has allowed water to enter the lamp. In this instance, the customer is also likely to report that moisture in the lamp is always present and never disappears (Fig. 3) . A lamp that exhibits internal moisture permanently should be replaced.

Fig. 3
Condensation/Fogging Not Begun To Clear

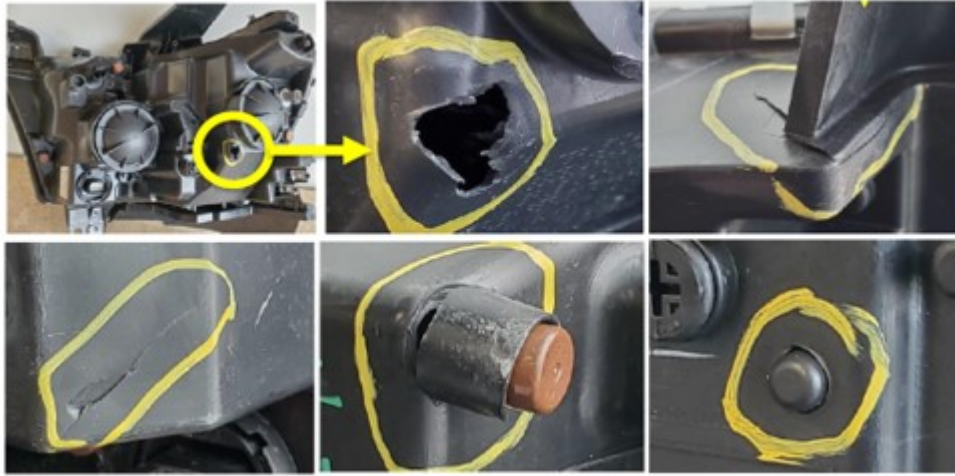
- **Damage:** Breakage on the head lamp housing will allow moisture/water to enter to the head lamp (damage, cracks, holes, etc.) (Fig. 4) . If this is noticed the failure code must be recorded accordingly: **11/BROKEN OR CRACKED**

Fig. 4
Cracked or Broken Head lamps

If no obvious causes are observed, proceed using the failure code for leaks (65) and replace the head lamp. Refer to the detailed service procedures available in DealerCONNECT/Service Library under: Service Info>08 - Electrical / 8L - Lamps and Lighting / Lamps/Lighting - Exterior / Unit, Front Lamp / Removal and Installation.

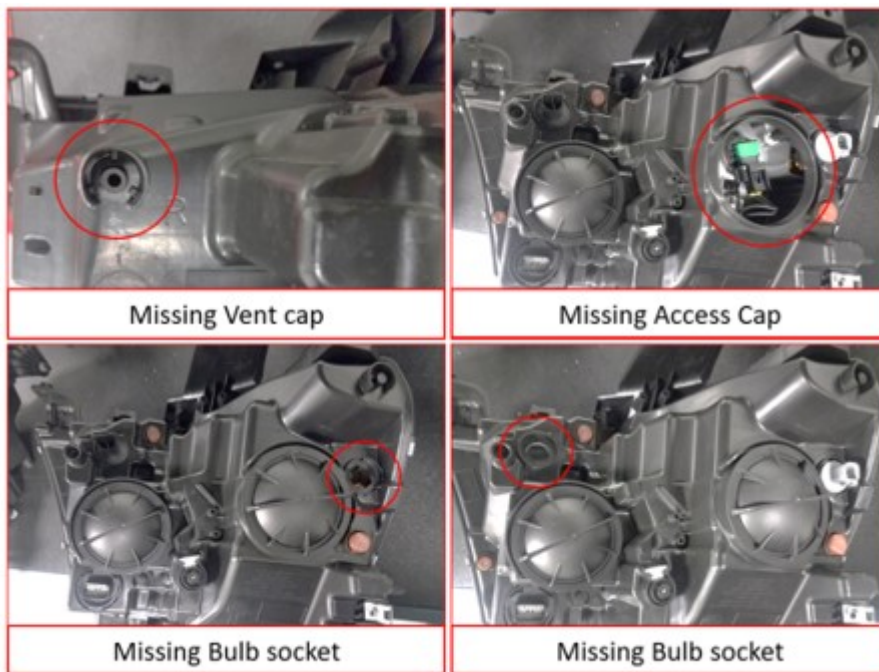
- **Missing Sealing Components:** Missing vent caps, access caps or bulb sockets will allow moisture/water to enter to the head lamp (Fig. 5) . If this is noticed the failure code must be recorded accordingly: **1C / CONNECTOR LOOSE NOT ATTACHED**
- **Misplaced Sealing Components:** Misplaced vent caps, access caps or bulb sockets will allow moisture/water to enter to the head lamp (Fig. 6) . If this is noticed the failure code must be recorded accordingly: **1C / CONNECTOR LOOSE NOT ATTACHED**

Fig. 5
Missing Sealing Components

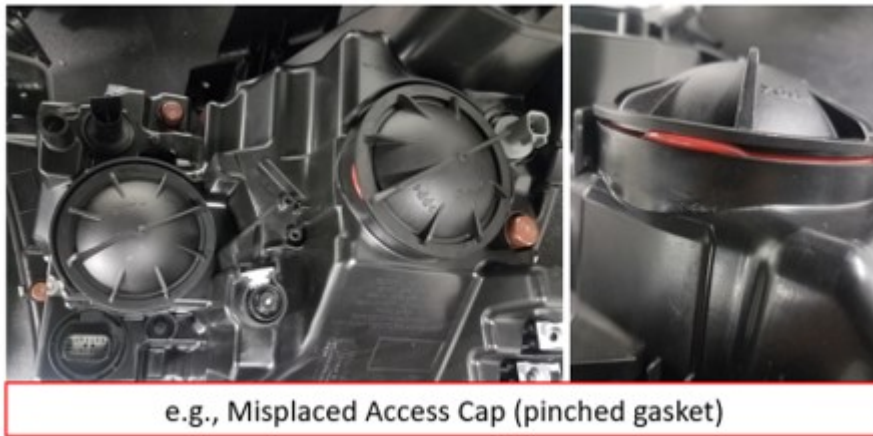
Fig. 6
Misplaced Sealing Components
