94-23-01 - Headlamp: Rubber lip-seal (between headlight and fender) loose

Release date: 4/6/2023

Technical Service Bulletin

Transaction No: 2069487/2

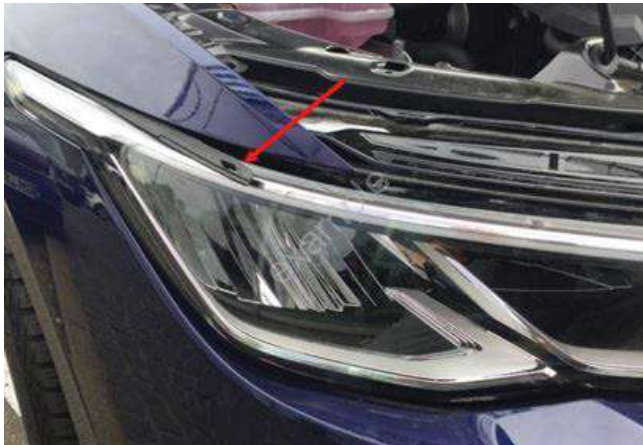
Figure 1.

Incorrect assembly of the rubber lip/seal in the assembly process. This can result in damage to the locking lug. As a result of the damage to the locking lug, the rubber lip/seal comes loose or protrudes.

The rubber lip/seal (see Figure 1, red arrow) between the headlamp and the fender (left/right) is loose/detaching/is off.

Glue the rubber lip/seal.
