## Technical Service Bulletin # 2023-001

**Models affected:** Micro Minnie

**Subject: Micro Minnie Outrigger**

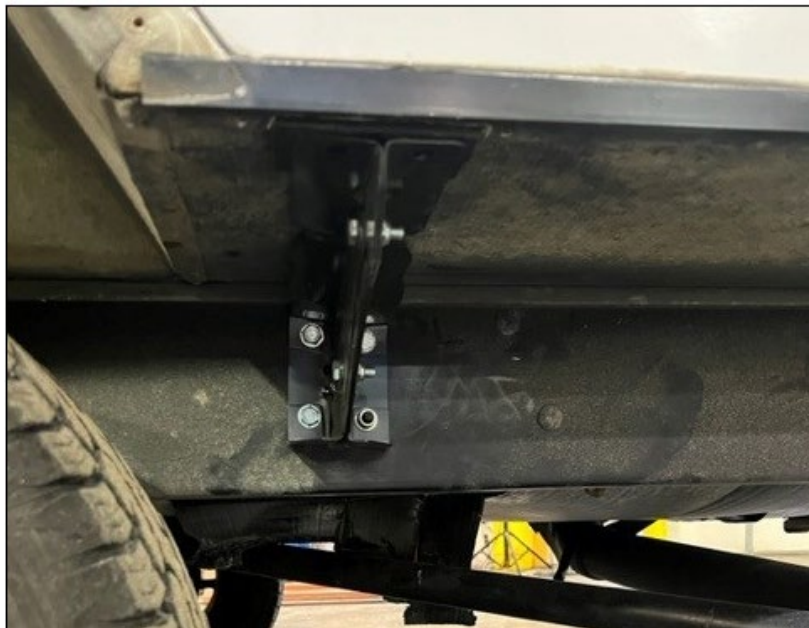
Winnebago has come to the realization that some Micro Minnie models may experience a flex on the outside edge of the floor and off door sidewall. As a result, the single outrigger support behind the wheel well may become deformed and/or the exterior structure will become compressed at this point.

1. Place jack next to current outrigger behind wheel well and raise just enough to relieve pressure off the outrigger.
2. Remove outrigger bolt running vertically into the sidewall.
3. Raise jack just high enough to allow room for the ¼" shim to slide freely above the outrigger.
4. Install additional outrigger into the frame rail using self-tapping screws next to the current outrigger so that the side face plates rest against each other, and the tops are flush.
5. Join the 2 outriggers together using bolts and lock nuts.
6. Place the steel shim on top of the joined outriggers and lower the jack.
7. Repeat steps for opposite sidewall.
