# Technical Service Bulletin

**91 Rear parking aid or hands-free tailgate release inop, DTC U115200, B107D31, B107BF0, or B107E31 are stored**

91 23 89 2057357/5 April 13, 2023. Supersedes Technical Service Bulletin Group 91 number 21-85 dated March 29, 2021, for reasons listed below.

Model(s)	Year	VIN Range	Vehicle-Specific Equipment
A6, and A7	2019	All	Not Applicable

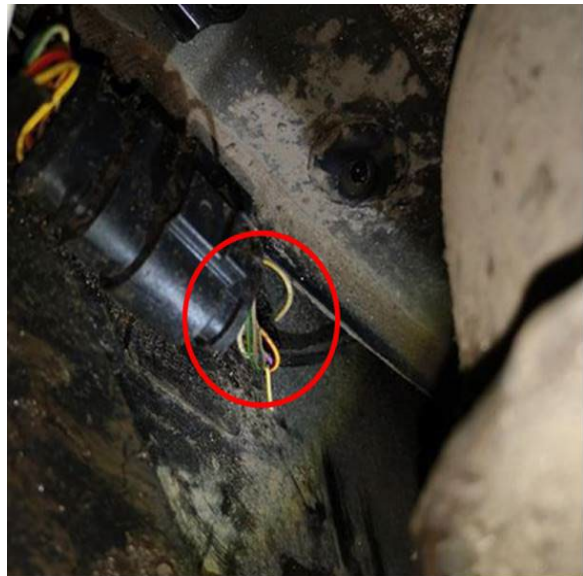
The connector housing or wires leading to connector T14m may become damaged due to road debris.

**Figure 1.** Location to inspect T14m for damage.

2. If there is damage found, repair the affected wires and/or connector housing using VAS1978B.
3. Slide the new grommet, part number 6X0 971 921 B onto the harness and then reassemble the connector. Ensure the grommet is fully seated on the connector before refitting the bumper.
4. Once the repair is complete, clear out all DTC's and check the system for functionality.

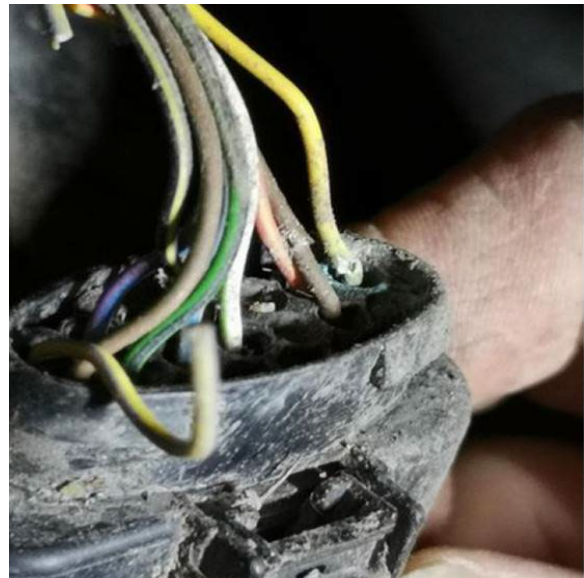
**Figure 2.** Close up of T14m connector showing harness damage.
