Technical Service Bulletin

87 Air conditioning does not cool - P053000, P251500 stored in C5

87 23 40 2068460/3 April 10, 2023. Supersedes Technical Service Bulletin Group 87 number 23-38 dated January 31, 2023, for reasons listed below.

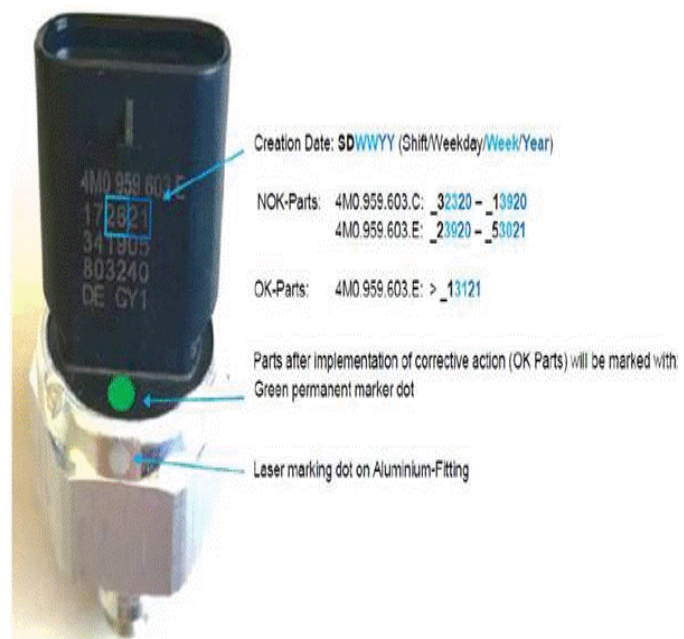
A failure of the sensor electronics causes a loss of pressure evaluation. The sensor with base part number 4M0959603 and a build date before the date Calendar Week 31, 2021 is at issue (G395 / G827).

2. Inspect the markings on the sensor to determine if the sensor has been previously replaced with an improved sensor produced after Calendar Week 31, 2021. Figure 1 shows the locations of the markings and their interpretation. In this example, while the sensor is an 'E' index sensor, contains a green dot on the connector housing and a laser marking on the aluminum housing the build date of the sensor is *before* Calendar Week 31, 2021, and would require replacement.

Figure 1. Pressure and temperature sensor markings and build date.

1. Should the vehicle present with the symptom profile described in this TSB inspect and/or replace all of the pressure sensors in the refrigerant circuit that are of the base part number 4M0959603 and have a build date before Calendar Week 31, 2021. Each model for which this TSB appears will have between 1 and 3 of this type of sensor installed at various positions in the refrigerant circuit, either on the low or high pressure sides of the circuit (G395 / G827).

3. A sensor with index 'E', produced after Calendar Week 31, 2021, has a green dot on the connector housing, and has a laser marking on the aluminum housing is of the improved type and need not be replaced.
