GROUP	MODEL
Engine	2021-2023MY K5 (DL3a) w/1.6L T-GDI
NUMBER	DATE
PS744	April 2023

COOLANT RESERVOIR OVERFLOW PORT

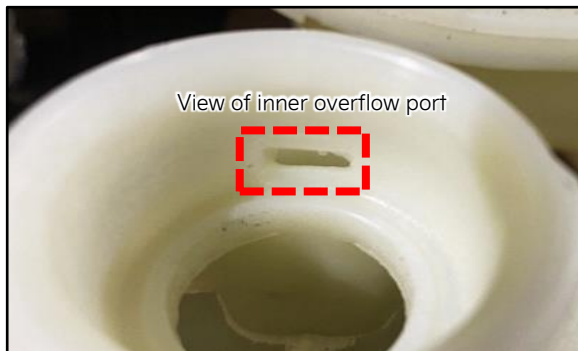
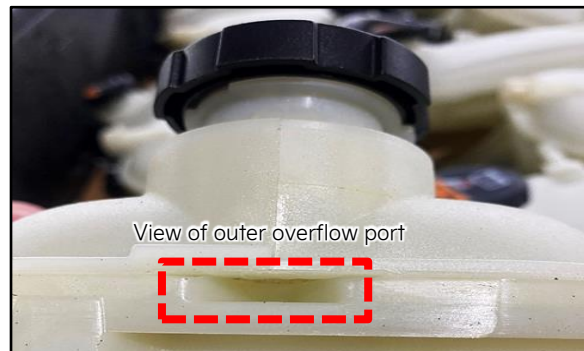
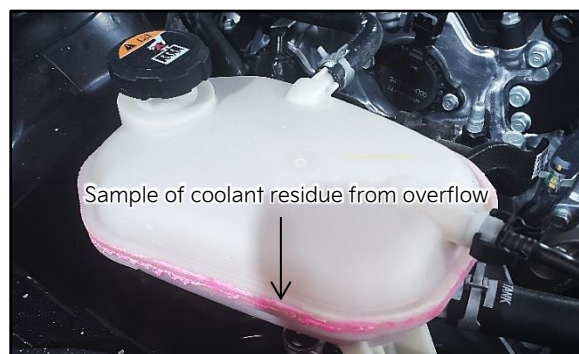
This Pitstop provides information regarding the presence of engine coolant residue found on the coolant reservoir of some 2021-2023MY K5 (DL3a) vehicles equipped with a 1.6L T-GDI engine. The coolant reservoir on these Kia models was designed with a coolant overflow port located in the rear of the reservoir. During normal vehicle operation, coolant level may rise at or above the overflow port which can seep out of the coolant reservoir, therefore causing coolant to flow out and accumulate around the center seam of the reservoir. This may lead technicians to believe the coolant reservoir is faulty.

If coolant residue is found along the seam, clean the reservoir exterior using water only and wipe clean with a cloth. DO NOT use harsh chemicals such as a degreaser, brake cleaner, or throttle body cleaner to clean the reservoir. Using harsh chemicals can discolor and/or weaken the reservoir nylon material causing premature wear. Follow the 'Cooling System → Troubleshooting' instructions on KGIS or use a cooling system pressure tester to confirm if a leak is present prior to replacing the coolant reservoir.

DO NOT replace the coolant reservoir for the underlined concern described. Warranty claims filed for the replacement of the coolant reservoir will be subject to dealership chargeback.
