GROUP	MODEL
BOD	2023MY Telluride (ON)
NUMBER	DATE
315 (Rev 1, 04/04/2023)	March 2023

TECHNICAL SERVICE BULLETIN

SUBJECT: SERVICE ACTION: CRASH PAD CENTER SPEAKER GRILL INSPECTION/REPLACEMENT (SA528)

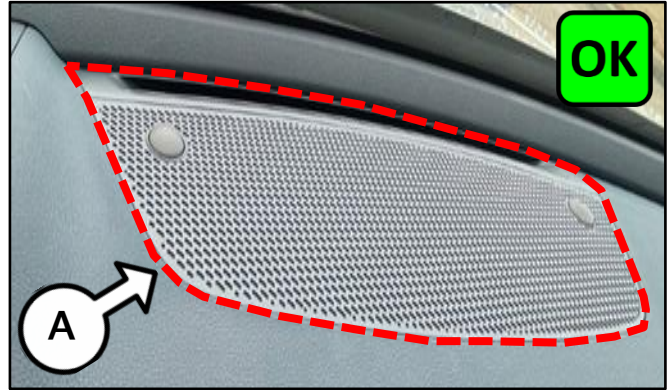
- Speaker grill cover is properly seated (OK). No further action required.

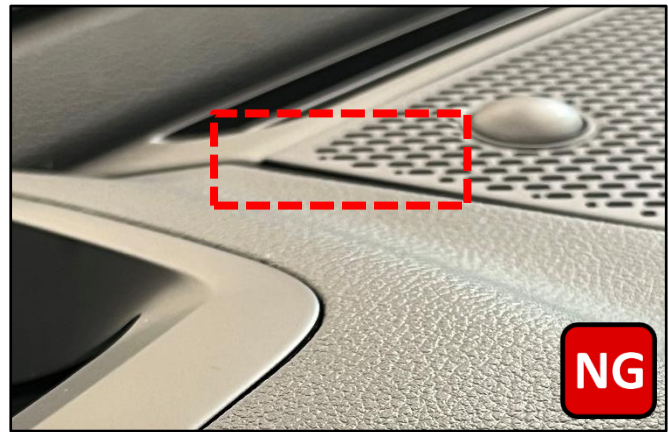
- Speaker grill cover LH corner is sticking up (NG). Proceed to 'Replacement Procedure' on page 3.

Replacement Procedure:

1. Disconnect the negative (-) battery terminal.
2. Remove crash pad center speaker grill cover (A).
