# Customer Satisfaction Program

## N222381840 Side Blind Zone Alert Retrofit

Release Date: April 2023

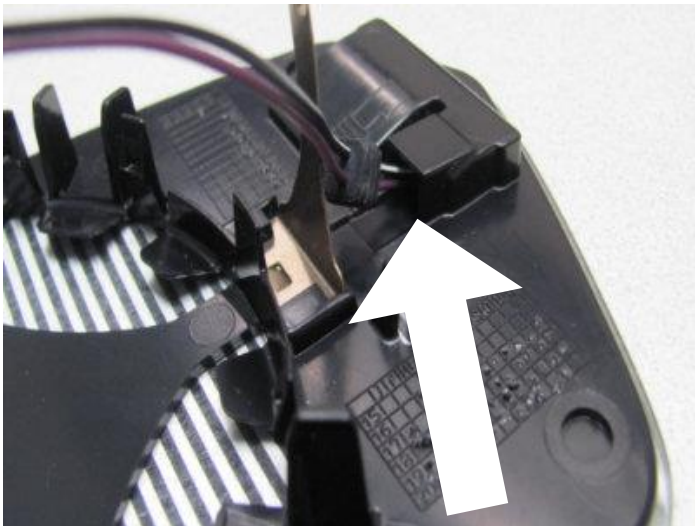
6291752

1. Install the left and right-side obstacle detection control modules. Ensure the correct part number is installed in the correct left-right position. Refer to *Side Obstacle Detection Control Module Replacement* in SI. The brackets and fasteners are already installed on the vehicle. Only remove the rear bumper fascia enough to install the modules, it is not necessary to completely remove the assembly. When programming the modules, only the left module requires programming.

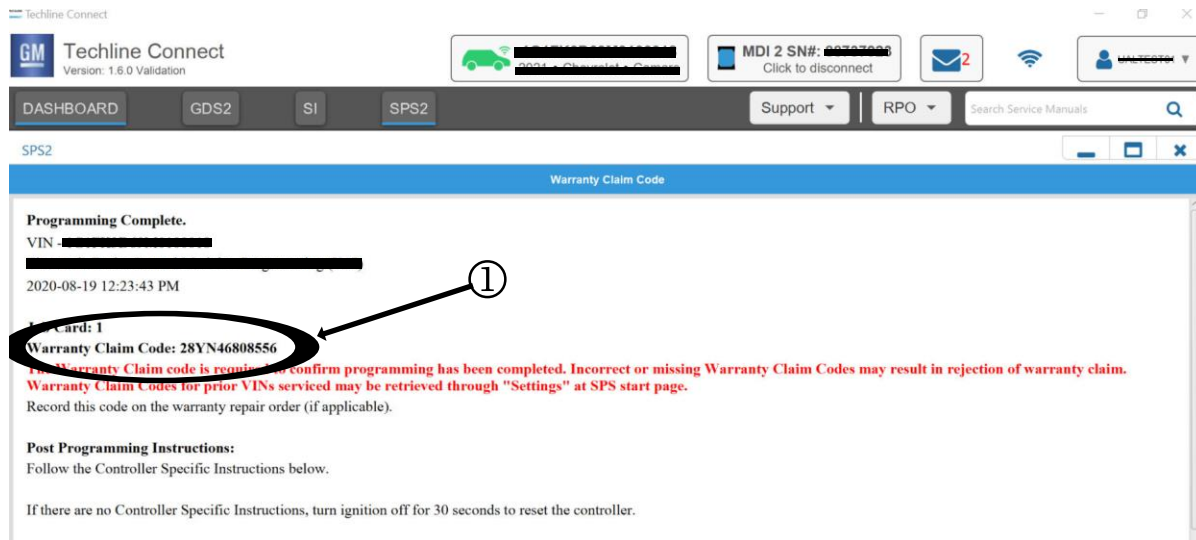
5644478

**Note:** The screenshot above is an example of module programming and may not be indicative of the specific module that is being programmed. Module selection and VIN information have been blacked out.

**Important:** To avoid warranty transaction rejections, you **MUST** record the warranty claim code provided on the Warranty Claim Code (WCC) screen shown above on the job card. Refer to callout 1 above for the location of the WCC on the screen.

5. Record SPS Warranty Claim Code on job card for warranty transaction submission.
