MAS003517 RU 23-06

Rapid Update 611 MC20 – steering column control stuck (OPT SBE)

DATE: MARCH 28 2023

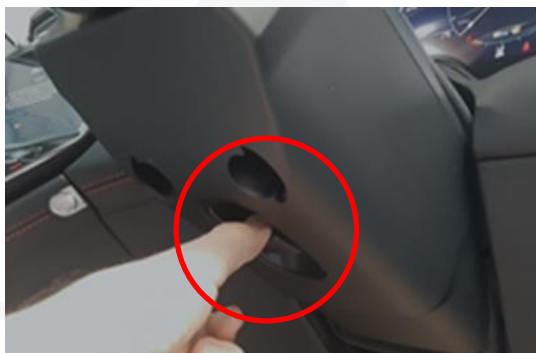
1. Always check ModisCS+ to see if the vehicle is involved in this action and if it has not been previously performed.
2. Switch the Ignition to the "ON" position.
3. Use the "power tilt/telescoping steering column/wheel switch" to operate the power tilt/telescopic steering column in the following sequence below:

- a. 3 UP activations
- b. 3 DOWN activations
- c. 3 SLIDE FORWARD activations
- d. 3 SLIDE BACK activations

- An acoustic "click" must be audible.
- At the end of the action, the button must return to the base or resting position.
- The steering wheel movement must stop when releasing the button.

4. Switch the Ignition "OFF".
5. If all the conditions are satisfied for all the activations, the **check is OK**, no further operation is needed, the procedure is complete.
6. If at least one of the conditions is not verified for one or more activations, the **check is NOT OK** and the component must be replaced, following the procedure below (available in the workshop manual):
 - a. **8.50.055.0 - STEERING COLUMN ADJUSTMENT CONTROL - Removal/refitting or replacement**
7. Operation is complete.
