Technical Journal

WPC (Wireless Phone Charger) charging information

REF NO: TJ 36125.3.0	ISSUING DEPARTMENT: Technical Service	CAR MARKET: United States and Canada	
PARTNER: 3 US 7510 Volvo Car USA		ISSUE DATE: 2023-02-24	STATUS DATE: 2023-01-11
FUNC GROUP: 3942	FUNC DESC: Mobile telephone	Page 1 of 4

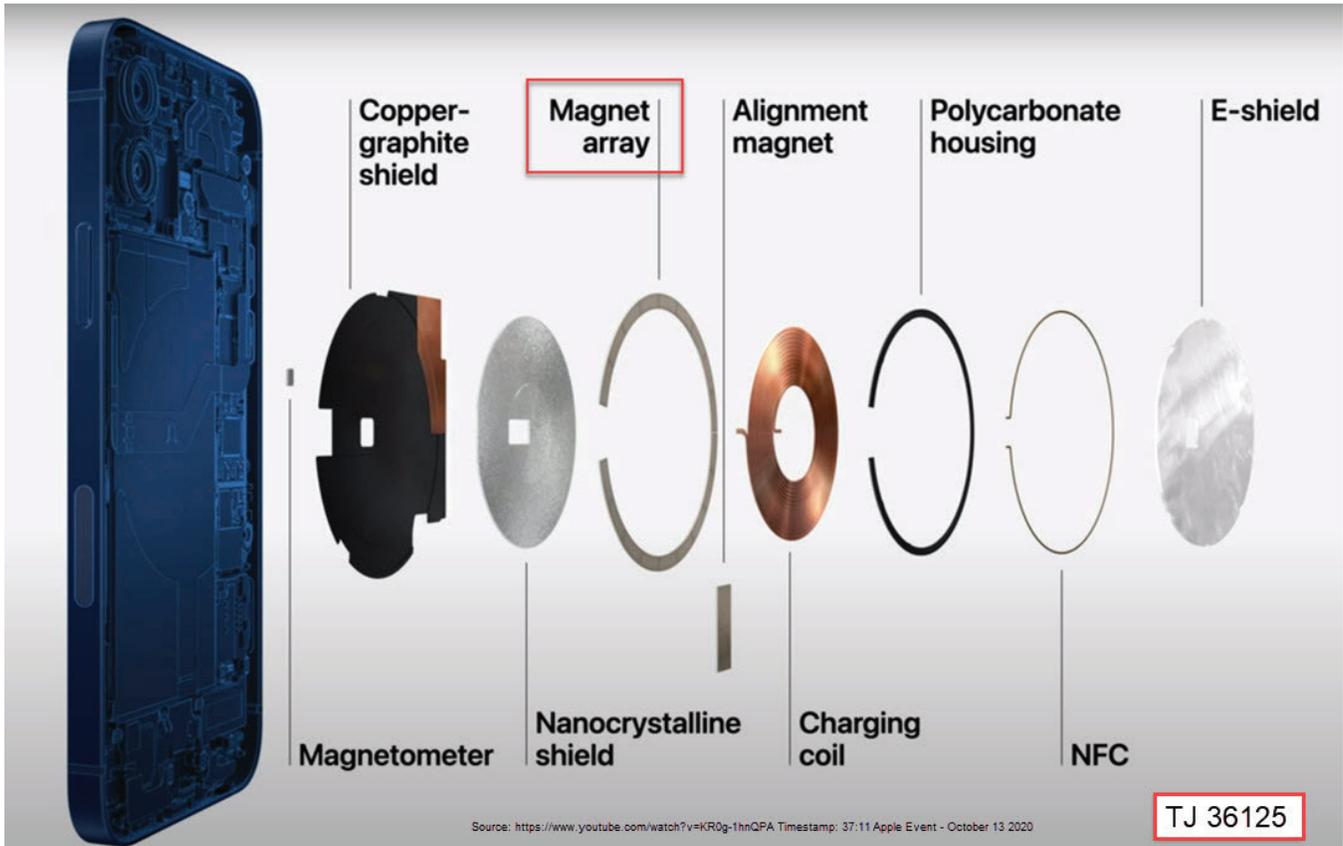
File Name	File Size
Reference Magnet array TJ 36125.jpg	0.0837 MB

- * For some phone brands, if a USB cable is connected to the phone it will not charge wirelessly.
- *The symptom that iPhone 12/13/14 sometimes does not charge, has to do with the construction of the iPhone, not the WPC. The iPhone 12/13/14 has a built in magnet array that are supposed to align Apple's own WPC table charger with the phone for best charging (see attachment). Since iPhone 12/13/14 is not Qi certified, we cannot ensure the full compatibility and functionality with our WPC. The WPC in the listed car models has a foreign object detection (FOD) function which detects the magnet array in the iPhone 12/13/14 models as a foreign object and therefore shuts off the charging (as a safety precaution). The WPC software released 21w27 has improved this issue. If not already done, perform a software upgrade as per TJ 31543 (this does not apply for XC40 with fuel engine, those has another type of WPC). The WPC software is included in Total Upgrade, Service 2.0 and PDS Upgrade packages.
