Volvo Car USA LLC

Technical Journal

Technical Journal Title		Ref. No.	
Creaking noise from right engine pad		TJ 36563.1.0	
Issuer (Dept.)		Issue Date	Status Date
Technical Service		3/14/23	3/17/23
Car Market	Partner	Function Group	
United States and Canada	3 US 7510 Volvo Car USA	2182	
Function Description		Page	
Rubber cushion		Page 1 of 3

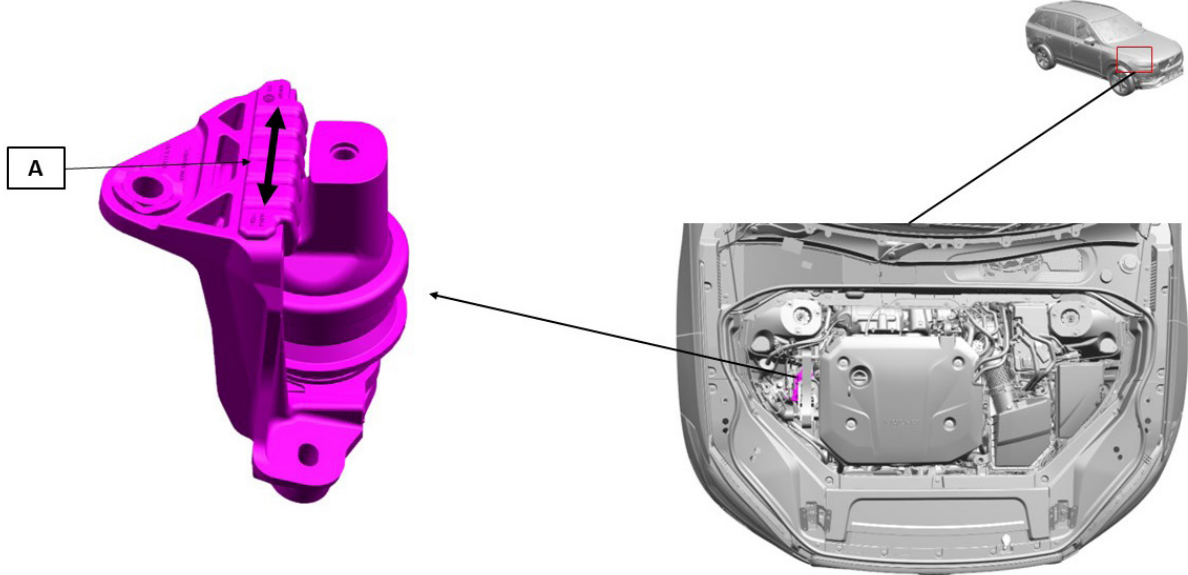
TJ 36563

If a creaking noise appears from the front right engine pad when turning sharp left at high load (see attached video *TJ 36563 Engine pad noise.mp4* for reference) and the outside temperature is under approx 41°F (5°C) for the first 10 minutes of driving, follow advice under “Service”.

Apply lubricant, Würth P/N 0893550, along the length of the rubber where it touches the metal according to attachment *TJ 36563.jpg* ref. A.
