**Volvo Car USA LLC****Technical Journal**

Technical Journal Title		Ref. No.	
Left front LED flickers after turning car off - Check outer position bulbs		TJ 36584.1.1	
Issuer (Dept.)		Issue Date	Status Date
Technical Service		3/20/23	3/24/23
Car Market	Partner	Function Group	
United States and Canada	3 US 7510 Volvo Car USA	3520	
Function Description		Page	
Lighting, front		Page 1 of 3

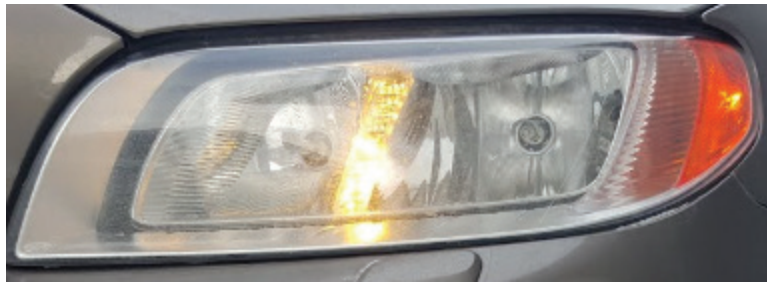
If customer has a complaint of the left front LED within the headlight assembly flickering after the car is turned off (See [attached video](#) for reference), please see service below.

If the symptom is confirmed please check outer position bulbs in both front headlights for proper operation.

Replace both position bulbs if found faulty. (See attachment)
