# TECHNICAL SERVICE BULLETIN

Technical Service Bulletin: 10-1629

Forest River is alerting you to an issue involving certain 2023 Rockwood Lite and Flagstaff Lite Travel Trailer recreational vehicles. Please see the information below, which describes the issue and provides you with details on the steps you should take to have your vehicle repaired.

The roof sealant on may show signs of cracking.

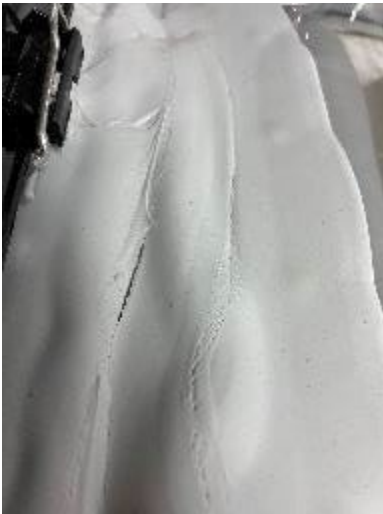
FIGURE 1

- IF CRACKED OR LOOSE SEAL(S) ARE FOUND (FIGURES 1, 2 & 3) THEN MOVE ON TO REMEDY.

IF THE ROOF CAULK (ALPHA SYSTEMS SELF-LEVELING SEALANT) IS DEFECTIVE IN ANY WAY, THEN PLEASE PULL UP ANY LOOSE CAULK.

DO NOT USE ANY TOOLS, SUCH AS A PUTTY KNIFE, THAT COULD PUNCTURE THE ROOF MEMBRANE MATERIAL.

IF YOU CANNOT PULL THE CAULK OFF BY HAND, THEN IT IS STILL ADHERED TO THE ROOF MATERIAL AND SHOULD BE LEFT ALONE.

NEW SEALANT CAN THEN BE APPLIED OVER THE OLD SEALANT.
