GROUP	MODEL
ELE	2023MY Seltos (SP2)
NUMBER	DATE
287	April 2023

TECHNICAL SERVICE BULLETIN

SERVICE ACTION: ICU-D CONNECTOR INSTALLATION (SA529)

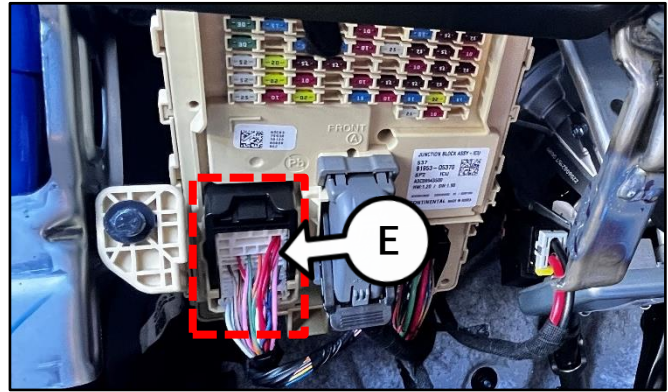
6. Locate the ICU-D connector (E) and confirm it is fully seated into the female plug.

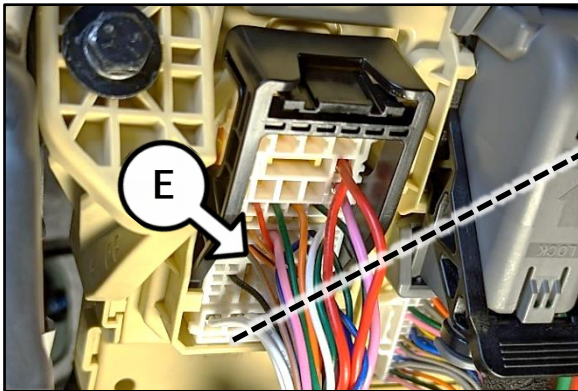
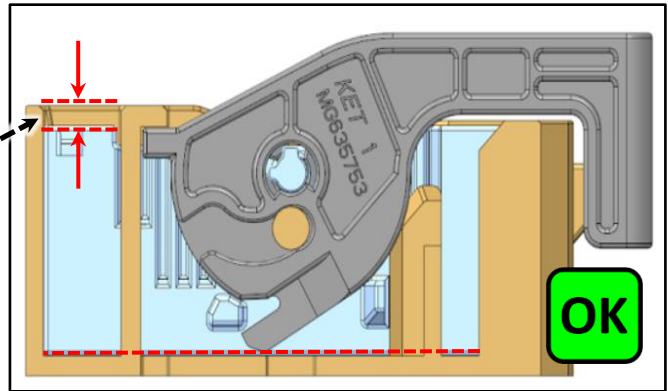
- 7a. Verify that the ICU-D connector (E) is fully inserted/seated correctly (OK). Refer to images below. There should be a visible small gap at the surface of the connector in the red outlined area shown. The connector must be seated flush at the bottom of the female plug.

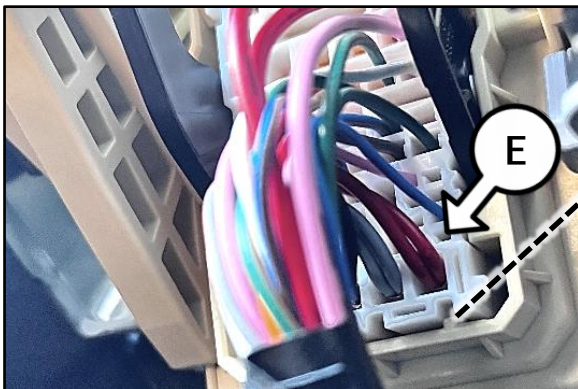
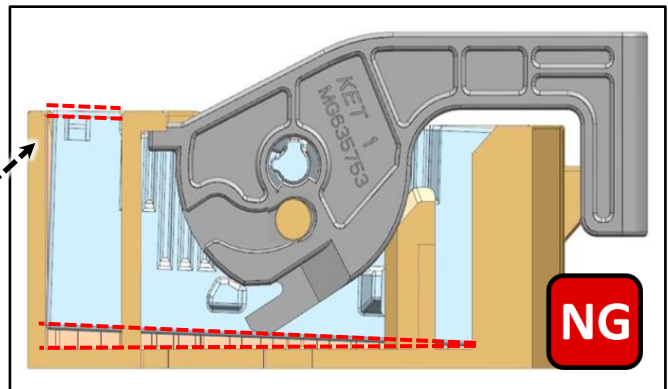
- 7b. The ICU-D connector (E) is not fully seated/inserted correctly (NG). Refer to images below. It is possible that the ICU-D connector may be sticking out slightly from the female plug outside edge as shown below. This may be due to the connector not seating flush at the bottom of the female plug.

Proceed to step 8 for repair instructions.
