# Newmar Corporation

RSB 597  
April 28, 2023

NHTSA #23V 138  
TC #2023-110

## RECALL SERVICE BULLETIN

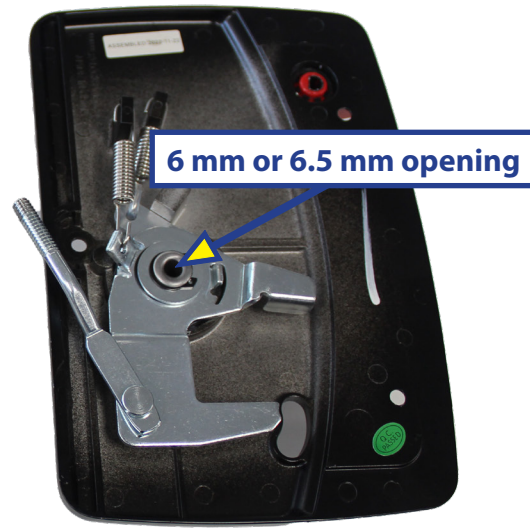
**Replacement Not Needed**

- Using a 1/4" screwgun bit, try to insert the bit into the spun rivet of the inside latch assembly (Fig. 5).
- If bit fits into rivet opening there are two options:
  - Replace the complete latch assembly, including both inside and outside latch assemblies.
  - Replace just the inside latch assembly to be combined with current outside latch assembly.
- If the bit does not fit, no action is required. Proceed to latch reassembly instructions.
